V2 NEVM VERMONT Septic System Inspection Report

20240606-18368780150

356 points north

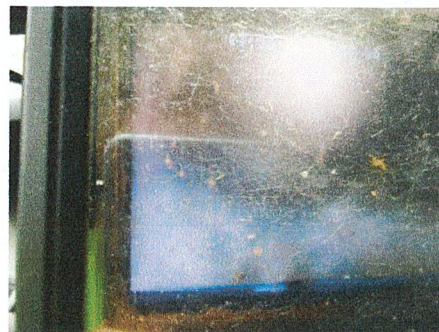
Inlet line condition

Functional

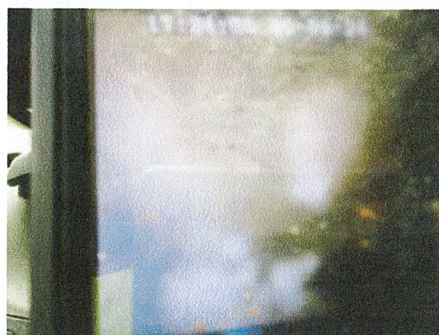
Septic tank inlet baffle

Inlet baffle condition

Functional

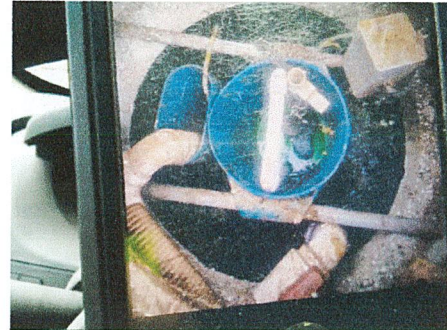
Is there a compartment wall present?	Yes
Compartment wall condition	Functional
Is the outlet baffle present?	No
Outlet baffle type	N/A
Outlet baffle condition	Not Functional
Septic tank outlet baffle

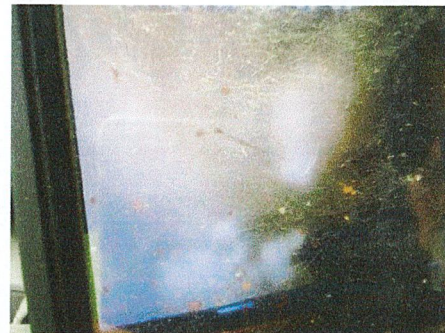
Does the tank have an effluent filter?	Yes
Was the effluent filter cleaned at time of inspection?	N/A
Outlet pipe type	PVC
Outlet pipe condition	Functional
Outlet pipe

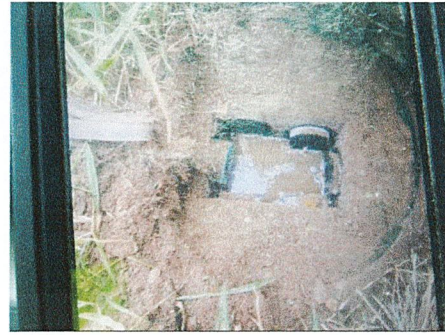
First component

Type of System	Galleries
Age of leaching system	Original
Is there a distribution box before the first component of the leaching system?	Yes
Condition of distribution box	Functional
What was the effluent level in the distribution box?	Level with all inverts
What is the effluent level in the first component?	Level with invert

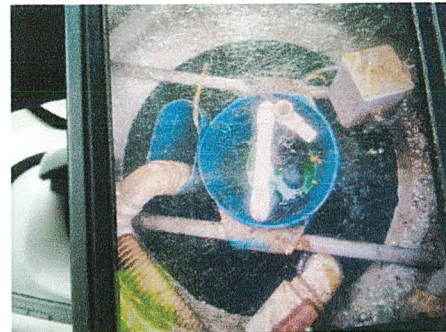
Is the system served by a pump and pump chamber?	Yes
Is the pump in working order?	Yes
Alarm	Yes
Manhole to grade	Yes
Pump & controls
