RE: 217 WOODS RD
STOWE.

- 1/ • BUILDING INSPECTION
- 2/ • WATER TEST
- 3/ • SEPTIC PUMPING
- 4/ • RADON REPORT.

Vermont Home Inspection Services

Address
217 Wood Rd
Stowe VT 05672

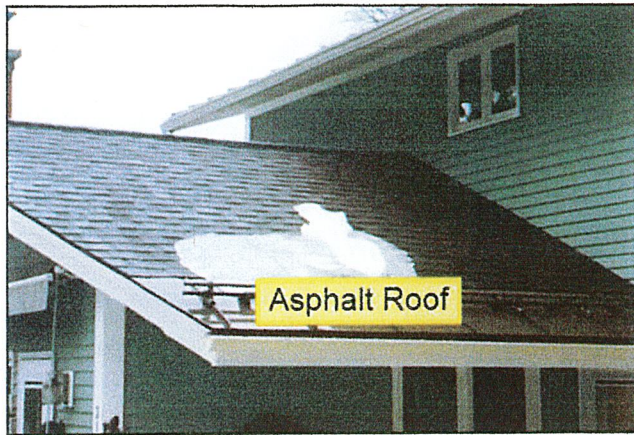
(1) Two types of warranties are offered when new asphalt shingles are installed; The manufacturer's warranty, which covers the shingles themselves and varies among manufacturers, and the contractors warranty, which covers the installation and workmanship. When a home is sold, a roof warranty may fully transfer to the home buyer, may transfer for a shortened length of time, may transfer with limited coverage, or may not transfer at all. I recommend you consult with the home owner as to the how the sale will affect the current warranty and confirm any seller claims by reading the warranty.

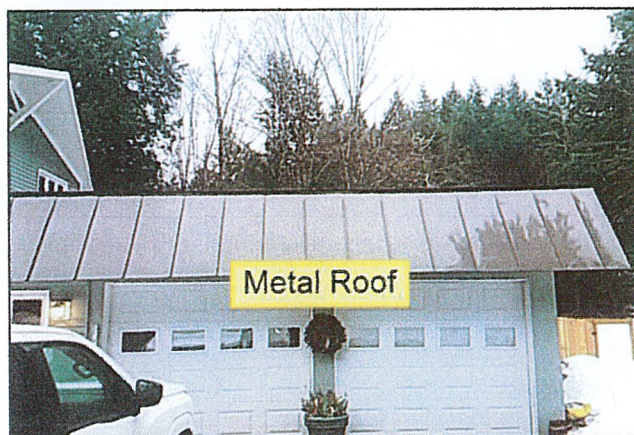
(2) Portions of the roof is covered with metal roofing. Typical life span is 50-75+ years depending upon the quality of installation. Metal roofs are known for their durability, longevity, and low maintenance requirements. They are resistant to fire, rot, insects and can withstand extreme weather conditions. This is provided for your information.

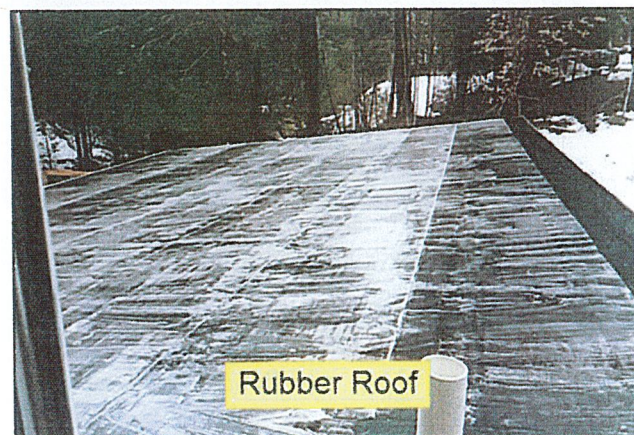
(3) The garage roof is covered with a rubber membrane. Rubber membrane roof life expectancy can last up to 40 years with proper installation and regular maintenance. This is provided for your information.

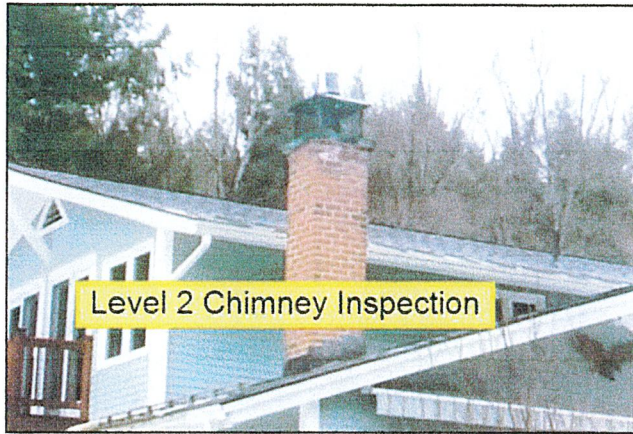
A Level 2 chimney inspection is recommended. Level 2 chimney inspections use a camera that runs into the flues to inspect the condition of the interior flues, liners, liner joints etc. Damaged flues can lead to costly repairs. Recommended accreditations for chimney sweeps; CSIA Chimney Sweep Institute of America and NFI National Fireplace Institute.

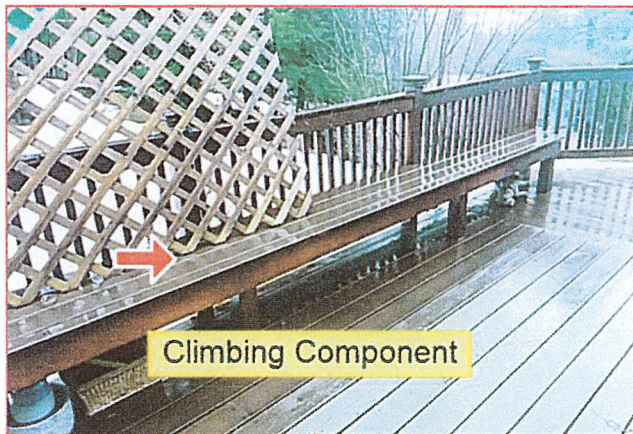
(1) There are horizontal components within the deck structure. These can provide a climbing surface for children. I recommend these horizontal components be repaired/replaced by a licensed contractor.

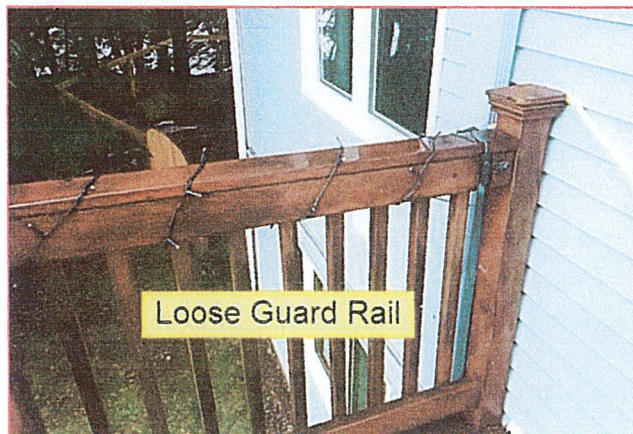
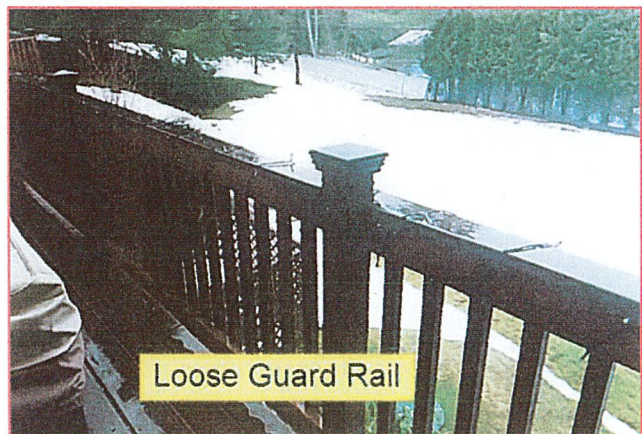
(2) The deck guard rail is loose to the framing. Guard rails are required to withstand up to 200 lbs of pressure to be safe. I recommend a licensed contractor repair/replace this guard rail.

Secured guard rail

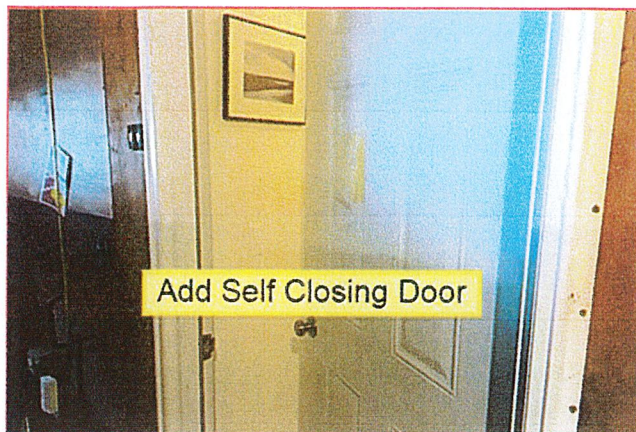
The occupant door from the garage into the home is not a self closing door. Self closing hinges are required at this location. I recommend self closing hinges be added to this door.

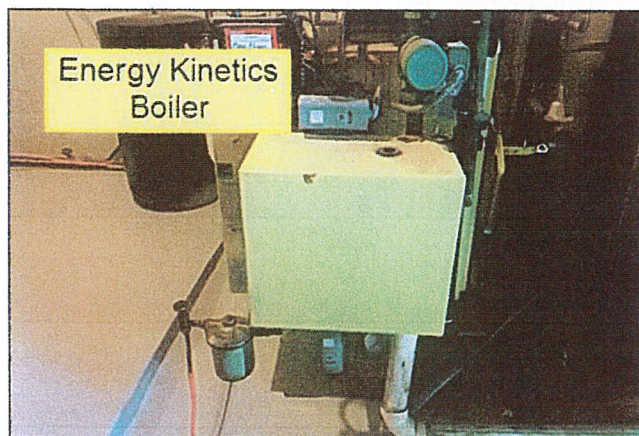
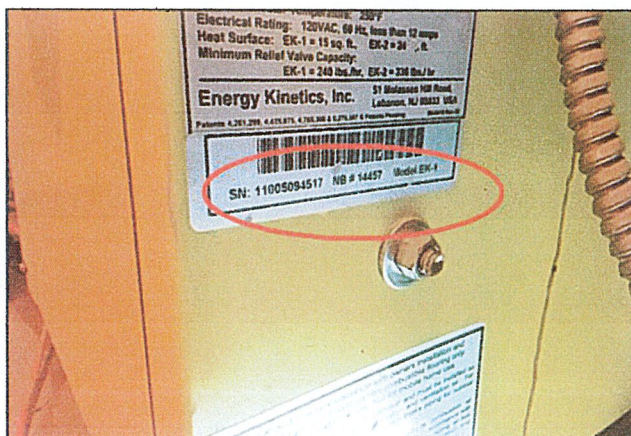
The home is serviced by a Energy Kinetics boiler. This unit was manufactured in May 2010 and was operational on the day of the inspection. This is provided for your information.

I recommend the heating system be cleaned and serviced on an annual basis by a qualified HVAC professional.

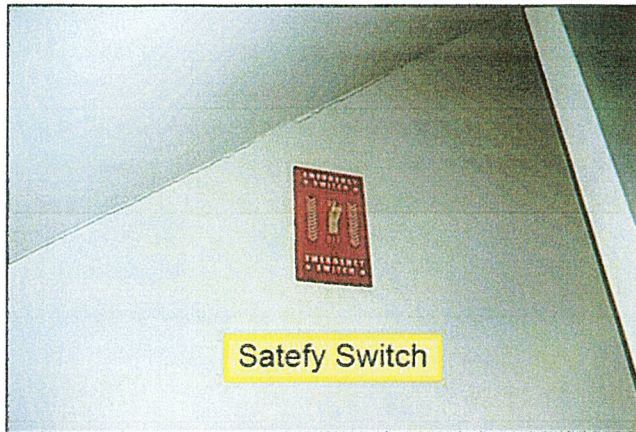
(1) The safety shut off for the heating appliance is located at the top of the cellar stairs. This is provided for your information.

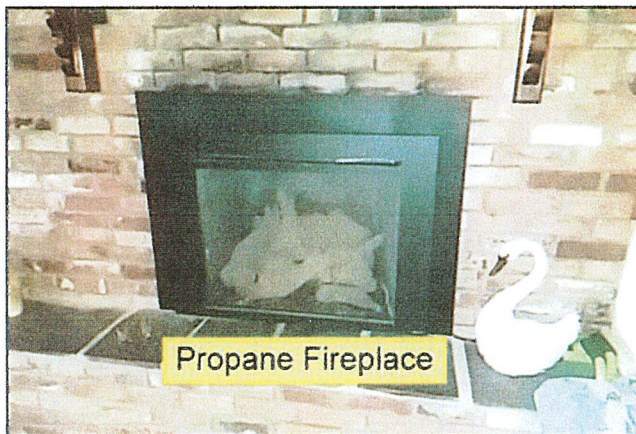
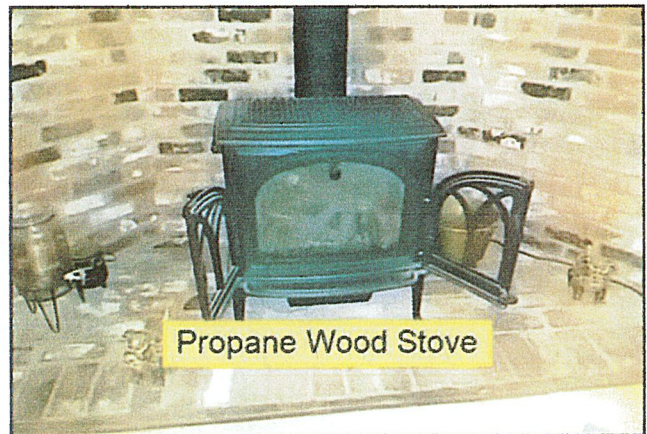
Two propane fireplaces are present in the home. these units were not tested on the day of the inspection. I recommend speaking with the current owner around the history and operation of these units.

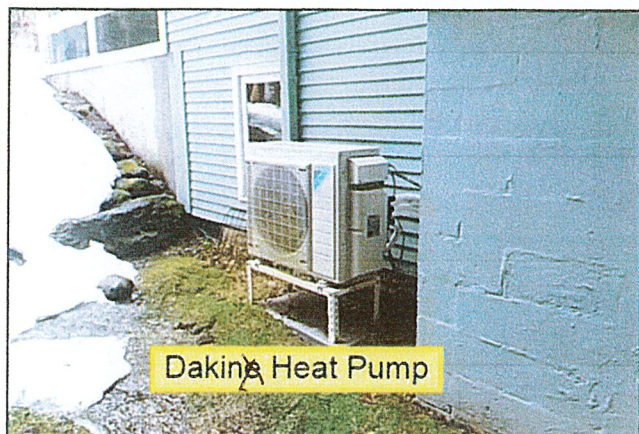
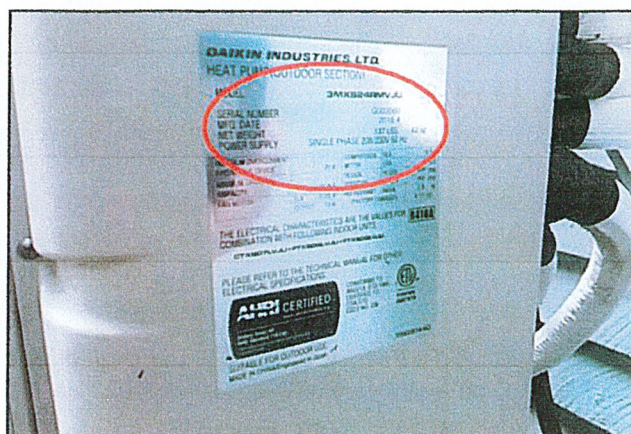
(1) The home is provided with a Dakine mini split/heat pump system. This system compressor was manufactured in April 2018. This is provided for your information.

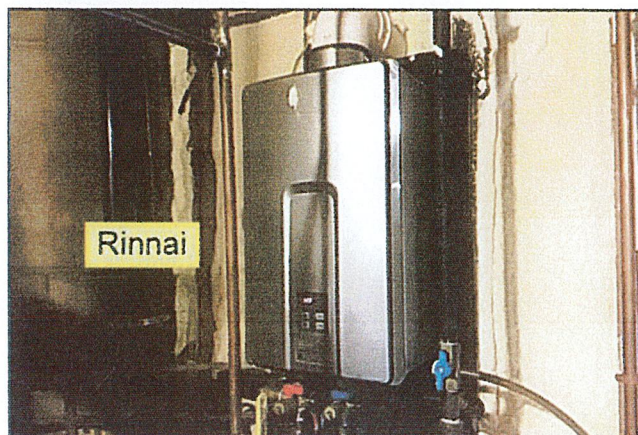
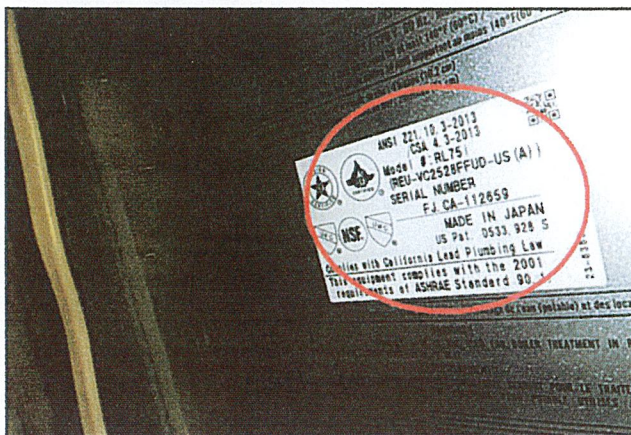
The home is supplied with a Rinnai hot water heater. This unit was manufactured in September 2014, and was operational on the day of the inspection. This is provided for your information.

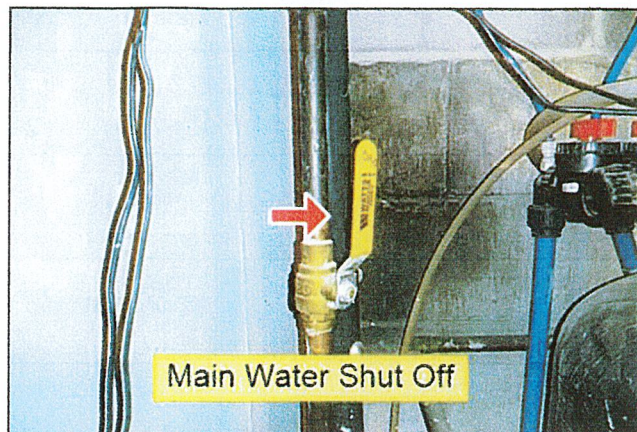
The main water shut off is located in the utility room in the basement. This is provided for your information.

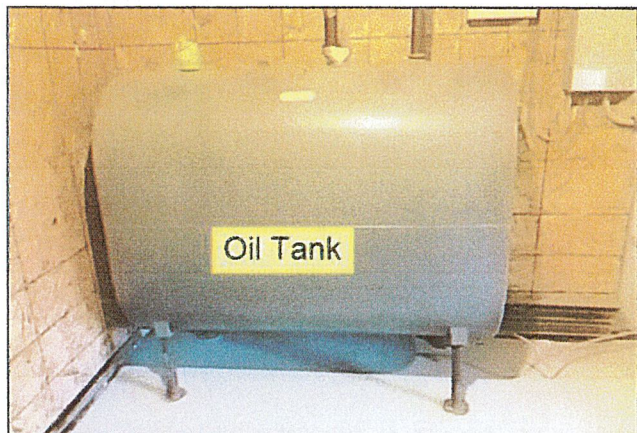
Photo 1

(1) Fuel dealers are required to inspect all oil tanks (Photo 1) prior to the initial delivery of fuel to a new customer. Any problems identified during their inspection which indicate a significant risk of a spill must be corrected before fuel is delivered. All oil tanks must be inspected every 3 years by a certified tank inspector.

Vermont law requires all above ground heating oil tanks storage tanks to be inspected every 3 years to insure the tank remains safe to fill.

The exterior of the oil tank was inspected for leaks and rust. Oil tanks rust from the inside and the outside. The only way to know the thickness of the tank is for a heating contractor to measure the thickness of the tank with an ultrasonic devise. An oil shut off is present at the base of the oil tank (Photo 2).

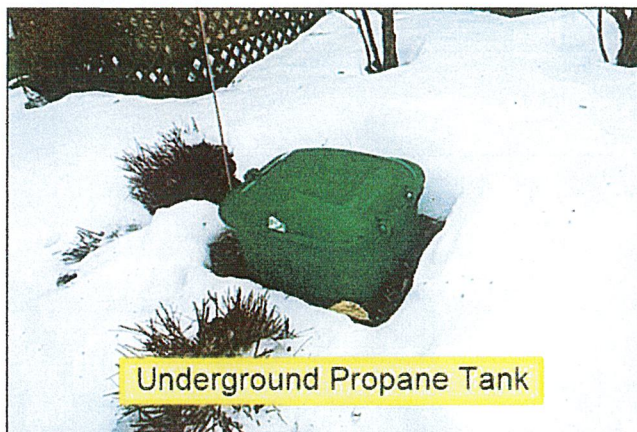
Photo 1

(2) A underground propane tank is present at the exterior of the home (Photo 1). A propane shut off is located under the tank cover (Photo 2). This is provided for your information.

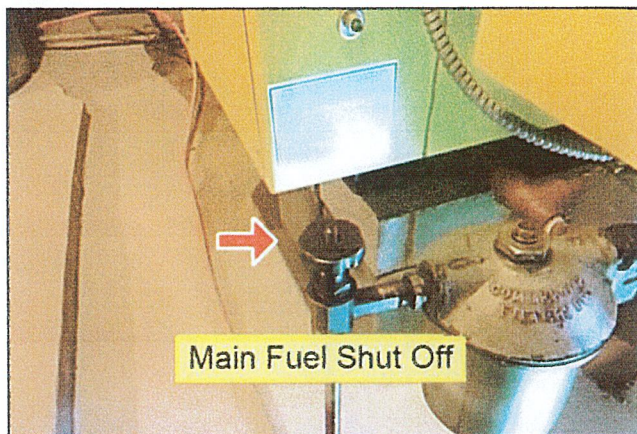
(1) The main fuel shut off is located at the oil burner in the basement. This is provided for your information.

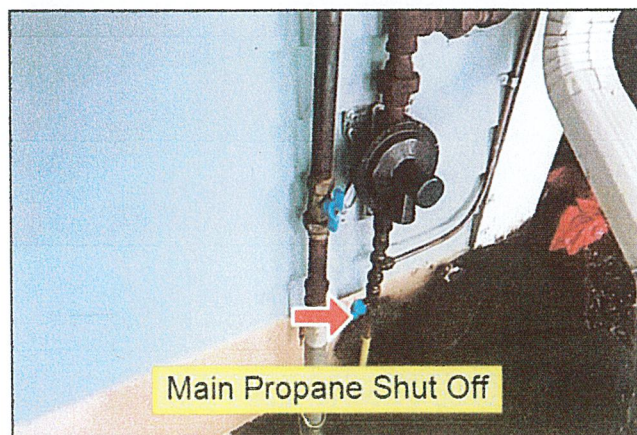
(2) The main propane shut off is located at the exterior of the home. There are also individual shut offs at appliances. This is provided for your information.

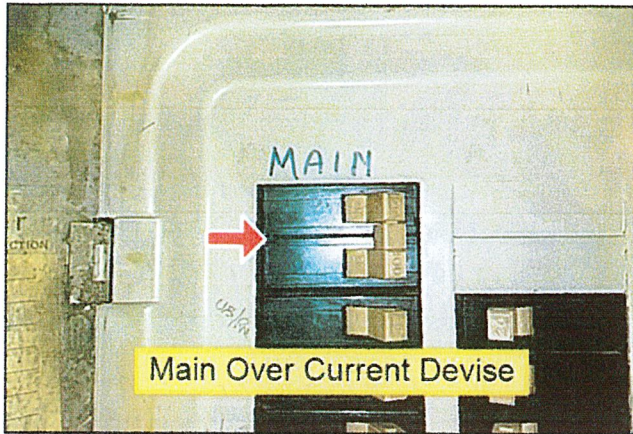
(1) The main over current device is located in the main electric panel located in the basement. This is provided for your information.

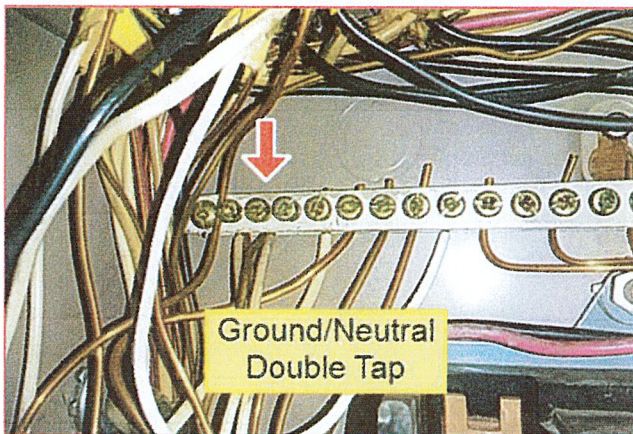
(2) Ground wires and neutral wires are double tapped under the same terminal in the main panel bus bar. I recommend a licensed electrician repair this connection.

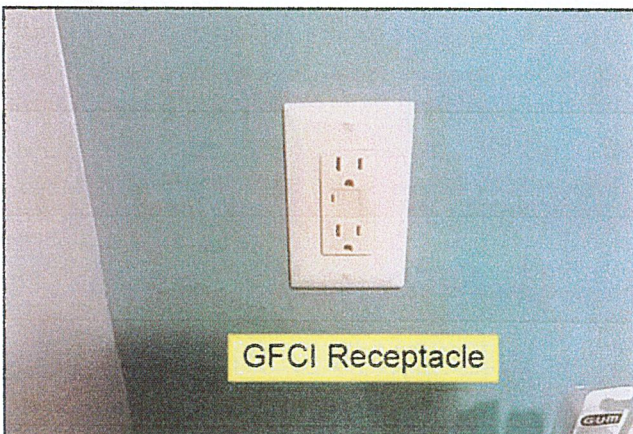
GFCI breakers are not tested in occupied homes. Testing of GFCI breakers in occupied homes can damage computers and other connected devices. I recommend testing all GFCI breakers prior to moving into the home.

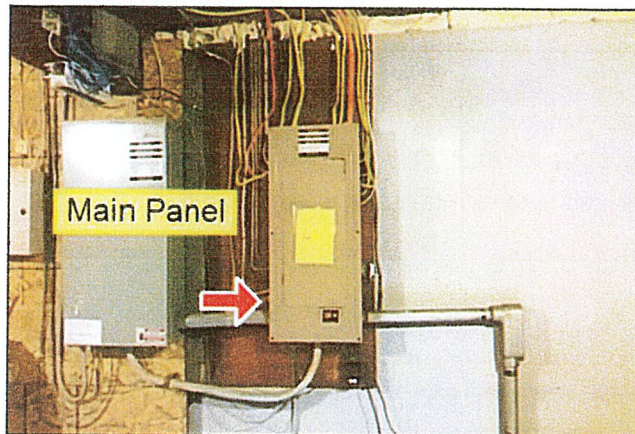
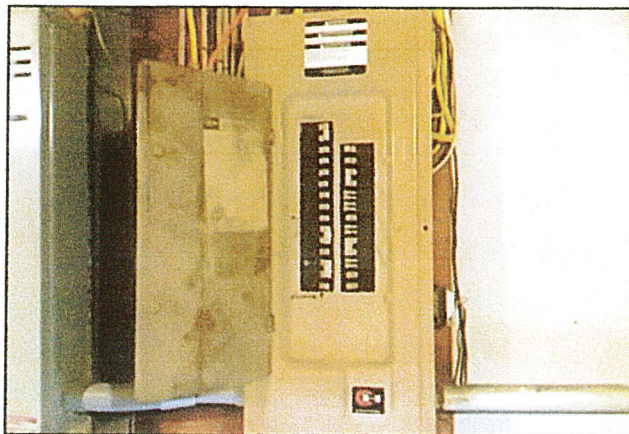
The main electric panel is located in the basement. This is provided for your information.

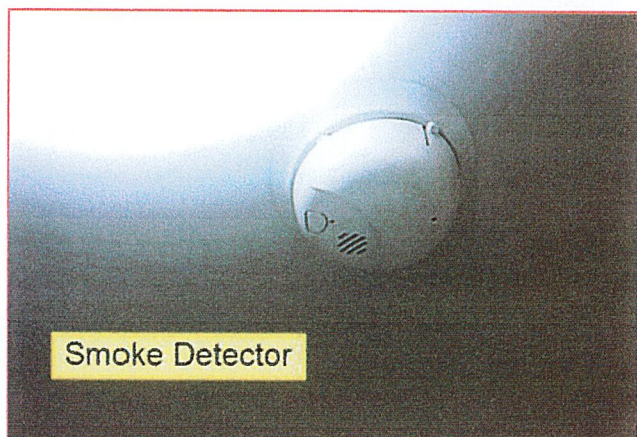
- +** (1) The smoke detectors in the home are old (3/2007) and may not be functional. The life expectancy of smoke detectors is generally 10 years, after which point their sensors can begin to lose sensitivity. The test button only confirms the battery, electronics, and alert system are working; it does not mean the smoke sensor is working. I recommend you have all smoke detectors tested and maintained, upgraded or replaced as needed. All hard wired smoke detectors should be replaced by a licensed electrical contractor.

Installed new detectors

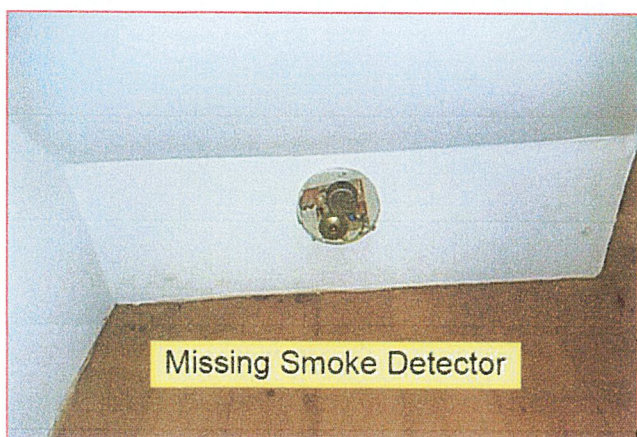
- +** (2) The smoke detector has been disconnected intentionally at the common hallway to bedrooms. Without a working smoke detector in your home you have no first alert to a possible fire. I recommend repair or replace as needed using a qualified person.

*NOT NEEDED
AS WE installed one
just feet away in hallway*

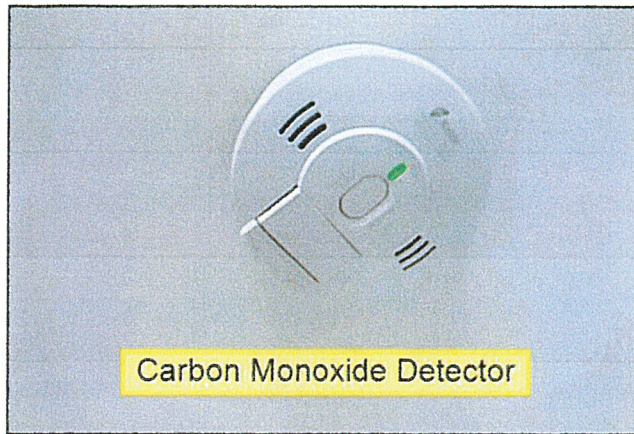
Carbon monoxide detectors are present in the home. At least one carbon monoxide detector is required in homes with a fuel burning appliance and in homes with an attached garage.

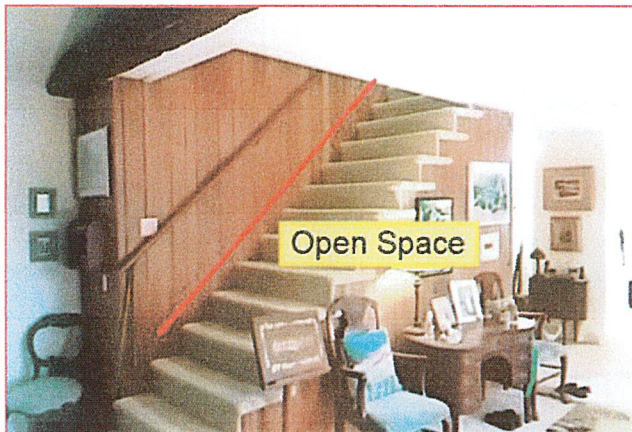
- +** (1) There are open spaces greater than four inches at the interior stairs. Open spaces in excess of four inches present entrapment hazards for people and pets. I recommend these open spaces be closed with proper materials by a licensed contractor.

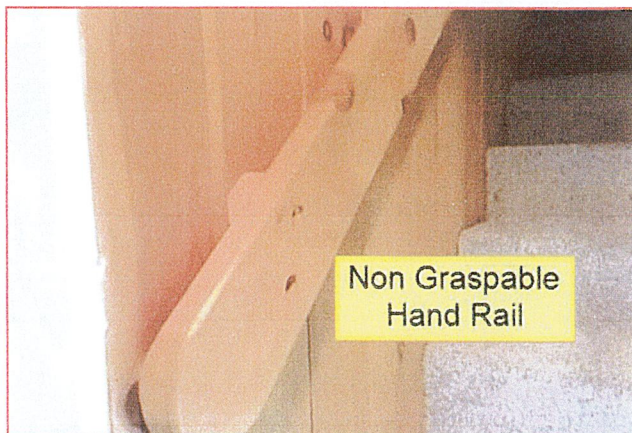
- +** (2) The hand rail located at the basement stairs is a non graspable handrail. I recommend a qualified contractor install a graspable hand rail at this location.

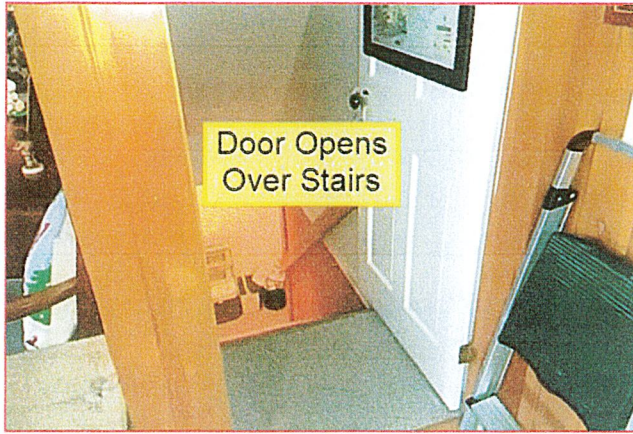
- +** The basement door opens over the stairs causing the user to step backwards on the stairs to open this door. This is a safety issue to be corrected by a qualified contractor.

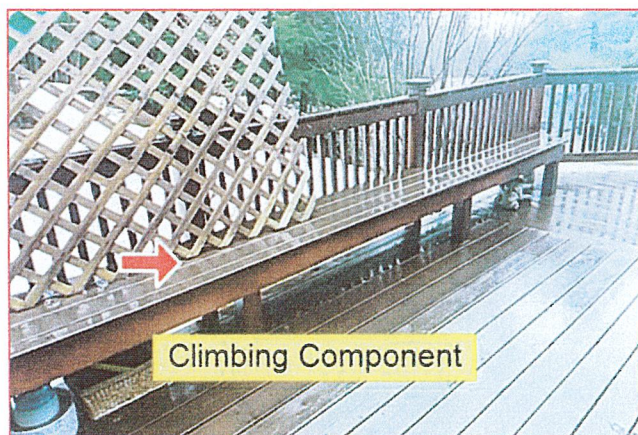
(1) There are horizontal components within the deck structure. These can provide a climbing surface for children. I recommend these horizontal components be repaired/replaced by a licensed contractor.

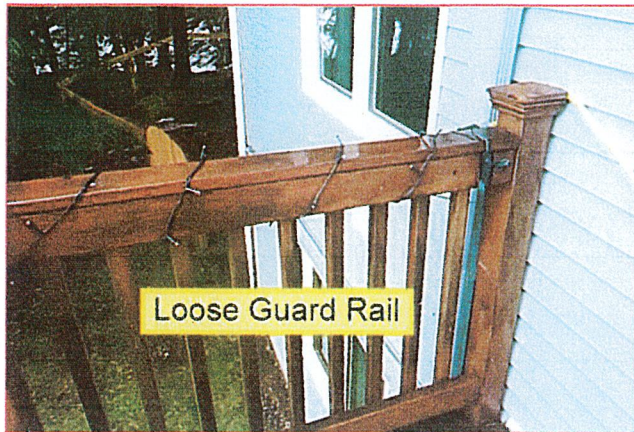
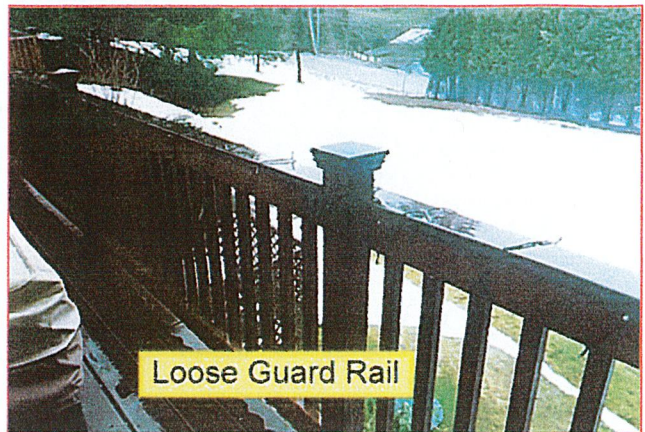
(2) The deck guard rail is loose to the framing. Guard rails are required to withstand up to 200 lbs of pressure to be safe. I recommend a licensed contractor repair/replace this guard rail.

Secured

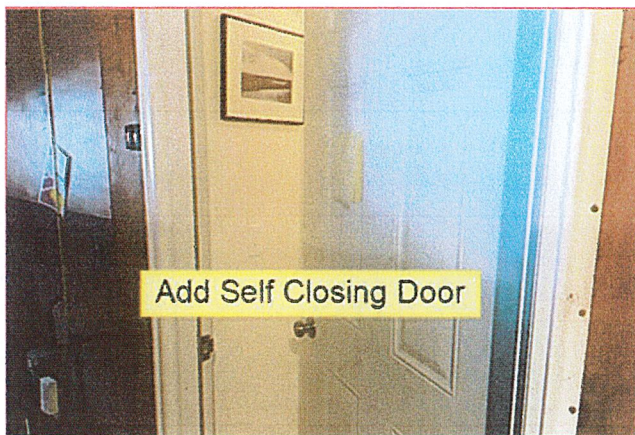
The occupant door from the garage into the home is not a self closing door. Self closing hinges are required at this location. I recommend self closing hinges be added to this door.

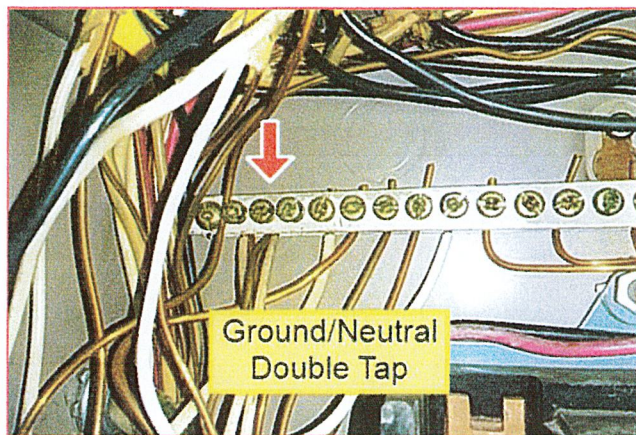
(2) Ground wires and neutral wires are double tapped under the same terminal in the main panel bus bar. I recommend a licensed electrician repair this connection.

Fixed

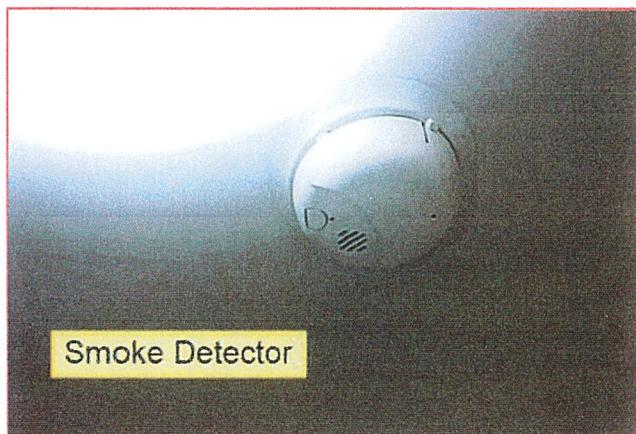
- +** (1) The smoke detectors in the home are old (3/2007) and may not be functional. The life expectancy of smoke detectors is generally 10 years, after which point their sensors can begin to lose sensitivity. The test button only confirms the battery, electronics, and alert system are working; it does not mean the smoke sensor is working. I recommend you have all smoke detectors tested and maintained, upgraded or replaced as needed. All hard wired smoke detectors should be replaced by a licensed electrical contractor.

Installed new ones
throughout house

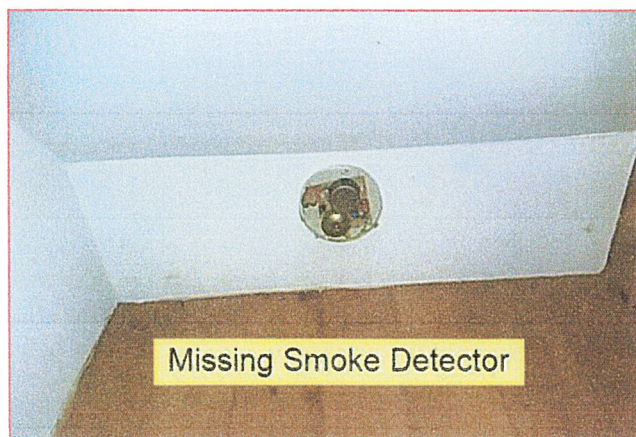
- +** (2) The smoke detector has been disconnected intentionally at the common hallway to bedrooms. Without a working smoke detector in your home you have no first alert to a possible fire. I recommend repair or replace as needed using a qualified person.

Installed new
one in hallway just
feet away

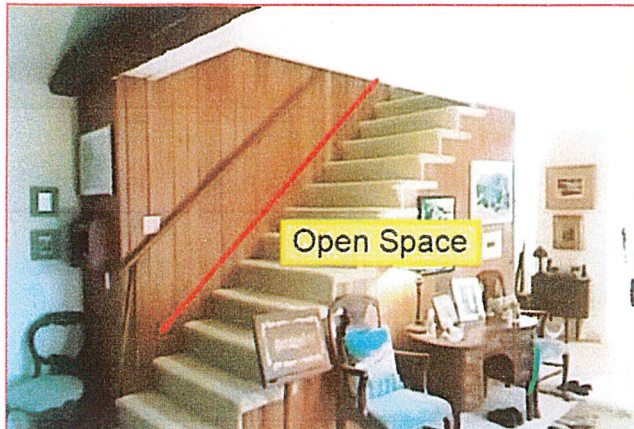
- +** (1) There are open spaces greater than four inches at the interior stairs. Open spaces in excess of four inches present entrapment hazards for people and pets. I recommend these open spaces be closed with proper materials by a licensed contractor.

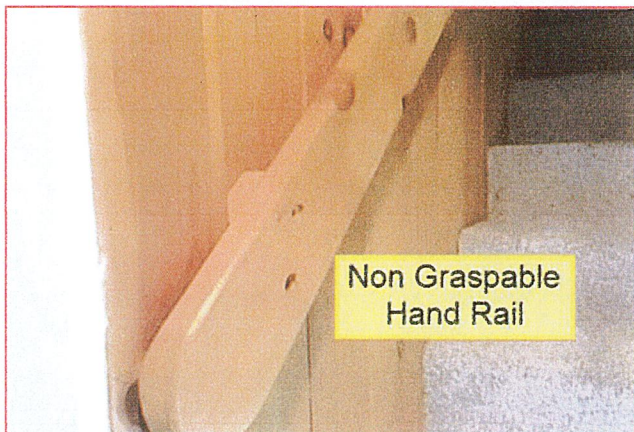
- +** (2) The hand rail located at the basement stairs is a non graspable handrail. I recommend a qualified contractor install a graspable hand rail at this location.

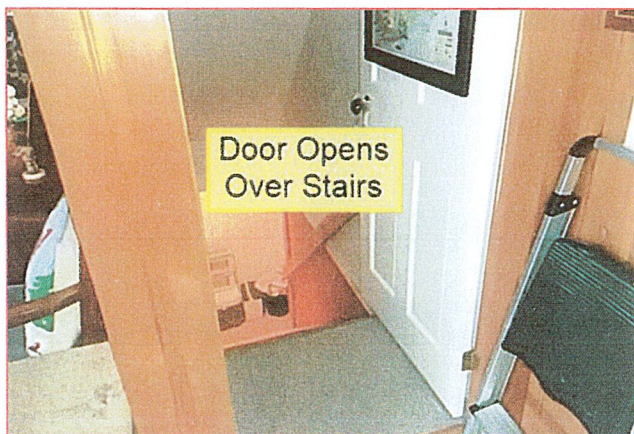
- +** The basement door opens over the stairs causing the user to step backwards on the stairs to open this door. This is a safety issue to be corrected by a qualified contractor.

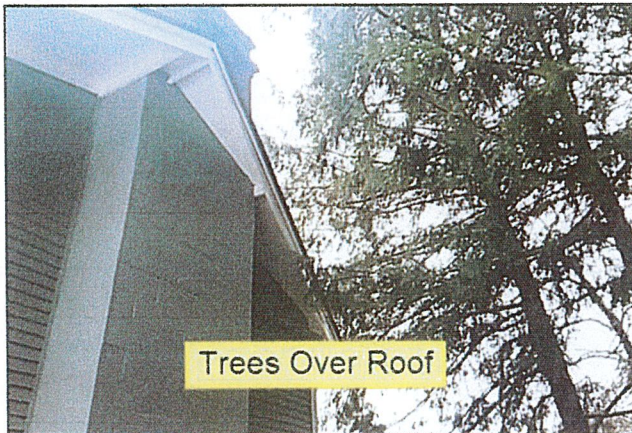
- (4) There are tree limbs overhanging the roof. Tree limbs can damage roofing materials, hold moisture and allow animal access to the roof. I recommend these tree limbs be trimmed or removed by a qualified landscape professional.

*Cut back trees.
Installed new gutter*

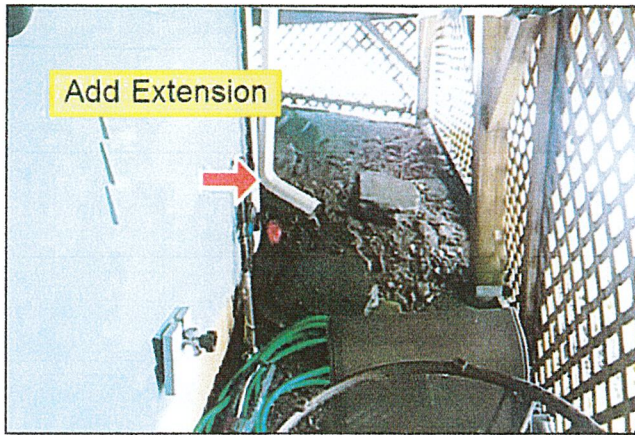
- The downspouts around the home need extensions to carry water away from the home. I recommend a qualified person install downspout extensions at these locations.

Added extension

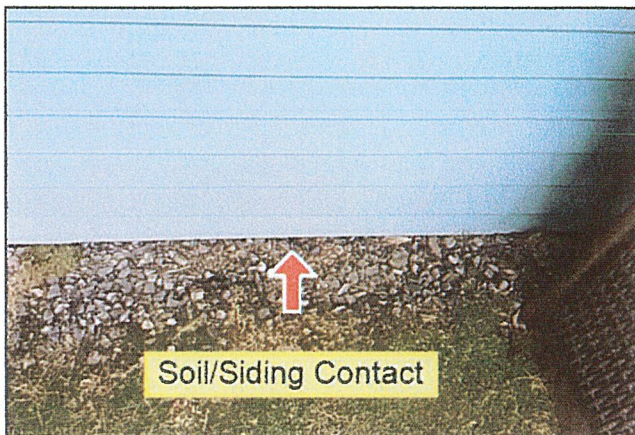
- Siding is in contact with the ground at the exterior in areas. Because the siding is in contact with the ground it is possible for framing to be deteriorated behind the siding. We did not inspect behind this siding. I recommend a ground clearance of six to eight inches where possible.

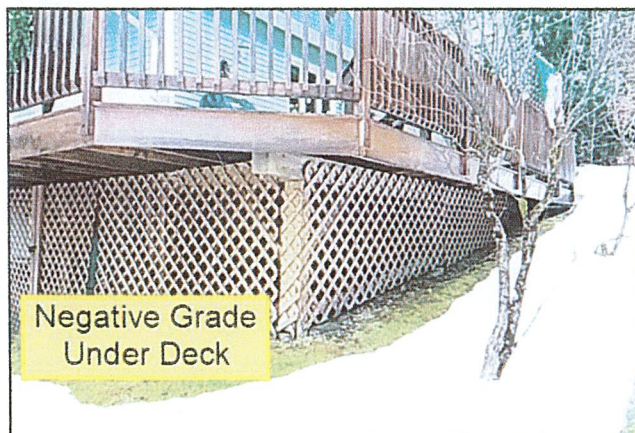
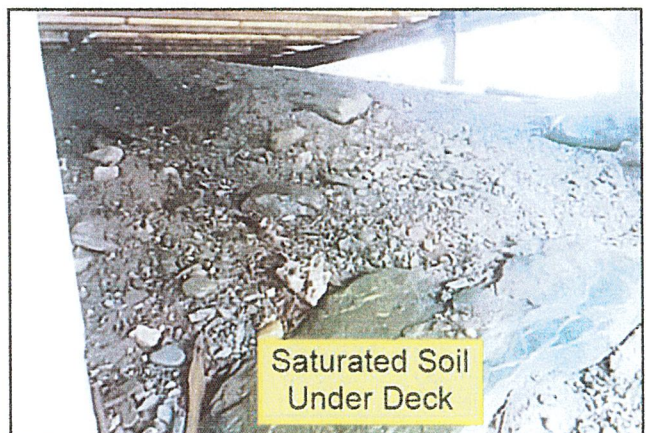
- (1) A negative grade is present to the deck side of the home. Soil under the deck was very wet. I recommend improving drainage around and above this area to move water away from the foundation of the home.

*Had new swale put in and
new driveway*

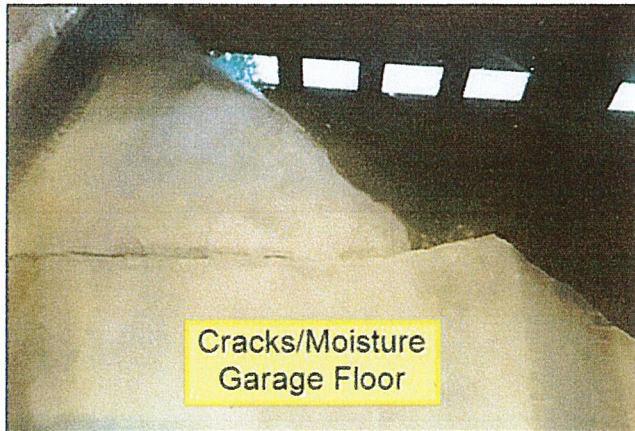
Concrete cracks and moisture are present on the garage floor. I recommend speaking with a dry basement company to better understand strategies for keeping this garage dry.

Sealer should help this

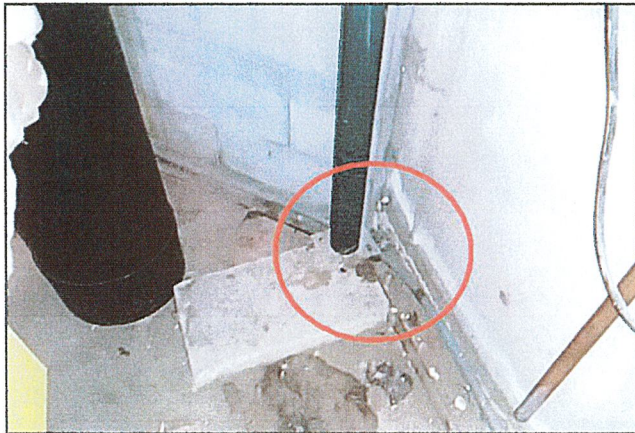
The column in the basement does not sit on a proper footing. I recommend a footing be added to this location by a qualified contractor.

Can't change without redoing all the plumbing. Fitting is solid.

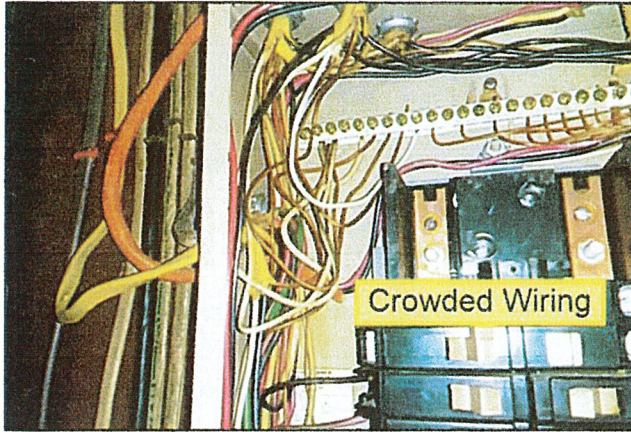
(3) Crowded wiring in an electric panel can increase the risk of over heating, short circuits and electric fires. I recommend repair by a licensed electrician.

Fixed 3/25/25

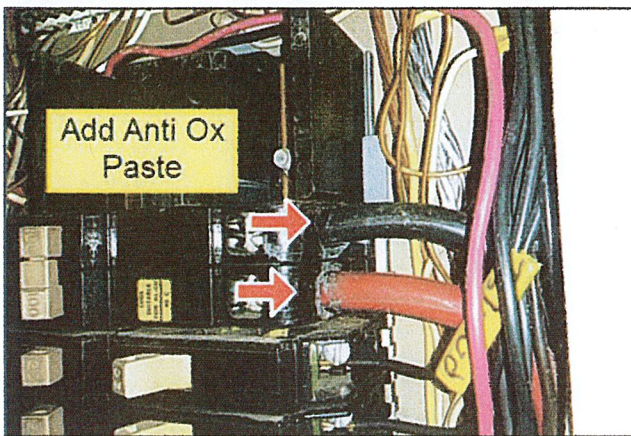
(4) The anti-oxidant paste on the aluminum wires that feed the main panel needs re-application. Because aluminum can oxidize, a paste is used to ensure a safe connection. I recommend that a licensed electrician apply anti-oxidant paste.

Didn't do as he would have had to turn all elec. off of box and he saw no corrosion or other issues

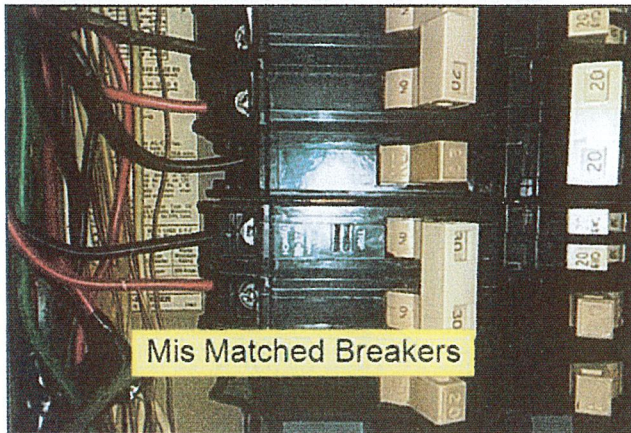
(5) Several circuit breakers in the main panel are of a different brand than the panel manufacturer. The manufacturer requires that in order for the panel to be safe, only their brand is allowed to be used inside the panel. Even though these circuit breakers are all "UL approved," they are not approved to be used in panels of different manufacturers unless so indicated on the panel label.

Cutler Hammer & Eaton are the same company. One bought the other

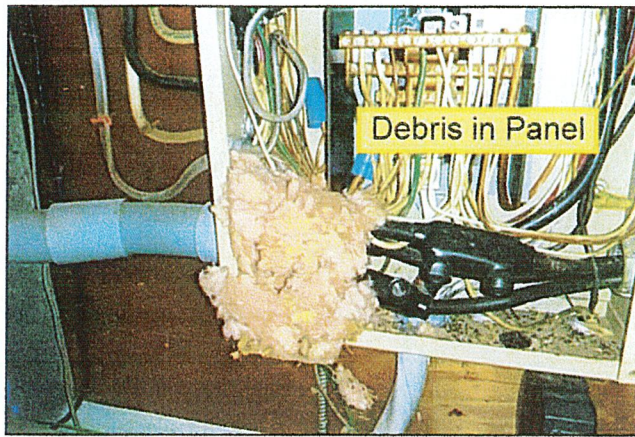
(6) There is dirt and debris at the base of the electric panel. I recommend this area be kept clean by a qualified electrician.

Vacuummed out & cleaned
3/25/25

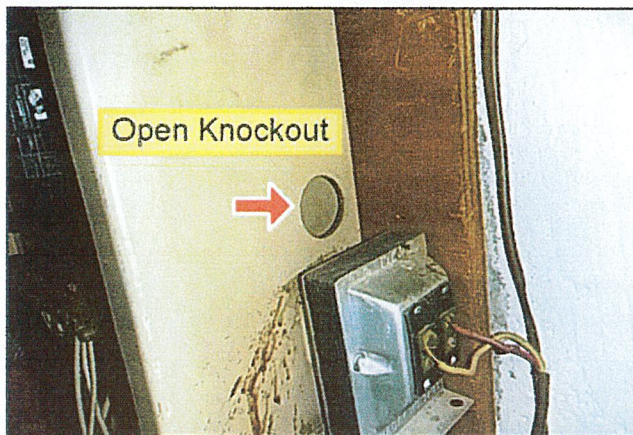
- (7) Open knockouts are present at the main electric panel. Open knockouts can allow small fingers and/or rodents into the electric panel. I recommend a licensed electrician close all open knockouts in the electric panel.

Fixed 3/25/25

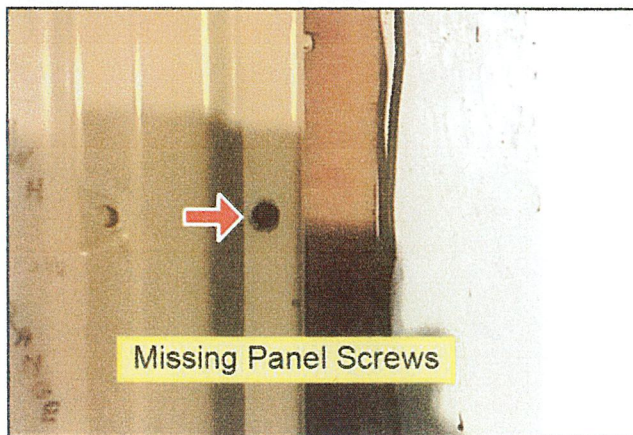
- (8) Screws are missing to the electric panel deadfront. I recommend these screws be replaced with blunt end screws by a licensed electrician.

Fixed. 3/25/25

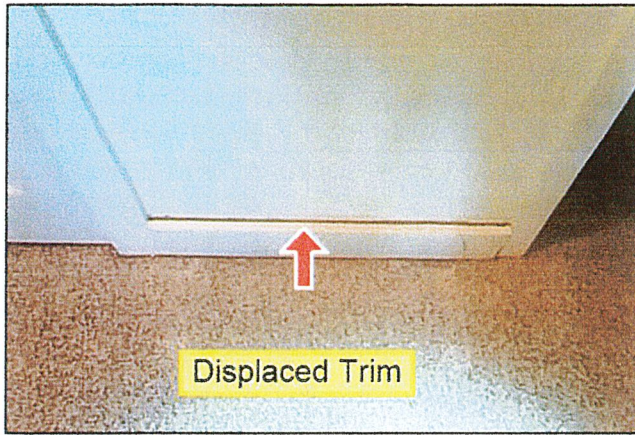
- Trim is loose in the basement of the home. I recommend repair by a qualified person.

Fixed 3/28

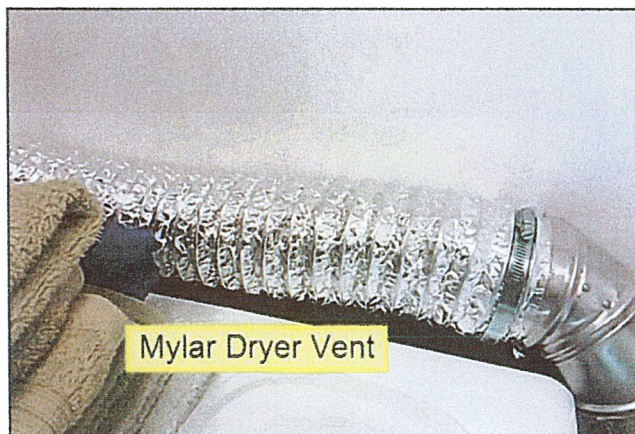
The clothes dryer exhaust duct is vinyl or mylar, flexible accordion style duct. These types of ducts can trap lint and become a fire hazard as air flow is reduced. I recommend the current ducts be replaced with rigid or corrugated rigid metal duct by a qualified contractor.

NO
Had solid duct
installed with new dryer. The
dryer stuck out so far you
couldn't get into the room. My
appliance man (Lammels)
current duct.

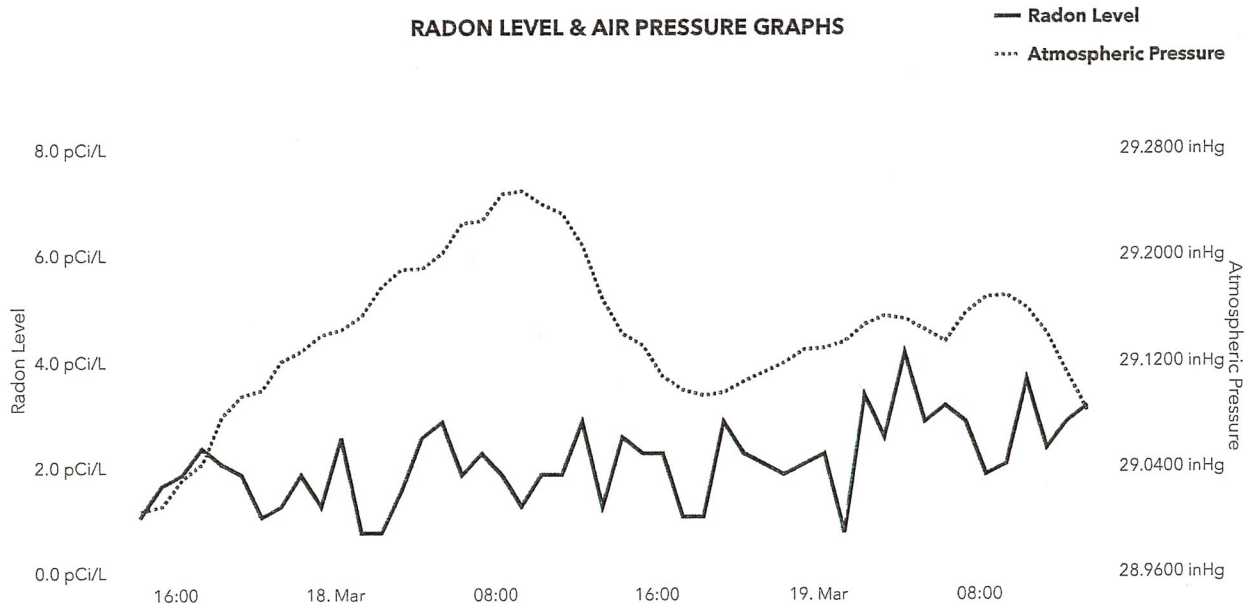
The measured average radon level is below the Environmental Protection Agency (EPA) Action Level of 4.0 pCi/L. However, since the measured average radon level is at least half the Action Level, the EPA suggests that homeowners consider having a radon mitigation system installed. The EPA recommends having this building retested at least once every 5 years to determine if a radon mitigation system is recommended at a later date since radon levels can change over time. If a radon mitigation system is installed, the EPA recommends having this building retested at least once every 2 years to ensure the system remains effective. Performing follow-up tests during the heating season is recommended since this is when radon levels tend to be the highest. A 12-month long test, or continuous monitoring, will most accurately reflect radon exposure throughout the year.
