RE: 217 WOODS RD  
STOWE.

- 1/ • BUILDING INSPECTION
- 2/ • WATER TEST
- 3/ • SEPTIC PUMPING
- 4/ • RADON REPORT.

Vermont Home Inspection Services

**Address**  
217 Wood Rd  
Stowe VT 05672

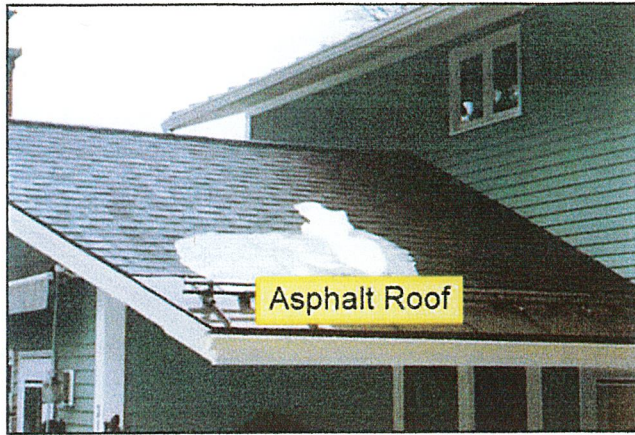
(1) Two types of warranties are offered when new asphalt shingles are installed; The manufacturer's warranty, which covers the shingles themselves and varies among manufacturers, and the contractors warranty, which covers the installation and workmanship. When a home is sold, a roof warranty may fully transfer to the home buyer, may transfer for a shortened length of time, may transfer with limited coverage, or may not transfer at all. I recommend you consult with the home owner as to the how the sale will affect the current warranty and confirm any seller claims by reading the warranty.

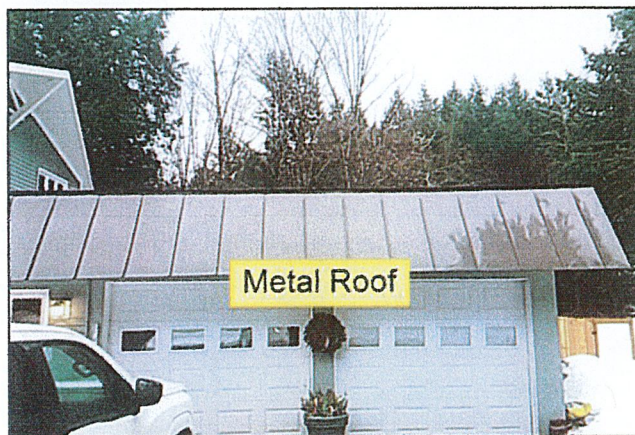
(2) Portions of the roof is covered with metal roofing. Typical life span is 50-75+ years depending upon the quality of installation. Metal roofs are known for their durability, longevity, and low maintenance requirements. They are resistant to fire, rot, insects and can withstand extreme weather conditions. This is provided for your information.

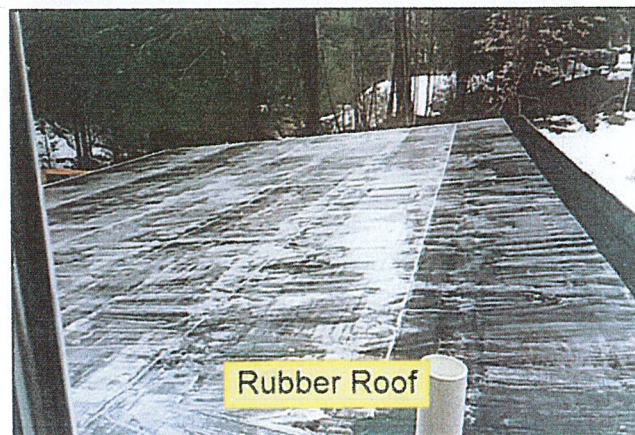
(3) The garage roof is covered with a rubber membrane. Rubber membrane roof life expectancy can last up to 40 years with proper installation and regular maintenance. This is provided for your information.

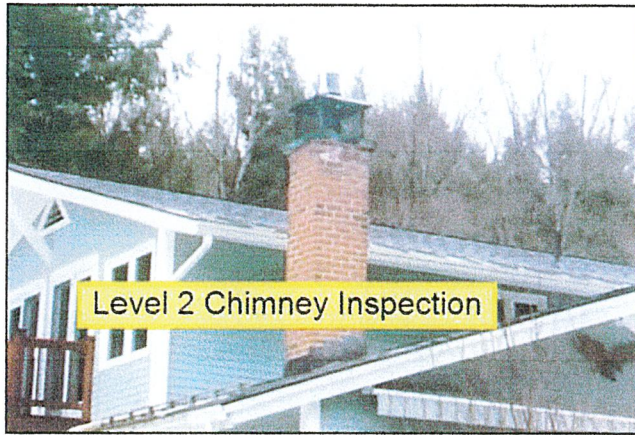
A Level 2 chimney inspection is recommended. Level 2 chimney inspections use a camera that runs into the flues to inspect the condition of the interior flues, liners, liner joints etc. Damaged flues can lead to costly repairs. Recommended accreditations for chimney sweeps; CSIA Chimney Sweep Institute of America and NFI National Fireplace Institute.

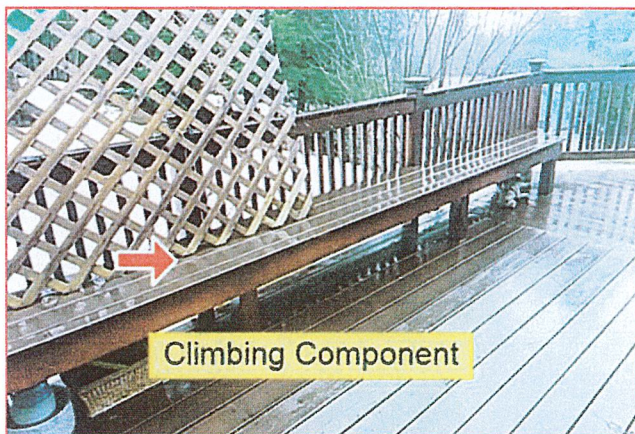
(1) There are horizontal components within the deck structure. These can provide a climbing surface for children. I recommend these horizontal components be repaired/replaced by a licensed contractor.

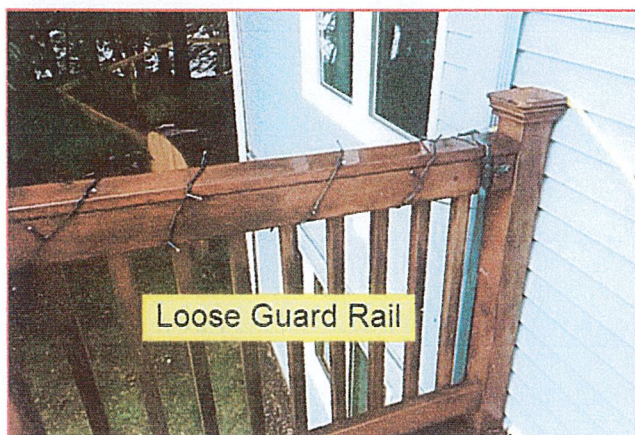
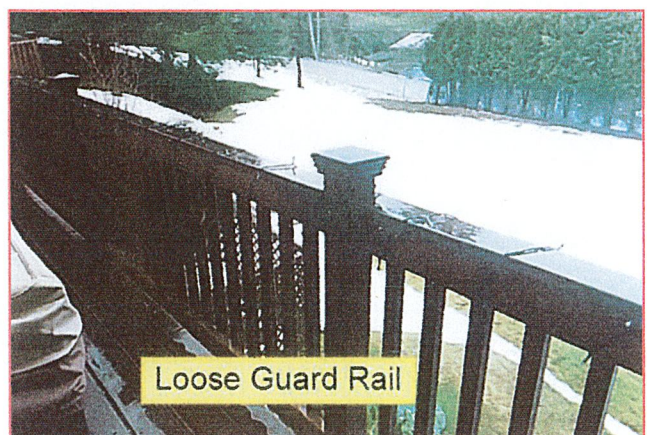
(2) The deck guard rail is loose to the framing. Guard rails are required to withstand up to 200 lbs of pressure to be safe. I recommend a licensed contractor repair/replace this guard rail.

*Secured guard rail*

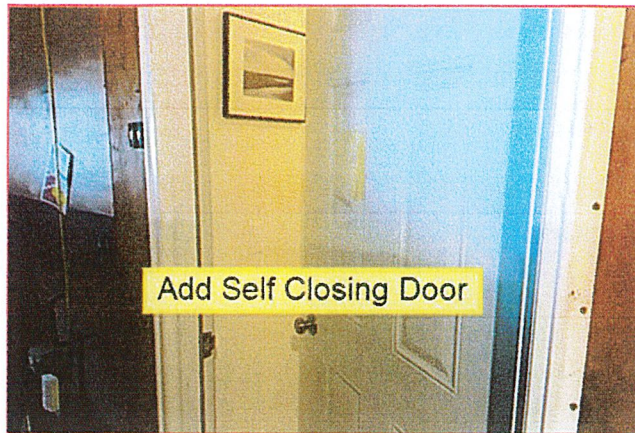
The occupant door from the garage into the home is not a self closing door. Self closing hinges are required at this location. I recommend self closing hinges be added to this door.

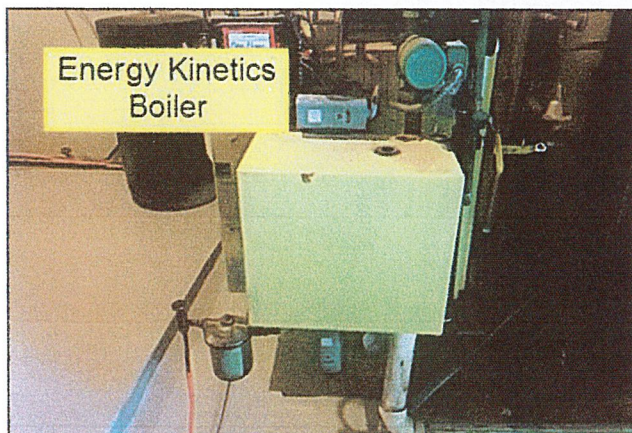
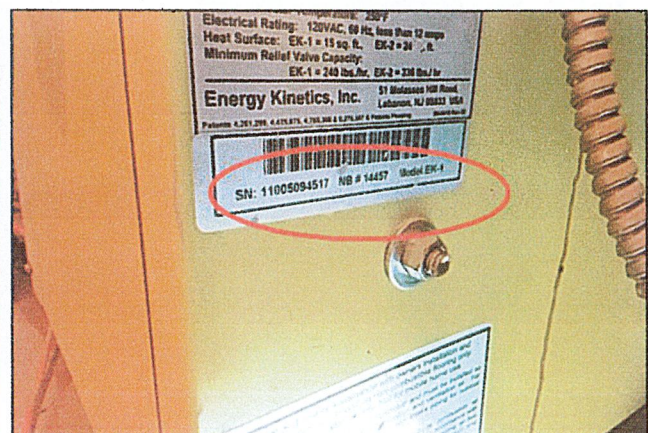
The home is serviced by a Energy Kinetics boiler. This unit was manufactured in May 2010 and was operational on the day of the inspection. This is provided for your information.

I recommend the heating system be cleaned and serviced on an annual basis by a qualified HVAC professional.

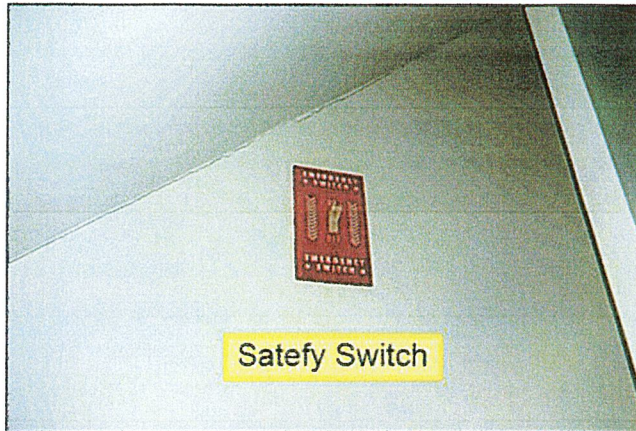
(1) The safety shut off for the heating appliance is located at the top of the cellar stairs. This is provided for your information.

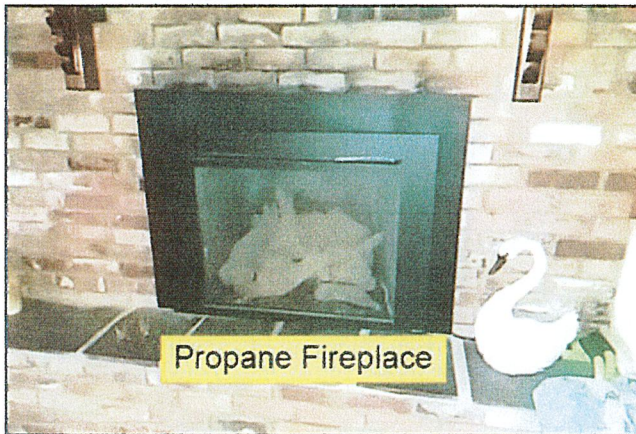
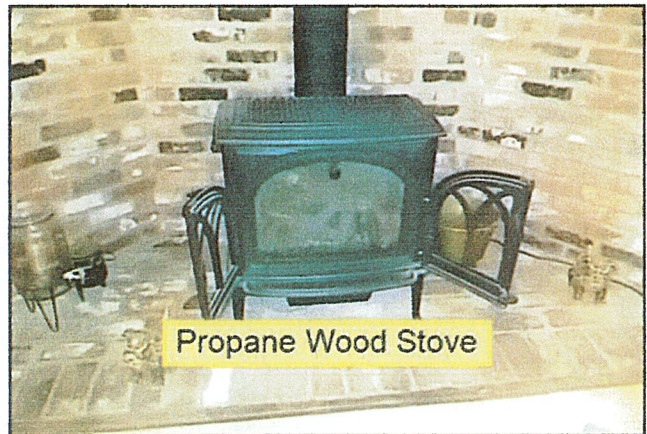
Two propane fireplaces are present in the home. these units were not tested on the day of the inspection. I recommend speaking with the current owner around the history and operation of these units.

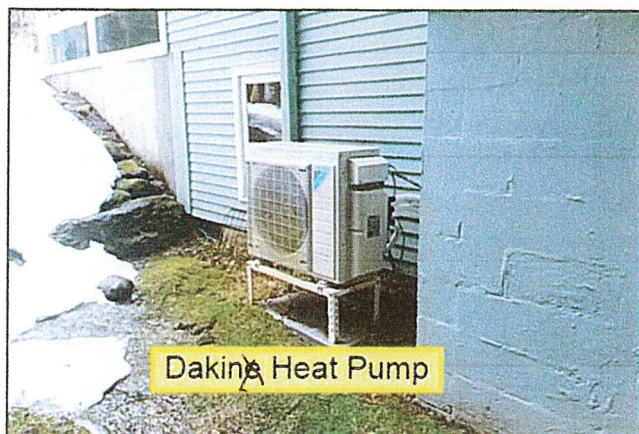
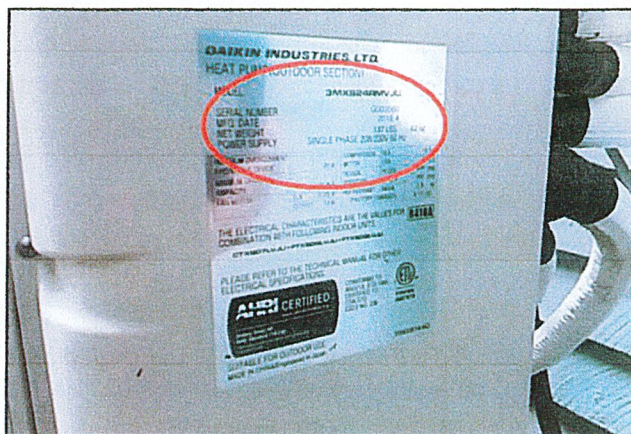
(1) The home is provided with a Dakine mini split/heat pump system. This system compressor was manufactured in April 2018. This is provided for your information.

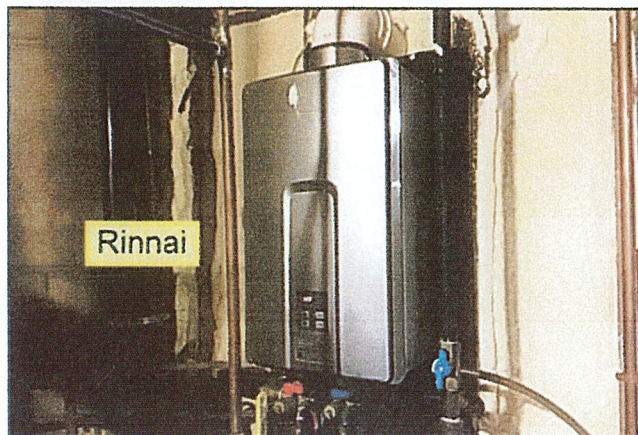
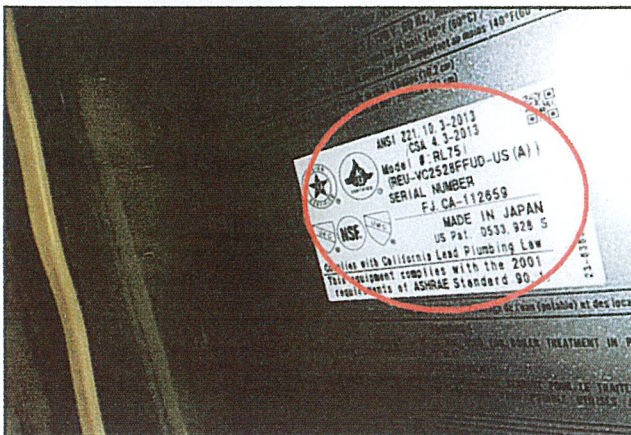
The home is supplied with a Rinnai hot water heater. This unit was manufactured in September 2014, and was operational on the day of the inspection. This is provided for your information.

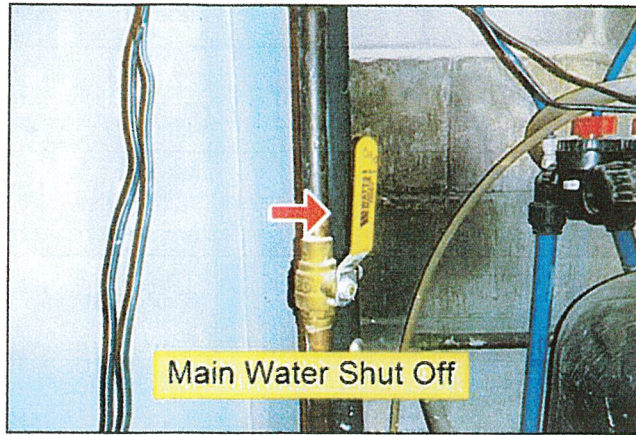
The main water shut off is located in the utility room in the basement. This is provided for your information.

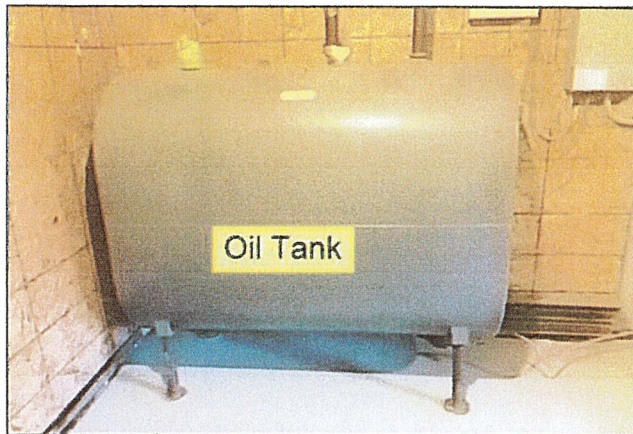
Photo 1

(1) Fuel dealers are required to inspect all oil tanks (Photo 1) prior to the initial delivery of fuel to a new customer. Any problems identified during their inspection which indicate a significant risk of a spill must be corrected before fuel is delivered. All oil tanks must be inspected every 3 years by a certified tank inspector.

The exterior of the oil tank was inspected for leaks and rust. Oil tanks rust from the inside and the outside. The only way to know the thickness of the tank is for a heating contractor to measure the thickness of the tank with an ultrasonic devise. An oil shut off is present at the base of the oil tank (Photo 2).

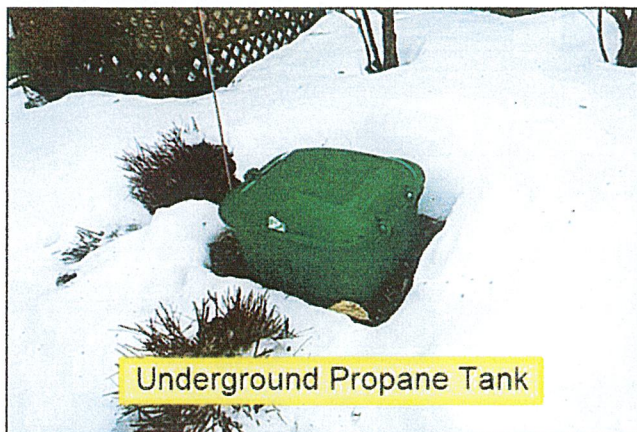
Photo 1

(2) A underground propane tank is present at the exterior of the home (Photo 1). A propane shut off is located under the tank cover (Photo 2). This is provided for your information.

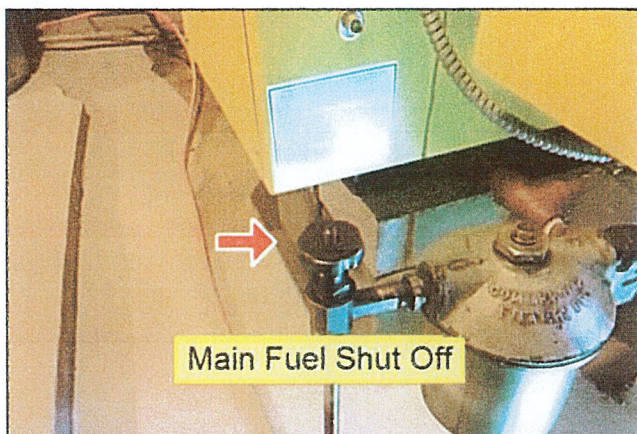
(1) The main fuel shut off is located at the oil burner in the basement. This is provided for your information.

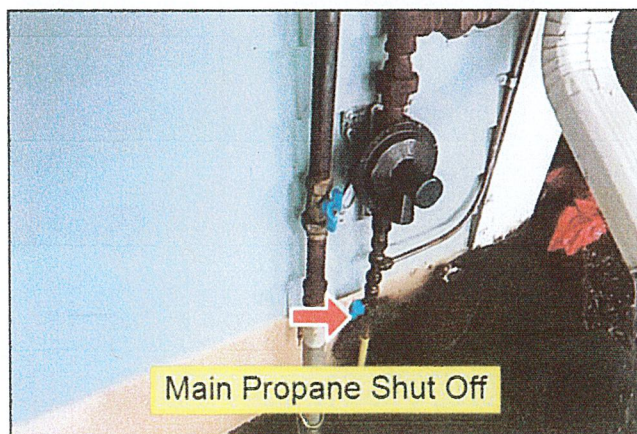
(2) The main propane shut off is located at the exterior of the home. There are also individual shut offs at appliances. This is provided for your information.

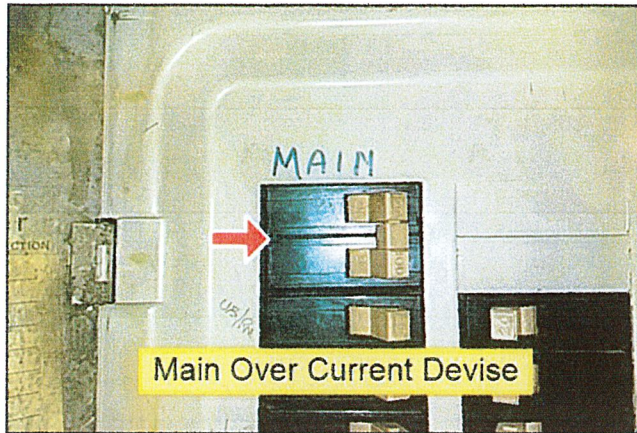
(1) The main over current device is located in the main electric panel located in the basement. This is provided for your information.

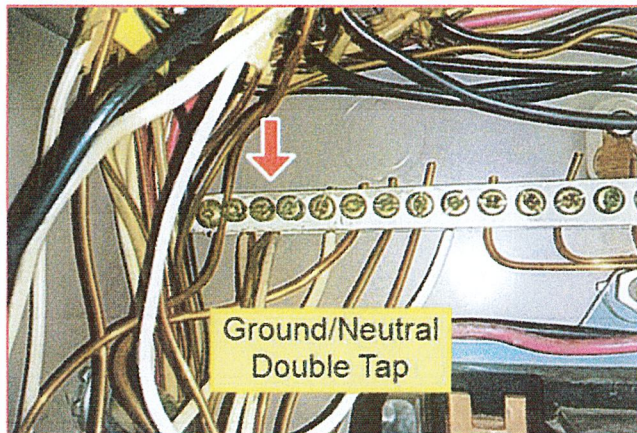
(2) Ground wires and neutral wires are double tapped under the same terminal in the main panel bus bar. I recommend a licensed electrician repair this connection.

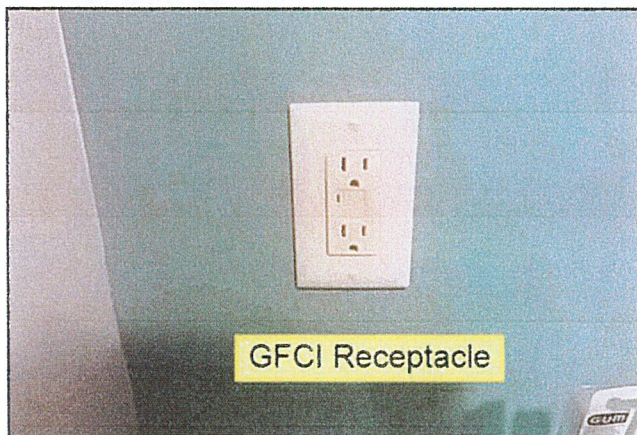
GFCI breakers are not tested in occupied homes. Testing of GFCI breakers in occupied homes can damage computers and other connected devices. I recommend testing all GFCI breakers prior to moving into the home.

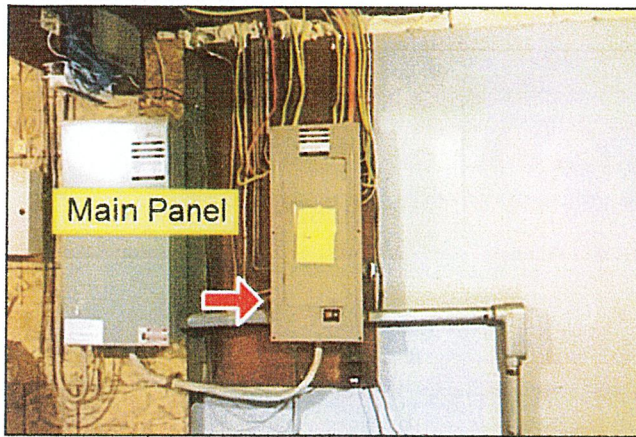
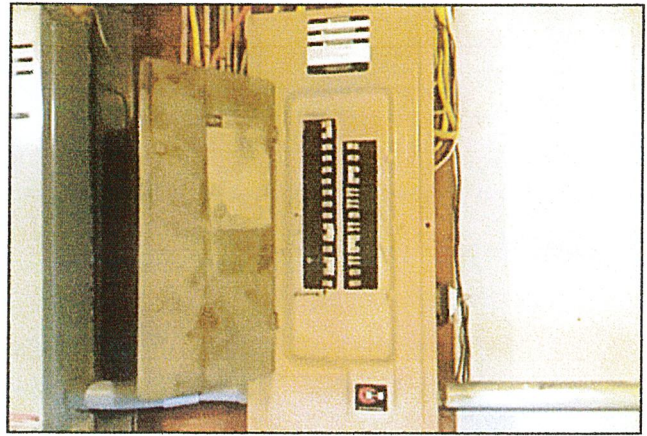
The main electric panel is located in the basement. This is provided for your information.

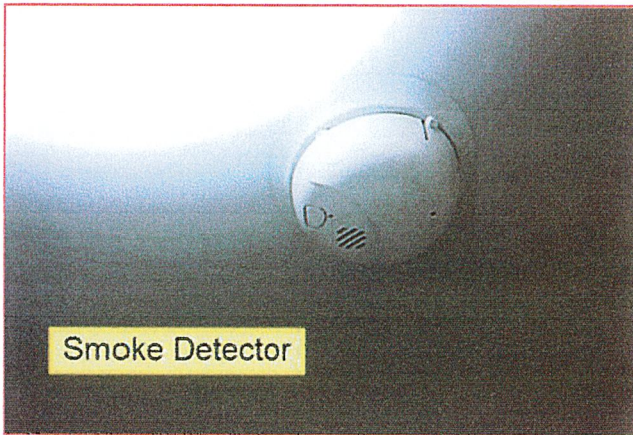
- +** (1) The smoke detectors in the home are old (3/2007) and may not be functional. The life expectancy of smoke detectors is generally 10 years, after which point their sensors can begin to lose sensitivity. The test button only confirms the battery, electronics, and alert system are working; it does not mean the smoke sensor is working. I recommend you have all smoke detectors tested and maintained, upgraded or replaced as needed. All hard wired smoke detectors should be replaced by a licensed electrical contractor.

*Installed new detectors*

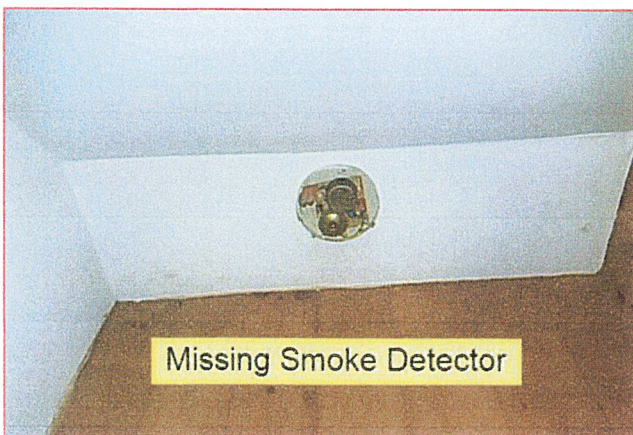
- +** (2) The smoke detector has been disconnected intentionally at the common hallway to bedrooms. Without a working smoke detector in your home you have no first alert to a possible fire. I recommend repair or replace as needed using a qualified person.

*NOT needed as we installed one just feet away in hallway*

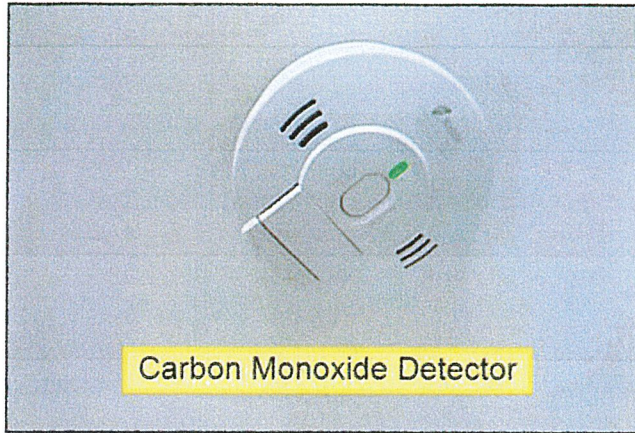
Carbon monoxide detectors are present in the home. At least one carbon monoxide detector is required in homes with a fuel burning appliance and in homes with an attached garage.

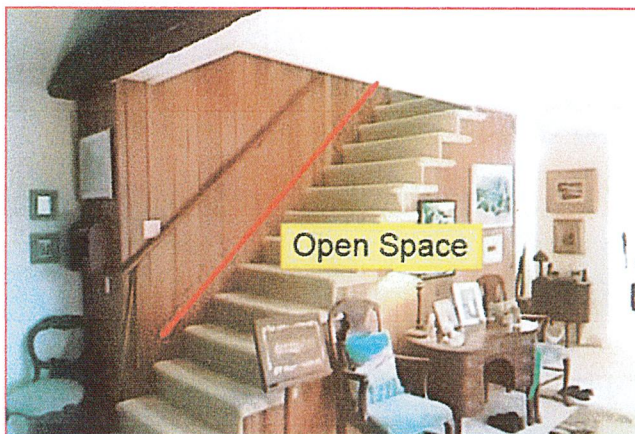
- +** (1) There are open spaces greater than four inches at the interior stairs. Open spaces in excess of four inches present entrapment hazards for people and pets. I recommend these open spaces be closed with proper materials by a licensed contractor.

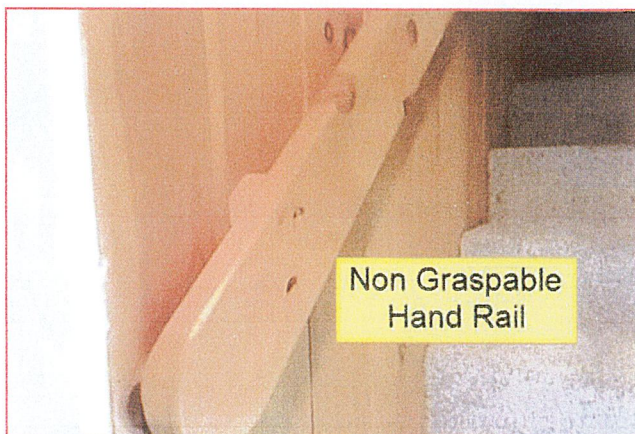
- +** (2) The hand rail located at the basement stairs is a non graspable handrail. I recommend a qualified contractor install a graspable hand rail at this location.

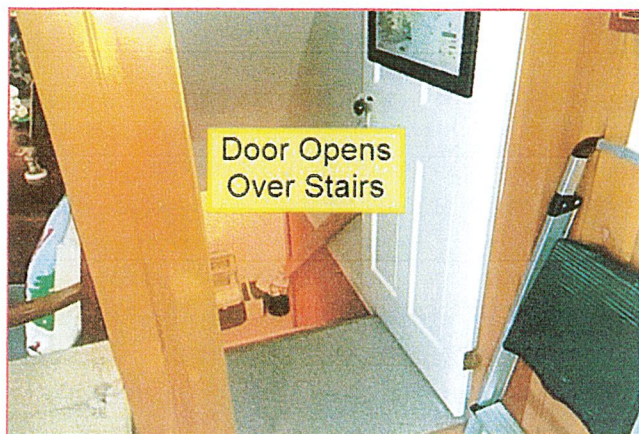
- +** The basement door opens over the stairs causing the user to step backwards on the stairs to open this door. This is a safety issue to be corrected by a qualified contractor.

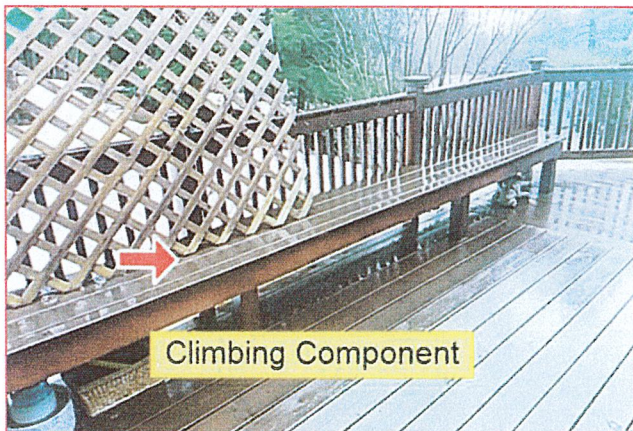
(1) There are horizontal components within the deck structure. These can provide a climbing surface for children. I recommend these horizontal components be repaired/replaced by a licensed contractor.

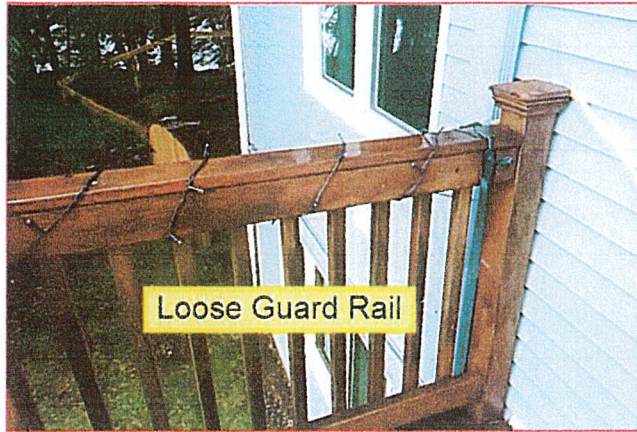
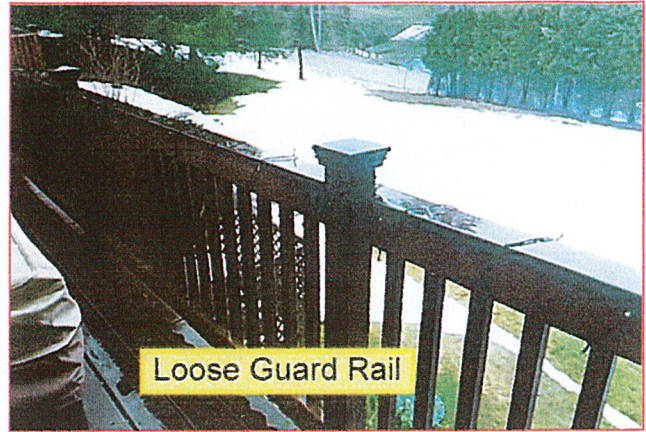
(2) The deck guard rail is loose to the framing. Guard rails are required to withstand up to 200 lbs of pressure to be safe. I recommend a licensed contractor repair/replace this guard rail.

Secured

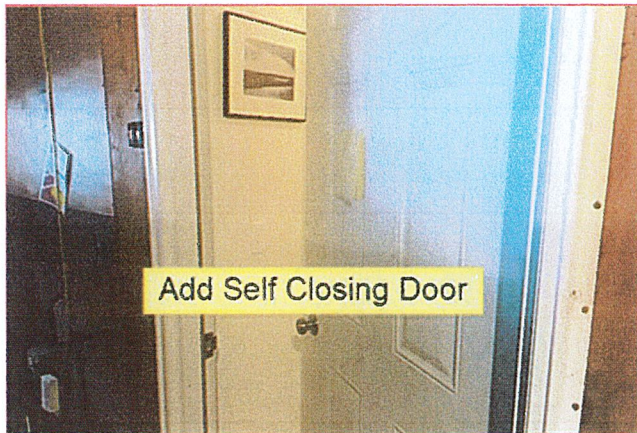
The occupant door from the garage into the home is not a self closing door. Self closing hinges are required at this location. I recommend self closing hinges be added to this door.

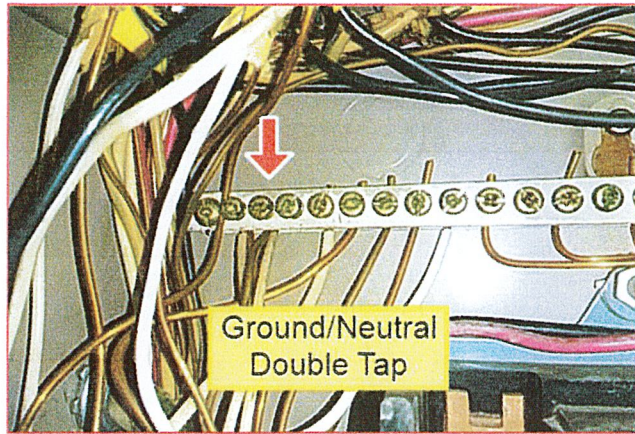
(2) Ground wires and neutral wires are double tapped under the same terminal in the main panel bus bar. I recommend a licensed electrician repair this connection.

Fixed

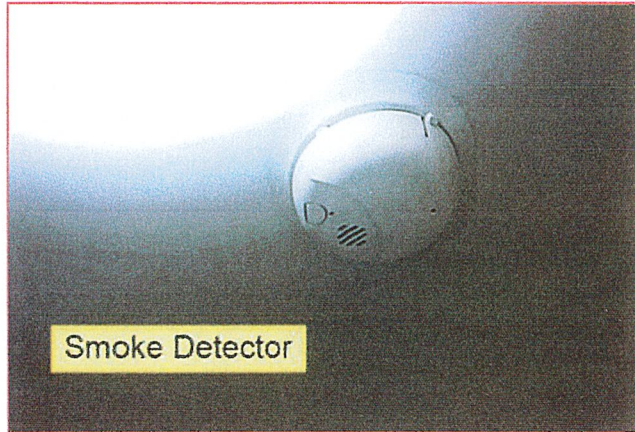
- +** (1) The smoke detectors in the home are old (3/2007) and may not be functional. The life expectancy of smoke detectors is generally 10 years, after which point their sensors can begin to lose sensitivity. The test button only confirms the battery, electronics, and alert system are working; it does not mean the smoke sensor is working. I recommend you have all smoke detectors tested and maintained, upgraded or replaced as needed. All hard wired smoke detectors should be replaced by a licensed electrical contractor.

Installed new ones  
throughout house

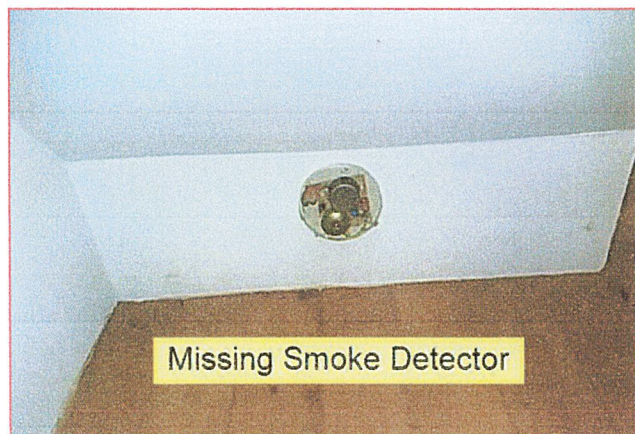
- +** (2) The smoke detector has been disconnected intentionally at the common hallway to bedrooms. Without a working smoke detector in your home you have no first alert to a possible fire. I recommend repair or replace as needed using a qualified person.

Installed new  
one in hallway just  
fret away

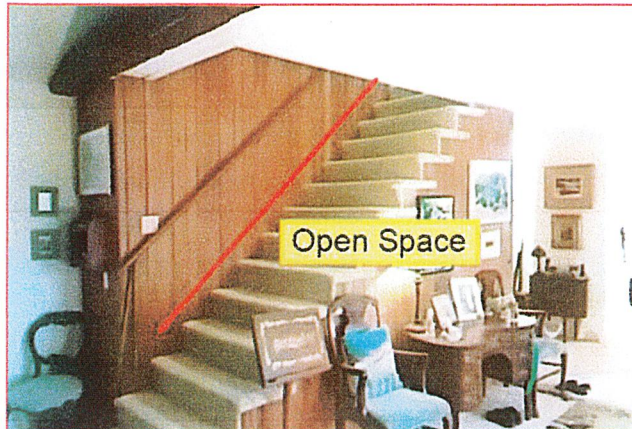
- +** (1) There are open spaces greater than four inches at the interior stairs. Open spaces in excess of four inches present entrapment hazards for people and pets. I recommend these open spaces be closed with proper materials by a licensed contractor.

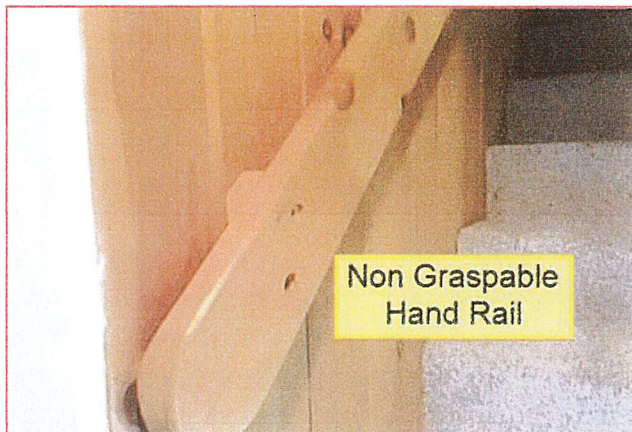
- +** (2) The hand rail located at the basement stairs is a non graspable handrail. I recommend a qualified contractor install a graspable hand rail at this location.

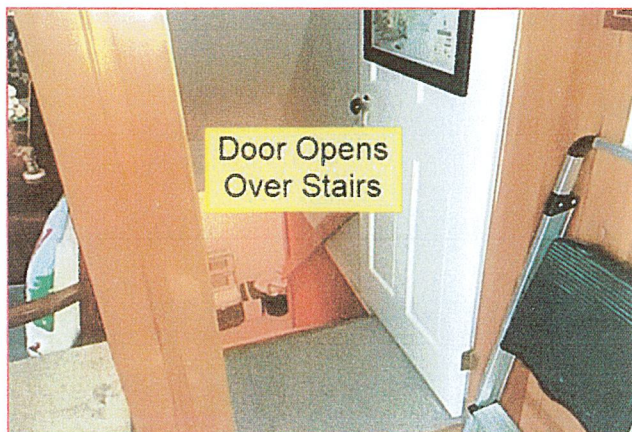
- +** The basement door opens over the stairs causing the user to step backwards on the stairs to open this door. This is a safety issue to be corrected by a qualified contractor.

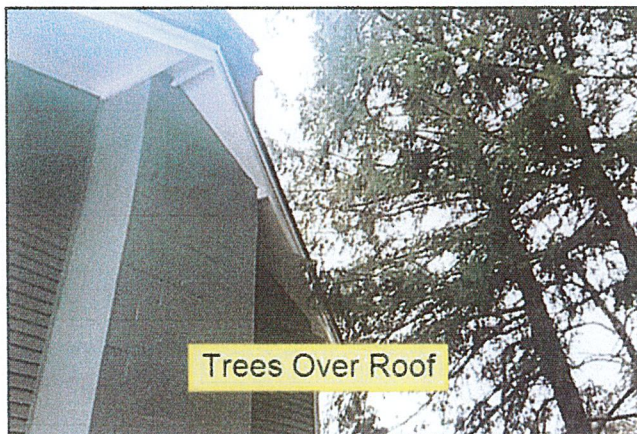
- 🔧 (4) There are tree limbs overhanging the roof. Tree limbs can damage roofing materials, hold moisture and allow animal access to the roof. I recommend these tree limbs be trimmed or removed by a qualified landscape professional.

*Cut back trees.  
Installed new gutter*

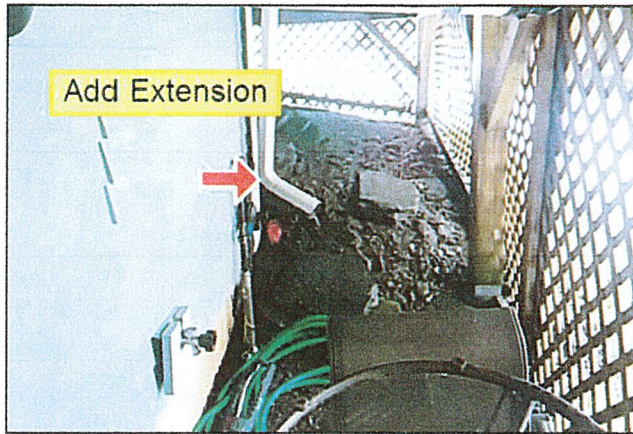
- 🔧 The downspouts around the home need extensions to carry water away from the home. I recommend a qualified person install downspout extensions at these locations.

Added extension

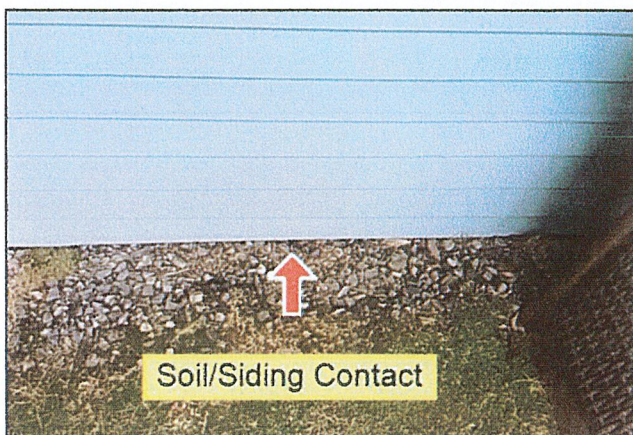
Siding is in contact with the ground at the exterior in areas. Because the siding is in contact with the ground it is possible for framing to be deteriorated behind the siding. We did not inspect behind this siding. I recommend a ground clearance of six to eight inches where possible.

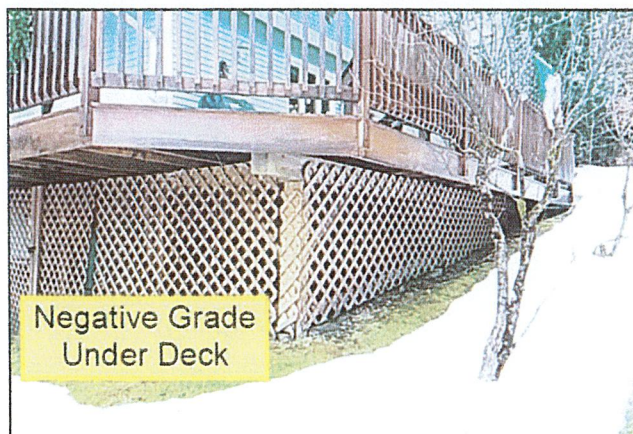
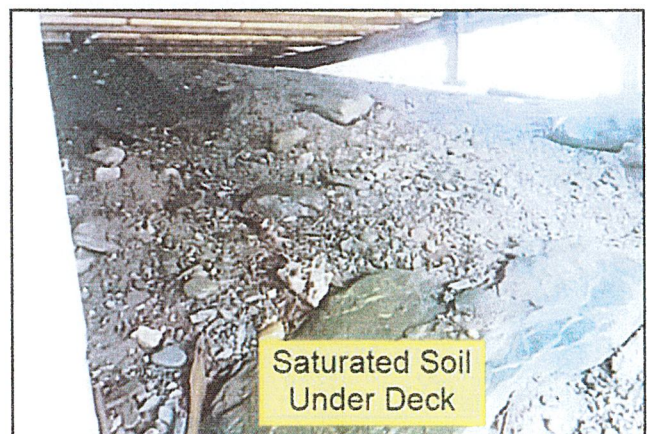
(1) A negative grade is present to the deck side of the home. Soil under the deck was very wet. I recommend improving drainage around and above this area to move water away from the foundation of the home.

Had new swale put in and  
new driveway

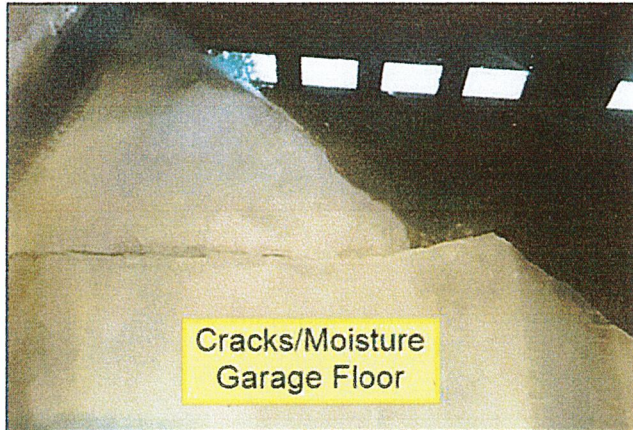
Concrete cracks and moisture are present on the garage floor. I recommend speaking with a dry basement company to better understand strategies for keeping this garage dry.

*Swale should help this*

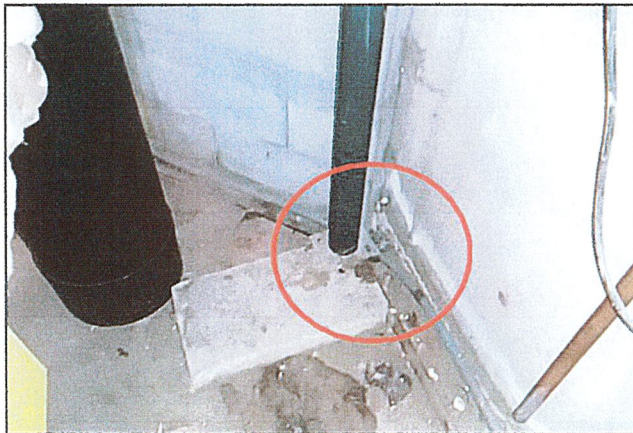
The column in the basement does not sit on a proper footing. I recommend a footing be added to this location by a qualified contractor.

*Can't change without redoing all the plumbing. Fitting is solid.*

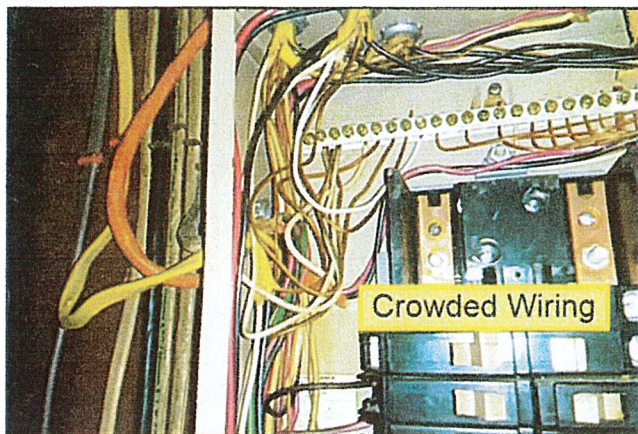
(3) Crowded wiring in an electric panel can increase the risk of over heating, short circuits and electric fires. I recommend repair by a licensed electrician.

Fixed 3/25/25

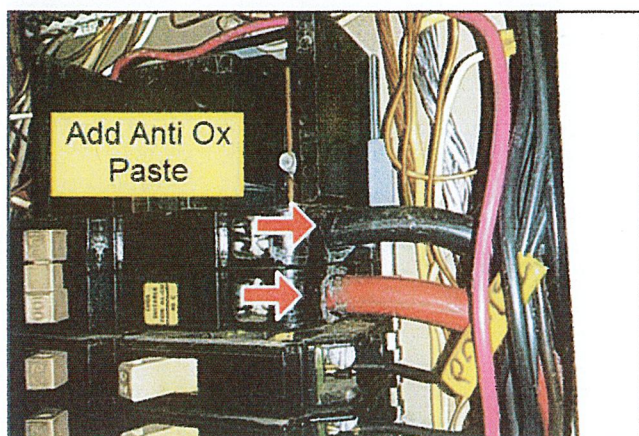
(4) The anti-oxidant paste on the aluminum wires that feed the main panel needs re-application. Because aluminum can oxidize, a paste is used to ensure a safe connection. I recommend that a licensed electrician apply anti-oxidant paste.

Didn't do as he would have had to turn all elec. off of box and he saw no corrosion or other issues

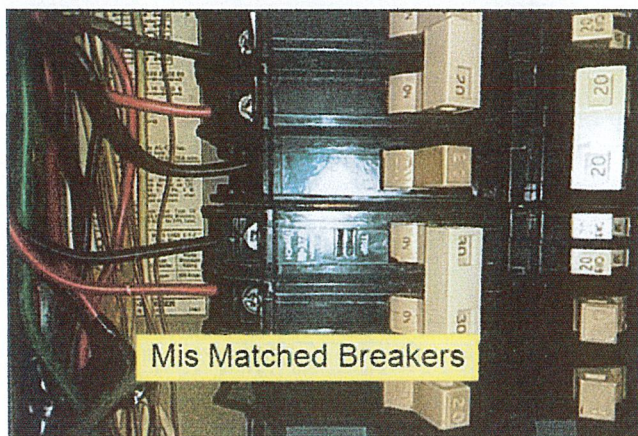
(5) Several circuit breakers in the main panel are of a different brand than the panel manufacturer. The manufacturer requires that in order for the panel to be safe, only their brand is allowed to be used inside the panel. Even though these circuit breakers are all "UL approved," they are not approved to be used in panels of different manufacturers unless so indicated on the panel label.

Cutler Hammer & Eaton are the same company. One bought the other

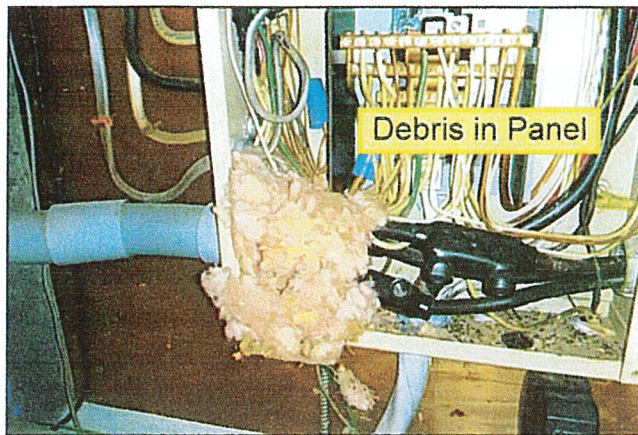
(6) There is dirt and debris at the base of the electric panel. I recommend this area be kept clean by a qualified electrician.

Vacuumed out & cleaned  
3/25/25

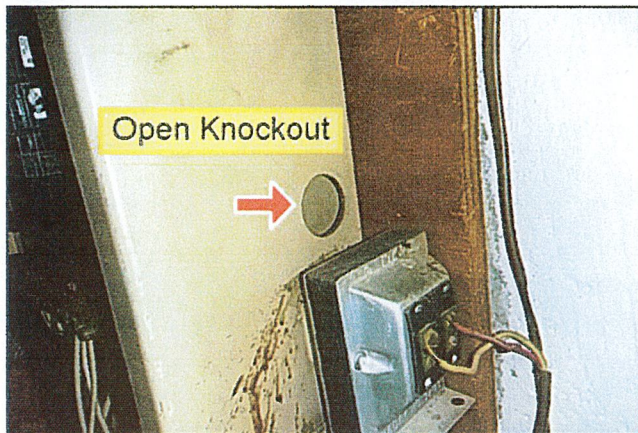
- (7) Open knockouts are present at the main electric panel. Open knockouts can allow small fingers and/or rodents into the electric panel. I recommend a licensed electrician close all open knockouts in the electric panel.

Fixed 3/25/25

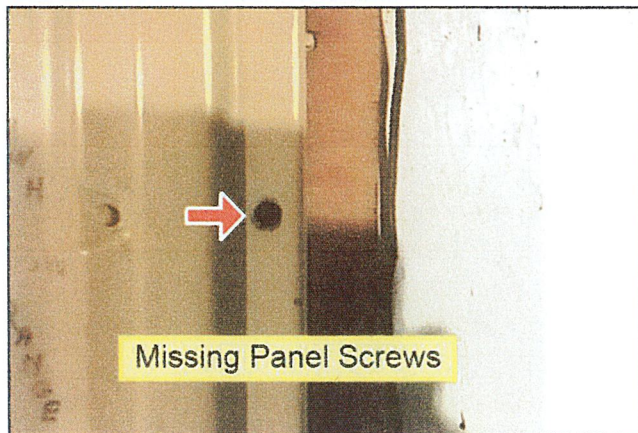
- (8) Screws are missing to the electric panel deadfront. I recommend these screws be replaced with blunt end screws by a licensed electrician.

Fixed. 3/25/25

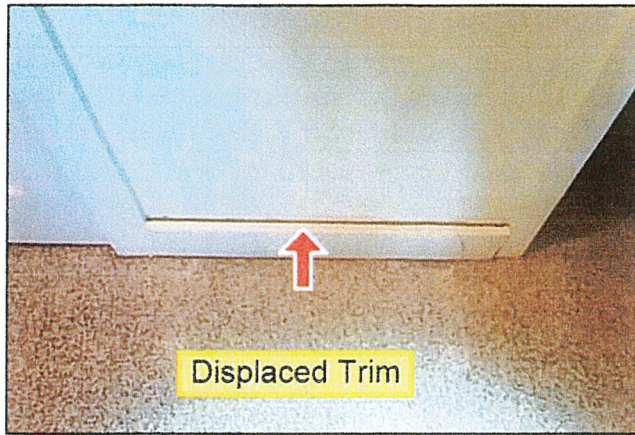
- Trim is loose in the basement of the home. I recommend repair by a qualified person.

Displaced Trim

Fixed 3/28

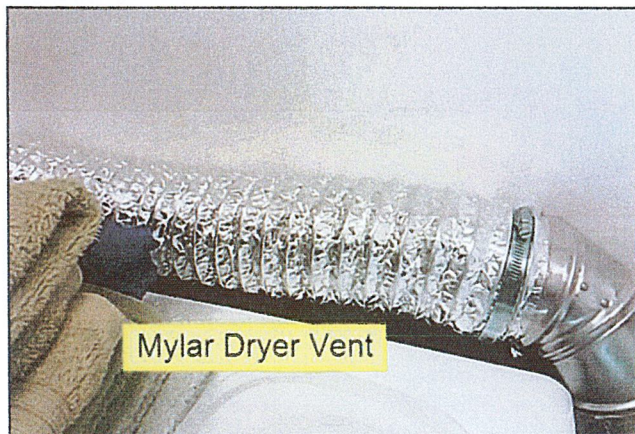
The clothes dryer exhaust duct is vinyl or mylar, flexible accordion style duct. These types of ducts can trap lint and become a fire hazard as air flow is reduced. I recommend the current ducts be replaced with rigid or corrugated rigid metal duct by a qualified contractor.

Mylar Dryer Vent

NO  
Had solid duct  
installed with new dryer. The  
dryer stuck out so far you  
couldn't get into the room. My  
appliance man (Hammel's  
Appliances) installed  
current duct.

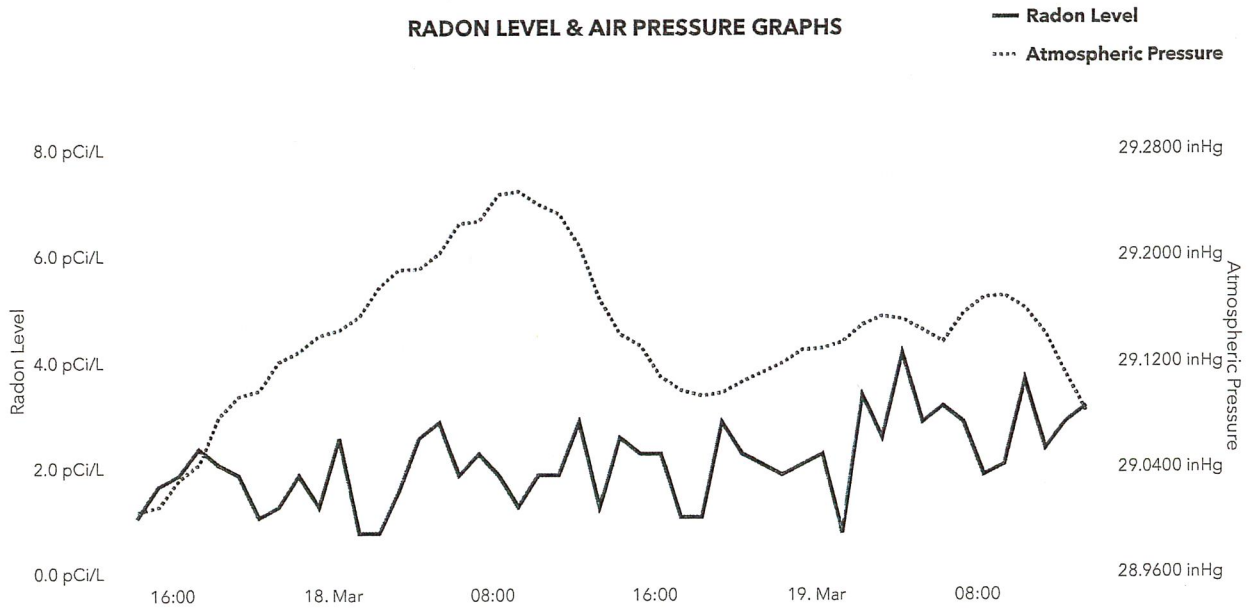
AVERAGE  
2.0 pCi/L

The measured average radon level is below the Environmental Protection Agency (EPA) Action Level of 4.0 pCi/L. However, since the measured average radon level is at least half the Action Level, the EPA suggests that homeowners consider having a radon mitigation system installed. The EPA recommends having this building retested at least once every 5 years to determine if a radon mitigation system is recommended at a later date since radon levels can change over time. If a radon mitigation system is installed, the EPA recommends having this building retested at least once every 2 years to ensure the system remains effective. Performing follow-up tests during the heating season is recommended since this is when radon levels tend to be the highest. A 12-month long test, or continuous monitoring, will most accurately reflect radon exposure throughout the year.
