ITEMS TO FIX AT 50 CHENEY LANE

Vermont Home Inspection Services

Customer
Christy Patt

Address
50 Cheney Ln
Morristown VT 05661

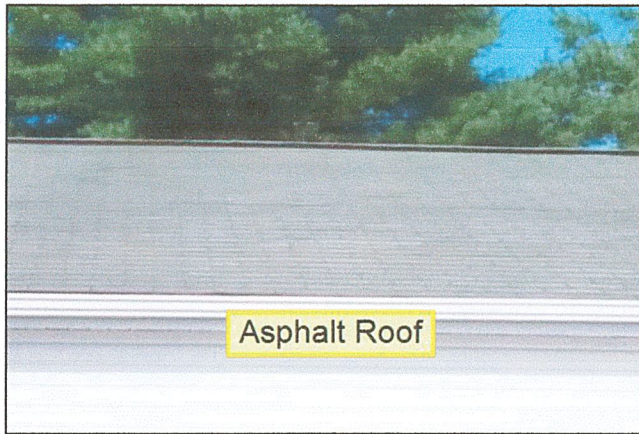
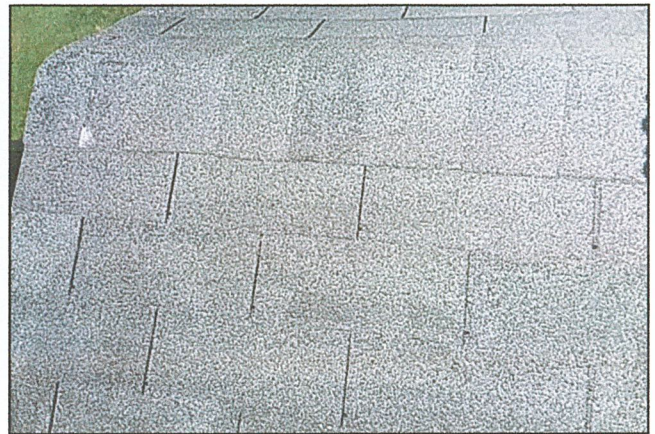
(1) Two types of warranties are offered when new asphalt shingles are installed; The manufacturer's warranty, which covers the shingles themselves and varies among manufacturers, and the contractors warranty, which covers the installation and workmanship. When a home is sold, a roof warranty may fully transfer to the home buyer, may transfer for a shortened length of time, may transfer with limited coverage, or may not transfer at all. I recommend you consult with the home owner as to the how the sale will affect the current warranty and confirm any seller claims by reading the warranty.

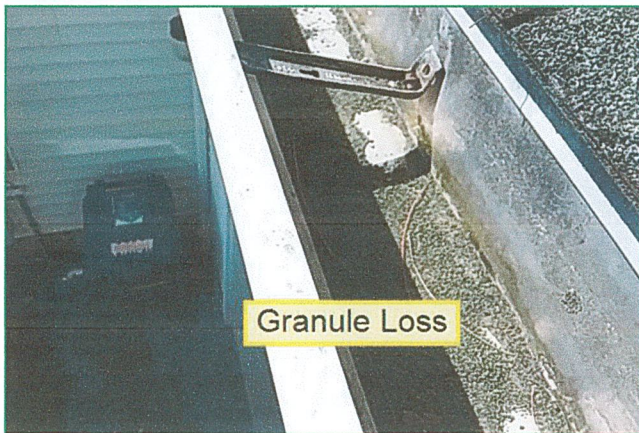
(2) Asphalt shingles are showing evidence of granule loss. Granules on asphalt shingles provide protection from excessive sun exposure. This roof is nearing the end of its useful life. I recommend replacement by a qualified roofing contractor.

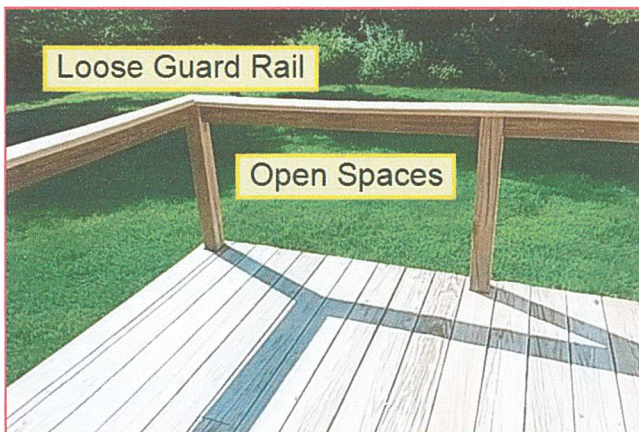
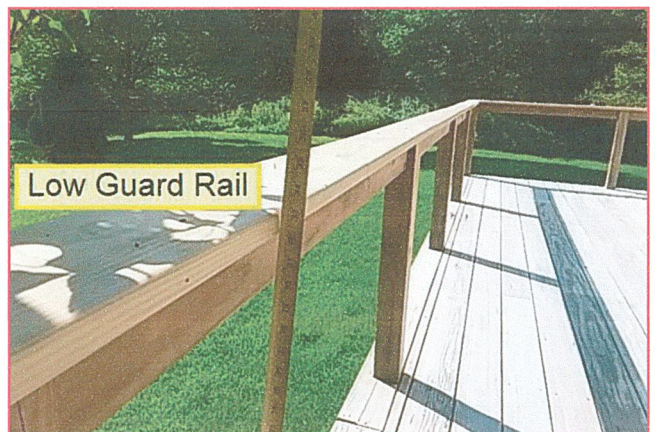
- +** (1) There are open spaces greater than six inches at the exterior/deck stairs. Open spaces in excess of six inches present entrapment hazards for people and pets. I recommend these open spaces be closed with proper materials by a licensed contractor.

The deck guard rail is loose to the framing. Guard rails are required to withstand up to 200 lbs of pressure to be safe. I recommend a licensed contractor repair/replace this guard rail.

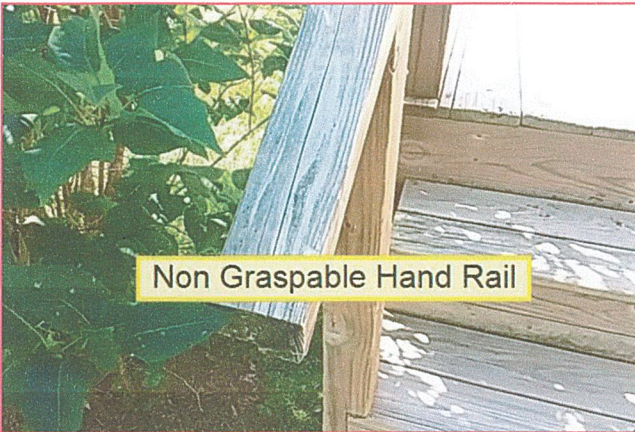
- +** (2) The hand rail located at the front deck is a non graspable handrail. I recommend a qualified contractor install a graspable hand rail at this location.

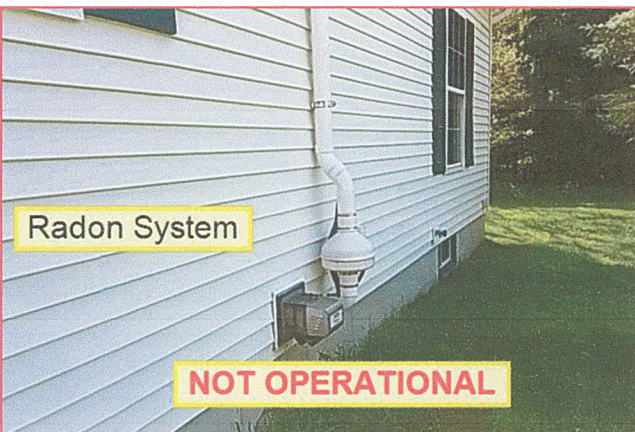
Photo 1

- +** A radon system utilizing sub slab depressurization is present in the home (Photo 1). A manometer is present in the basement (Photo 2). Uneven fluid level in the manometer indicates a working radon fan. I recommend retesting radon levels every two years.

The radon system was not operational on the day of the inspection. I recommend repair by a certified radon system installation professional.

RADON SYSTEM AND MANOMETER WORKING PROPERLY.

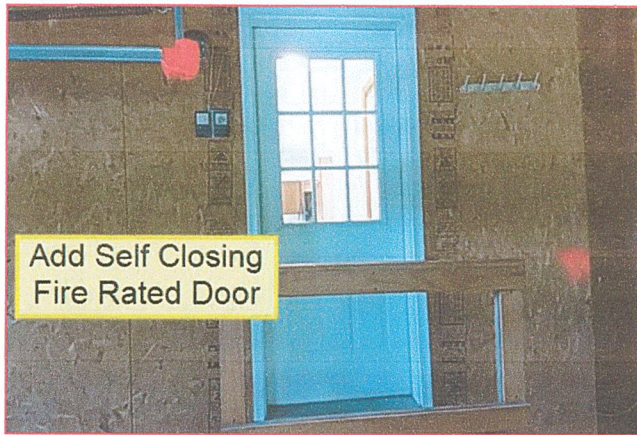
- +** (1) The occupant door from the garage into the home is not a self closing door. Self closing hinges are required at this location. I recommend self closing hinges be added to this door.

The occupant door from inside garage to inside the home is not a fire rated door. This means that should a fire occur in garage, the occupant door does not afford protection until fireman arrive. This door should be replaced with a fire rated door.

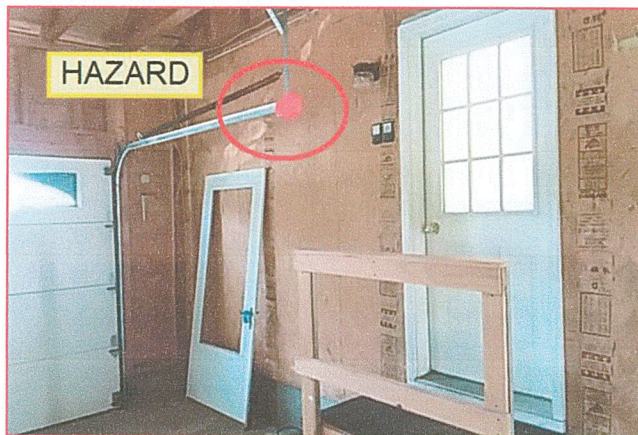
- +** (2) I recommend using caution when exiting this door into the garage due to the proximity of the automatic garage door track.

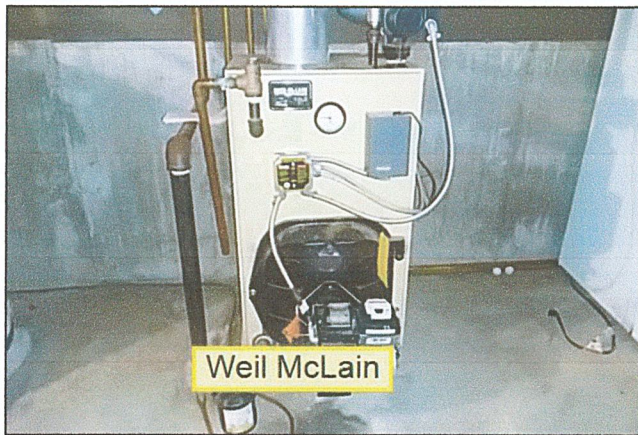
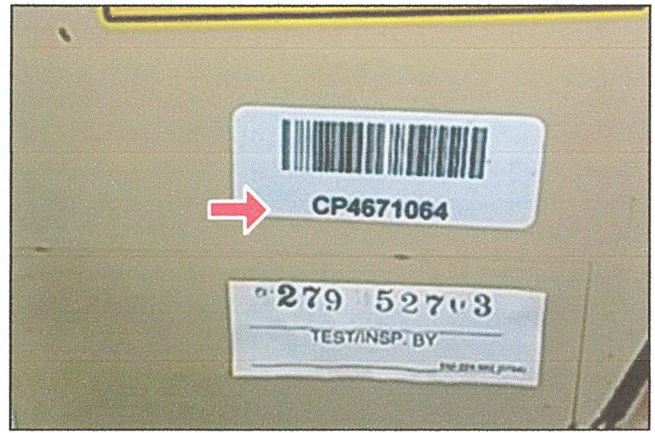
(1) The home is serviced by a Weil McLain boiler. This unit was manufactured in MY 2003 and was operational on the day of the inspection. This is provided for your information.

HEATING SYSTEM CLEANED AND SERVICED.

I recommend the heating system be cleaned and serviced on an annual basis by a qualified HVAC professional.

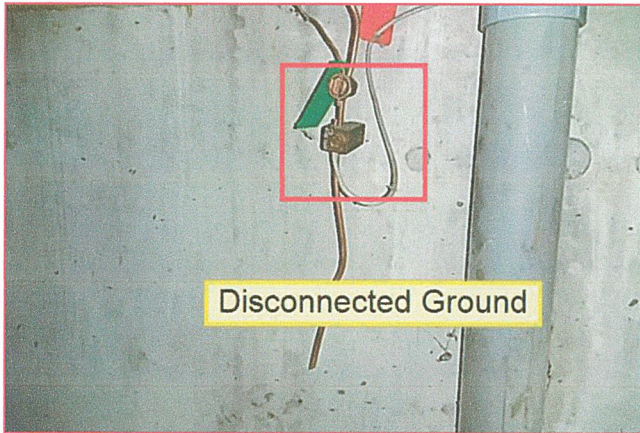
- +** (2) The ground wire has been disconnected at the electric panel. Repair by a licensed electrician is required.

GROUND WIRE RECONNECTED BY LICENSED ELECTRICIAN.

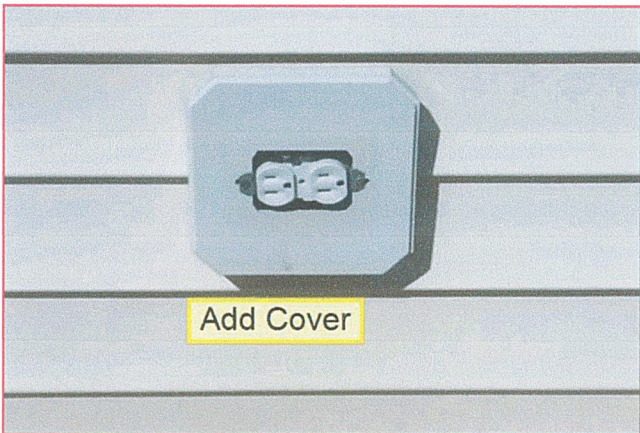
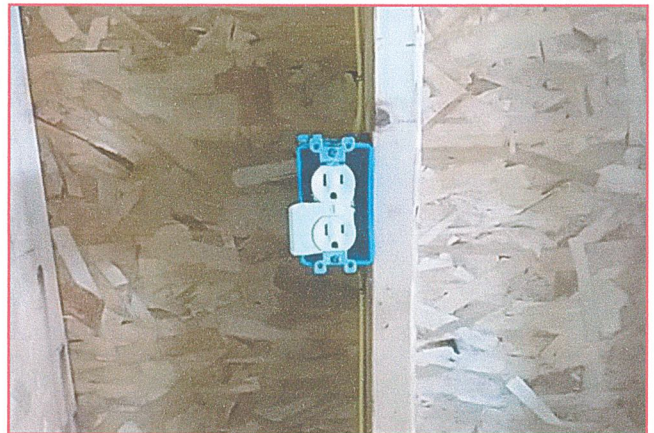
- +** There are several uncovered and incomplete switches, receptacles and junction boxes around the home. I recommend these electrical components be properly wired, covered and secured by a licensed electrician.

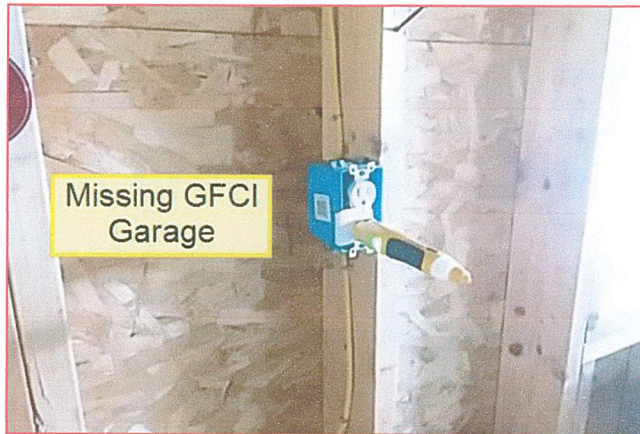
- +** The receptacles in the garage are not GFCI protected. GFCI circuit breakers and receptacles are to protect personnel from shock during a ground fault condition. These devices measure the current flow between the energized and neutral wires and trip when they detect a difference of 5-6 milliamperes or more. GFCI protection

can be provided by GFCI receptacles or circuit breakers. I recommend a licensed electrician provide GFCI/AFCI protection at all required locations within the home.

ADD GFCI COVERS TO OUTLETS AND RECEPTACLES IN GARAGE.

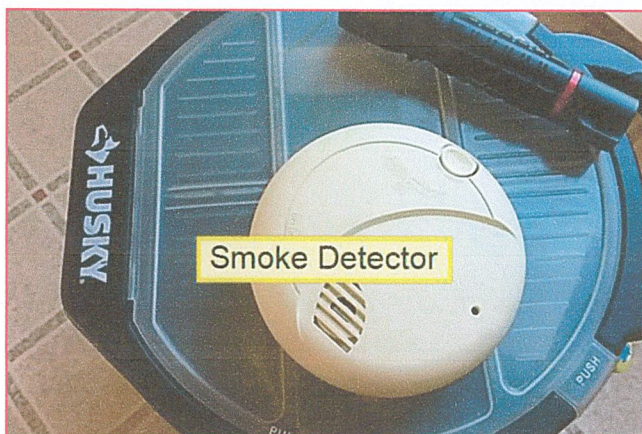
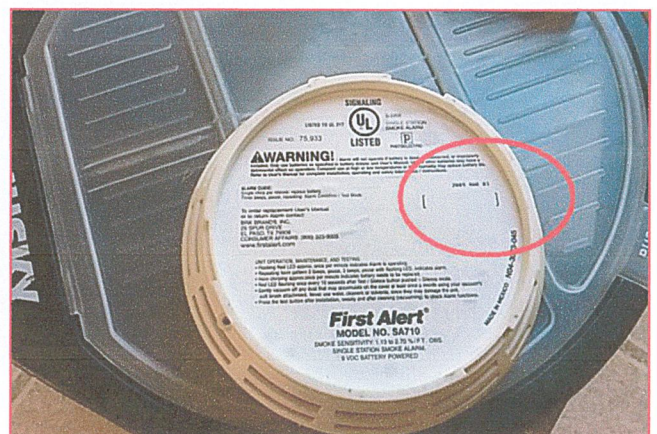
- +** (1) The smoke detectors in the home are old and may not be functional. The life expectancy of smoke detectors is generally 10 years, after which point their sensors can begin to lose sensitivity. The test button only confirms the battery, electronics, and alert system are working: it does not mean the smoke sensor is working. I recommend you have all smoke detectors tested and maintained, upgraded or replaced as needed. All hard wired smoke detectors should be replaced by a licensed electrical contractor.

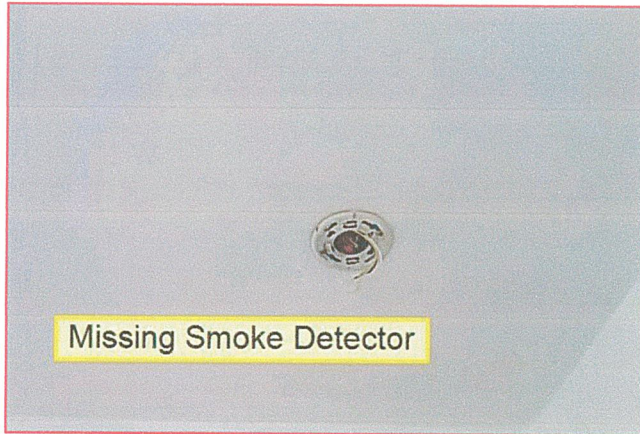
- +** (2) Smoke detectors are missing in several locations around the home. Smoke alarms are to be located in every bedroom, in hallways near bedrooms, one per story, including basements and habitable attics. Smoke alarms

batteries should be changed twice a year. All smoke alarms should be upgraded every 10 years. I recommend a qualified person install smoke detectors in all required locations of the home prior to occupancy.

MISSING SMOKE DETECTORS. ALL SHOULD BE LESS THAN 10 YEARS OLD. BATTERIES UP-TO-DATE.

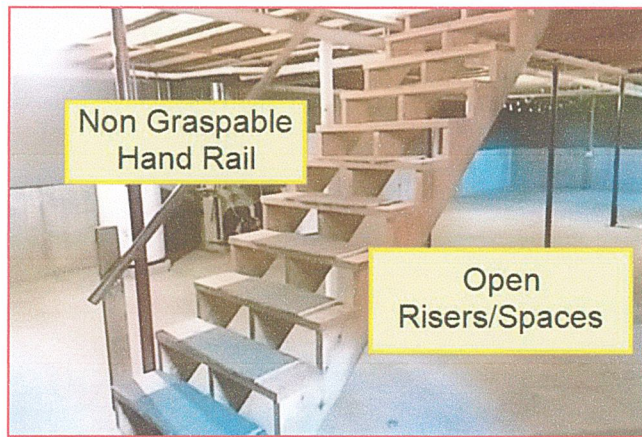
A hand rail is missing at the basement stairs. Stairs with more than 3 risers require a hand rail for occupant safety. I recommend proper hand rails be added at this location by a qualified contractor.

The hand rail located at the basement stairs is a non graspable handrail. I recommend a qualified contractor install a graspable hand rail at this location.

There are open risers on the basement stairs. Open risers, with spaces in excess of 4" present tripping/entrapment hazards for people and pets. I recommend these risers be closed with proper materials by a licensed contractor.

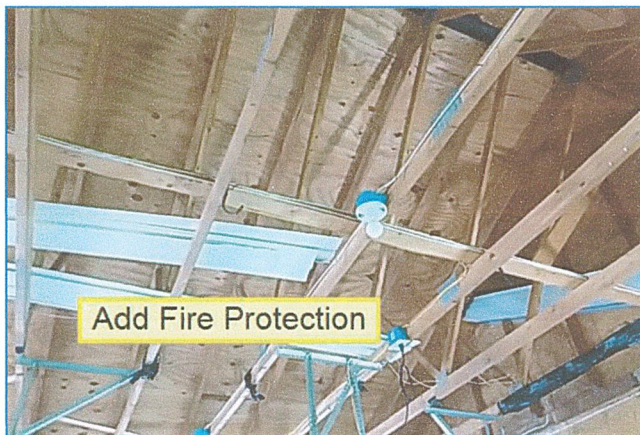
An attached garage should be separated from the home by at least 5/8 inch thick drywall, including tape and compound, applied to the ceiling on the garage side. No penetrations for attic stairs or HVAC components are allowed through fire separations. I recommend proper fire protection be added to the garage by a licensed contractor.

WANT TO TALK TO PALL ABOUT DRYWALL AND FIRE PROTECTION SEPARATION BETWEEN GARAGE AND HOUSE

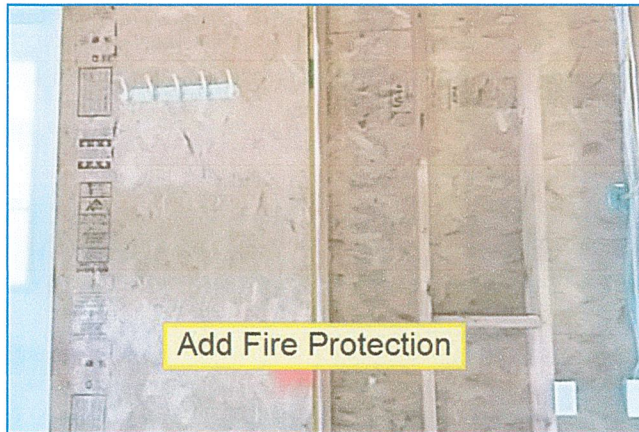
An attached garage should be separated from the home by at least 1/2 inch thick drywall applied to the walls and ceiling installed on the garage side. A garage should be separated from habitable space above by at least 5/8

inch thick Type X drywall applied to the garage ceiling, and the structural walls supporting the habitable space above should be covered by at least 1/2 inch thick drywall installed on the garage sides. No penetrations for pet doors, attic stairs or HVAC are allowed through fire separations. I recommend proper fire protection be added to the garage by a licensed contractor.

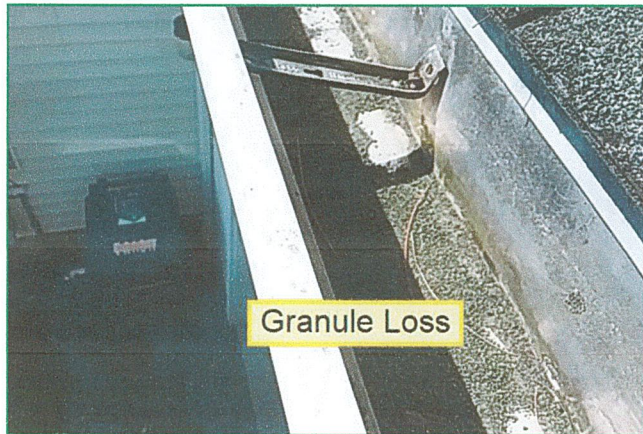
(2) Asphalt shingles are showing evidence of granule loss. Granules on asphalt shingles provide protection from excessive sun exposure. This roof is nearing the end of its useful life. I recommend replacement by a qualified roofing contractor.

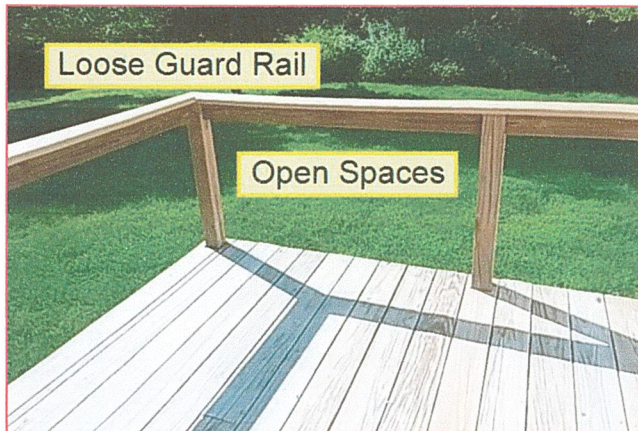
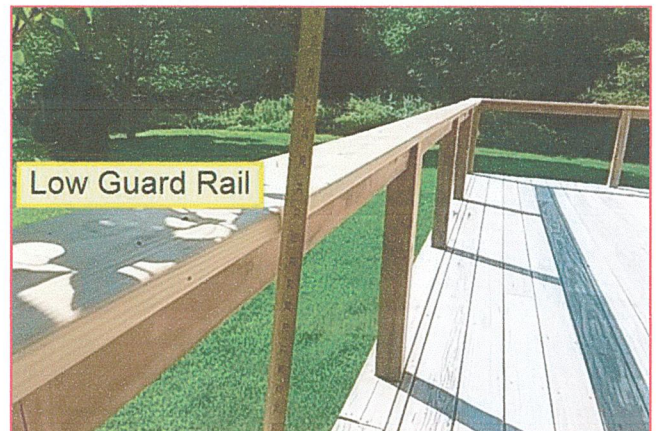
- +** (1) There are open spaces greater than six inches at the exterior/deck stairs. Open spaces in excess of six inches present entrapment hazards for people and pets. I recommend these open spaces be closed with proper materials by a licensed contractor.

The deck guard rail is loose to the framing. Guard rails are required to withstand up to 200 lbs of pressure to be safe. I recommend a licensed contractor repair/replace this guard rail.

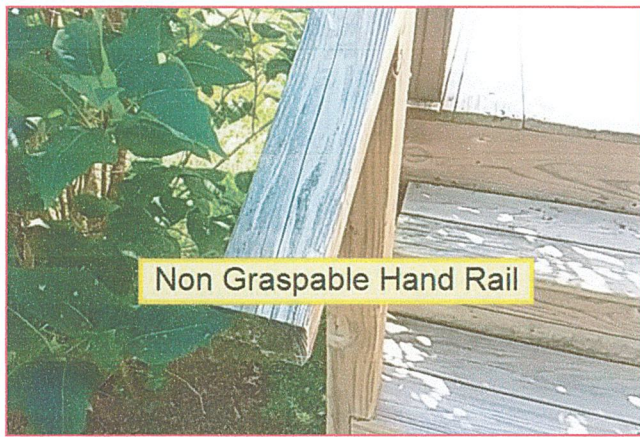
- +** (2) The hand rail located at the front deck is a non graspable handrail. I recommend a qualified contractor install a graspable hand rail at this location.

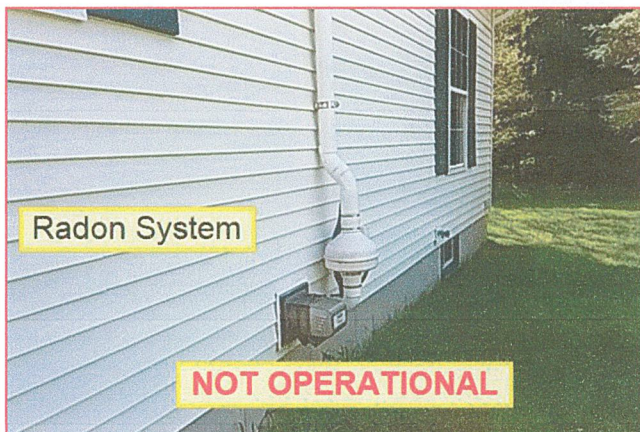
Photo 1

A radon system utilizing sub slab depressurization is present in the home (Photo 1). A manometer is present in the basement (Photo 2). Uneven fluid level in the manometer indicates a working radon fan. I recommend retesting radon levels every two years.

The radon system was not operational on the day of the inspection. I recommend repair by a certified radon system installation professional.

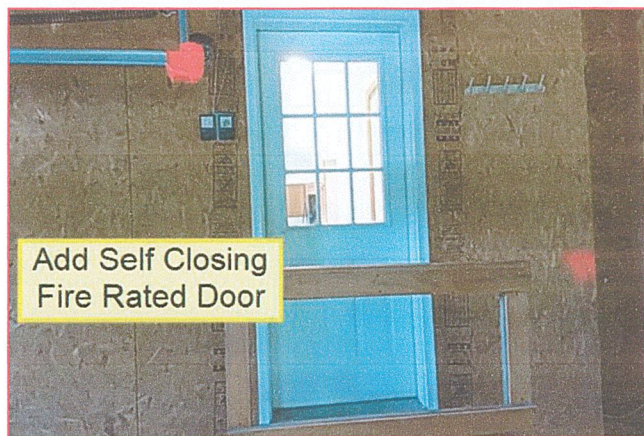
(1) The occupant door from the garage into the home is not a self closing door. Self closing hinges are required at this location. I recommend self closing hinges be added to this door.

The occupant door from inside garage to inside the home is not a fire rated door. This means that should a fire occur in garage, the occupant door does not afford protection until fireman arrive. This door should be replaced with a fire rated door.

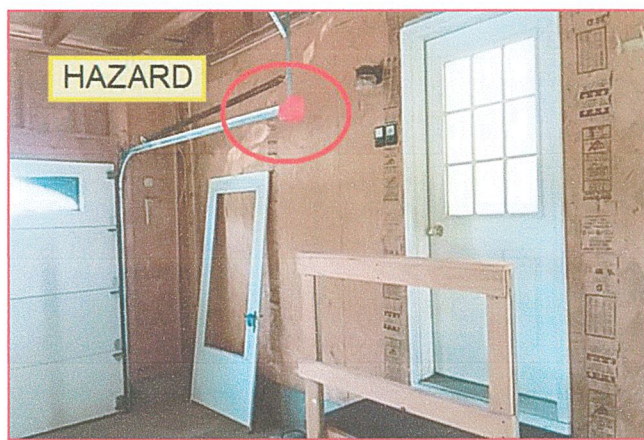
- +** (2) I recommend using caution when exiting this door into the garage due to the proximity of the automatic garage door track.

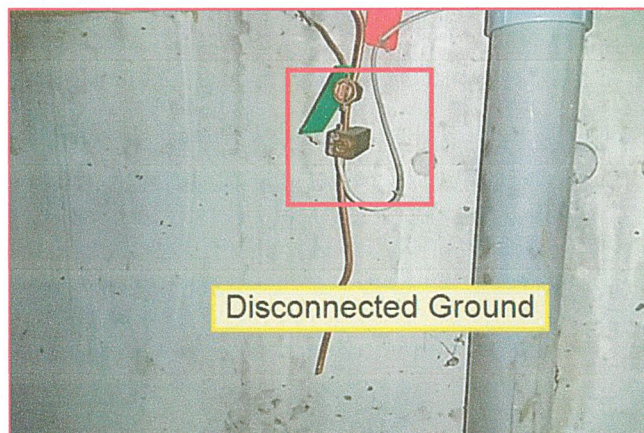
- +** (2) The ground wire has been disconnected at the electric panel. Repair by a licensed electrician is required.

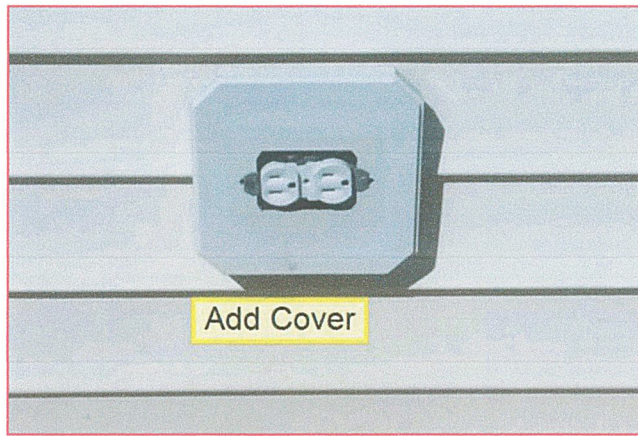
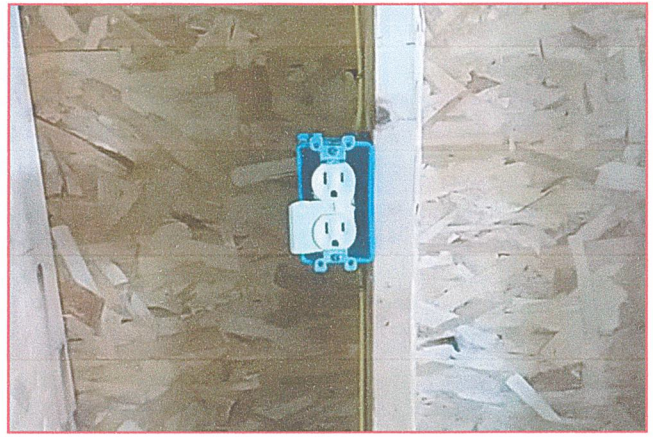
- +** There are several uncovered and incomplete switches, receptacles and junction boxes around the home. I recommend these electrical components be properly wired, covered and secured by a licensed electrician.

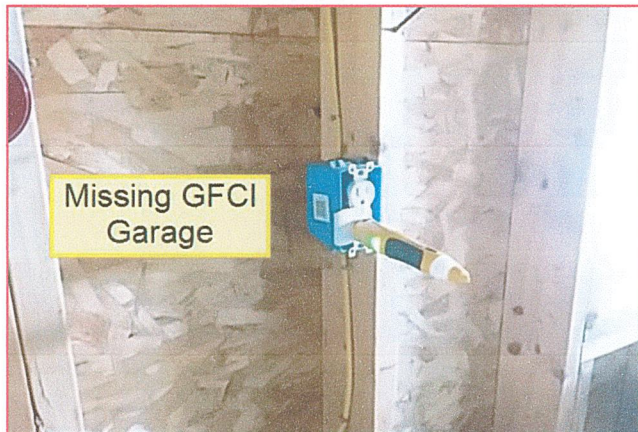
- +** The receptacles in the garage are not GFCI protected. GFCI circuit breakers and receptacles are to protect personnel from shock during a ground fault condition. These devices measure the current flow between the energized and neutral wires and trip when they detect a difference of 5-6 milliamperes or more. GFCI protection can be provided by GFCI receptacles or circuit breakers. I recommend a licensed electrician provide GFCI/AFCI protection at all required locations within the home.

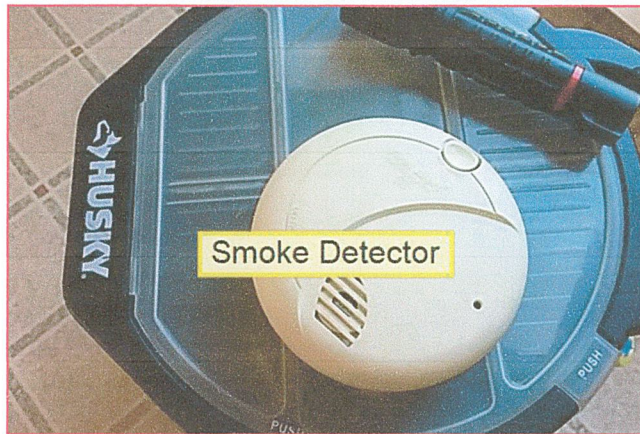
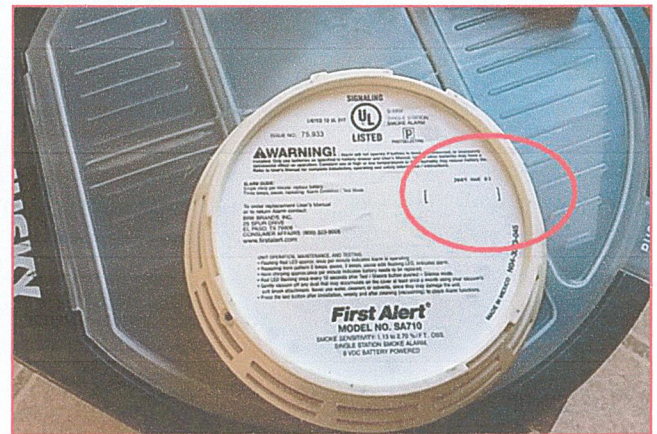
- +** (1) The smoke detectors in the home are old and may not be functional. The life expectancy of smoke detectors is generally 10 years, after which point their sensors can begin to lose sensitivity. The test button only confirms the battery, electronics, and alert system are working: it does not mean the smoke sensor is working. I recommend you have all smoke detectors tested and maintained, upgraded or replaced as needed. All hard wired smoke detectors should be replaced by a licensed electrical contractor.

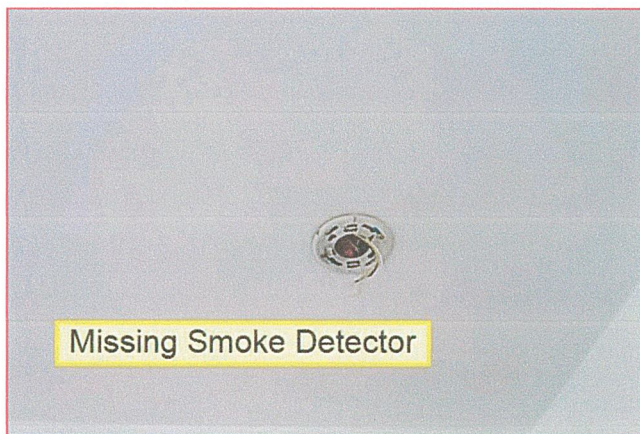
- +** (2) Smoke detectors are missing in several locations around the home. Smoke alarms are to be located in every bedroom, in hallways near bedrooms, one per story, including basements and habitable attics. Smoke alarms batteries should be changed twice a year. All smoke alarms should be upgraded every 10 years. I recommend a qualified person install smoke detectors in all required locations of the home prior to occupancy.

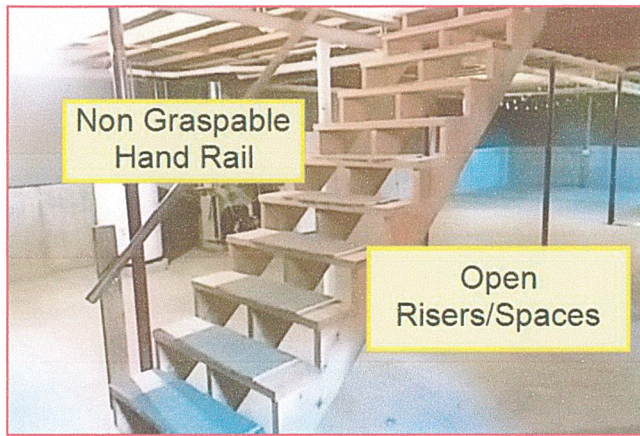
- +** A hand rail is missing at the basement stairs. Stairs with more than 3 risers require a hand rail for occupant safety. I recommend proper hand rails be added at this location by a qualified contractor.

The hand rail located at the basement stairs is a non graspable handrail. I recommend a qualified contractor install a graspable hand rail at this location.

There are open risers on the basement stairs. Open risers, with spaces in excess of 4" present tripping/entrapment hazards for people and pets. I recommend these risers be closed with proper materials by a licensed contractor.

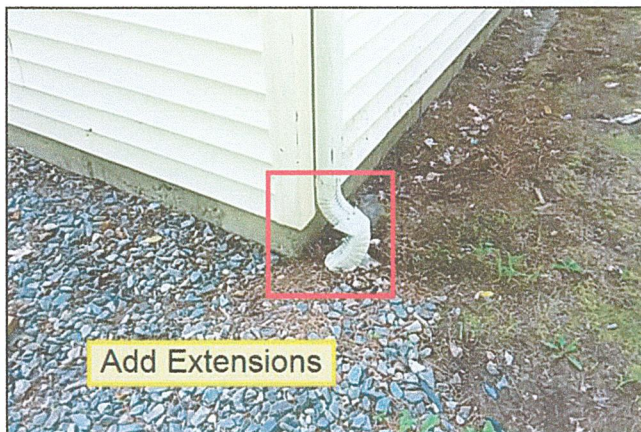
(1) The downspouts around the home need extensions to carry water away from the home. I recommend a qualified person install downspout extensions at these locations.

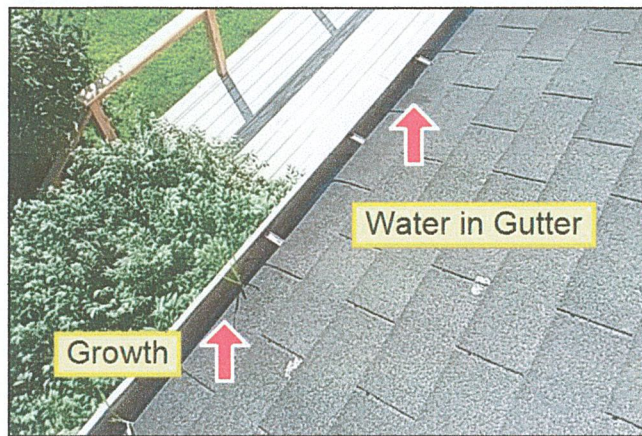
(2) The gutters are full of debris in areas and need to be cleaned. The debris in gutters can also conceal rust, deterioration or leaks that are not visible until cleaned, and I am unable to determine if such conditions exist.

Gutters and downspouts play an important role in leading water away from the foundation. Clean them each Spring and Fall, or more often if needed, particularly if large trees overhang the roof. Make certain the gutters drain and slope properly toward the downspouts. Maintain and repair periodically, as needed.

CLEAN GUTTERS AND SHORE UP FRONT GUTTER SO THAT IT IS DRAINING OFF PROPERLY.

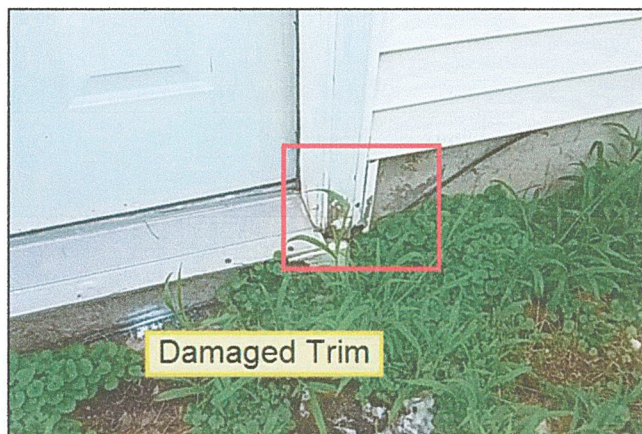
(1) There is decayed trim at various locations of the home. There is a potential for concealed damage behind the decayed areas. I could not inspect the areas behind this damage. I recommend that a qualified contractor remove and replace all decayed wood prior to painting the home.

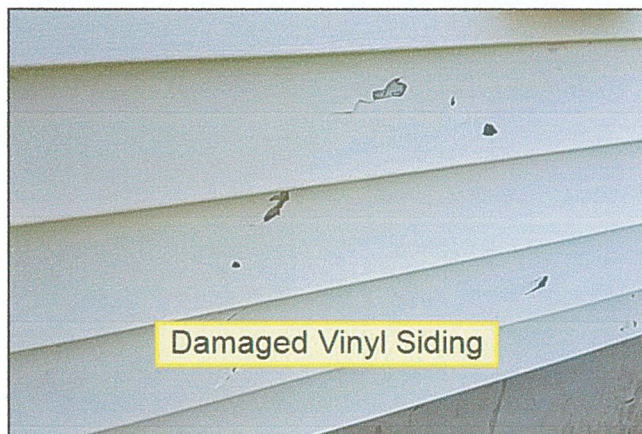
(2) Vinyl siding damage is present at the exterior of the home. Moisture and insects can enter at these locations. I recommend this siding be repaired/replaced by a qualified contractor.

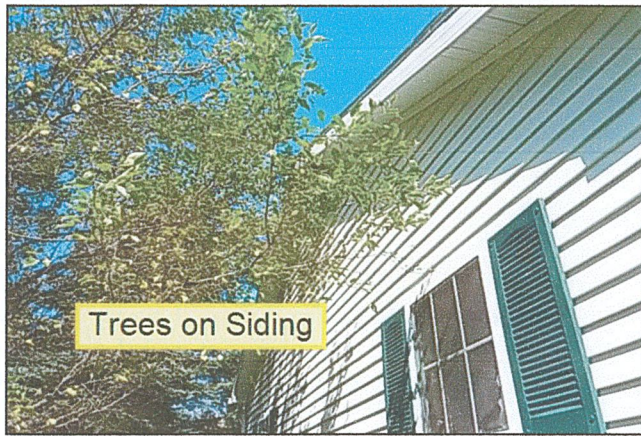
(3) There are shrubs/trees close to, or in contact with the siding. Tree limbs and shrubs can damage siding materials and hold moisture. I recommend these trees/shrubs limbs be trimmed away from the siding by a landscape professional.

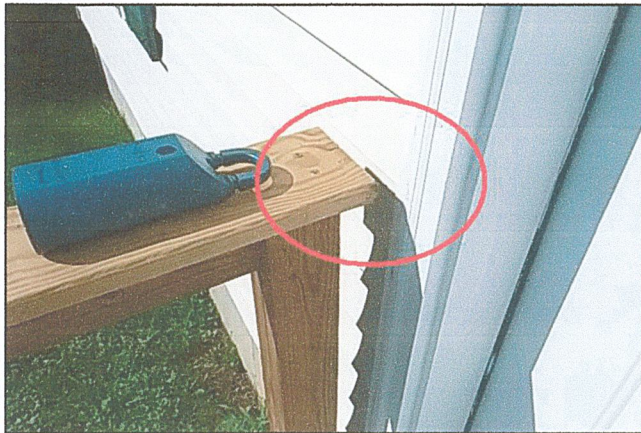
- 🔧 (3) Deck handrails/posts do not terminate into the framing/siding of the home at the front balcony. Terminating the handrail/post into the framing/siding of the home will increase stability of this railing. I recommend a qualified contractor properly terminate this handrail/post.

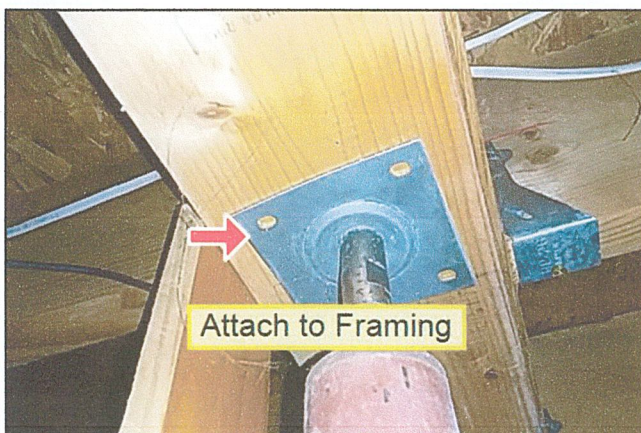
- 🔧 Basement columns are not mechanically secured to the framing. I recommend a qualified contractor properly secure these columns.

SECURE BASEMENT COLUMNS.

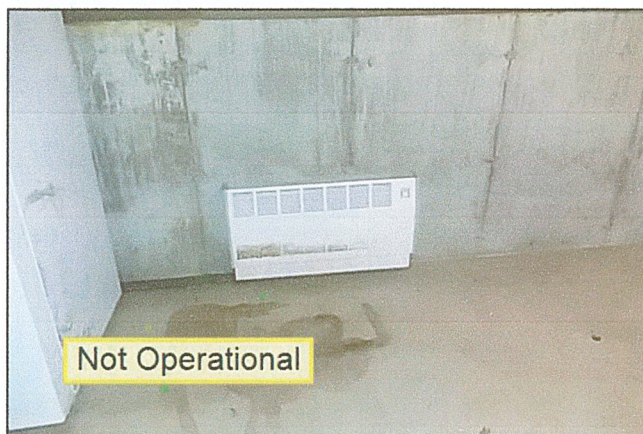
- 🔧 (2) The basement wall heating unit was not operational on the day of the inspection. I recommend repair by a qualified HVAC technician.

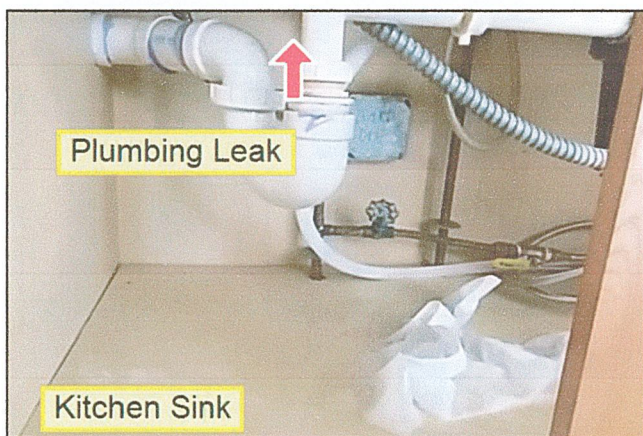
- 🔧 A leak is present in plumbing supply lines under the kitchen sink. I recommend repair by a qualified plumber.

REPAIR PLUMBING LEAK UNDER THE KITCHEN SINK AND POSSIBLY CHANGE OUT FLOORING UNDER SINK IF AT ALL DAMAGED BY LEAKING WATER.

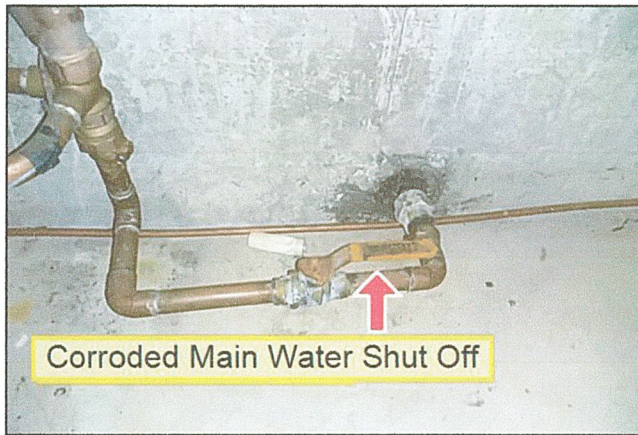
- 🔧 (2) The main water shut off valve is corroded at the time of the inspection. A corroded valve may lead to valve failure causing extensive damage to the home. I recommend the shut off valve be replaced by a licensed plumber.

REPAIR CORRODED MAIN WATER SHUT OFF.

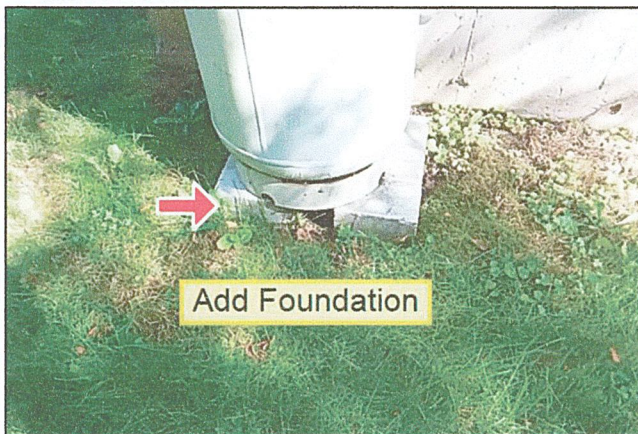
- (2) The exterior propane tank is not located on a stable foundation. I recommend this foundation be repaired to provide a stable footing for the exterior propane tank. This work can be done by a qualified contractor.

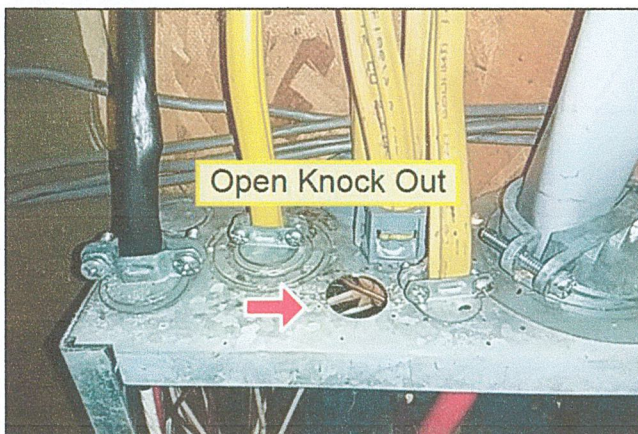
- (3) Open knockouts are present at the main electric panel. Open knockouts can allow small fingers and/or rodents into the electric panel. I recommend a licensed electrician close all open knockouts in the electric panel.

CLOSE UP ALL KNOCKOUTS ON THE ELECTRIC PANEL.

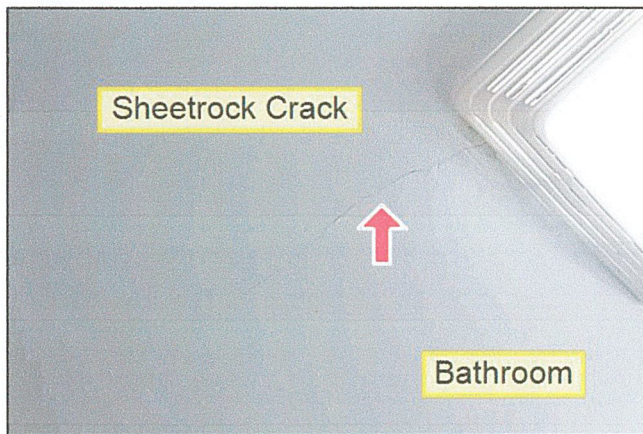
Settlement cracks are present in drywall around the home. I recommend a qualified contractor properly prep and paint these areas.

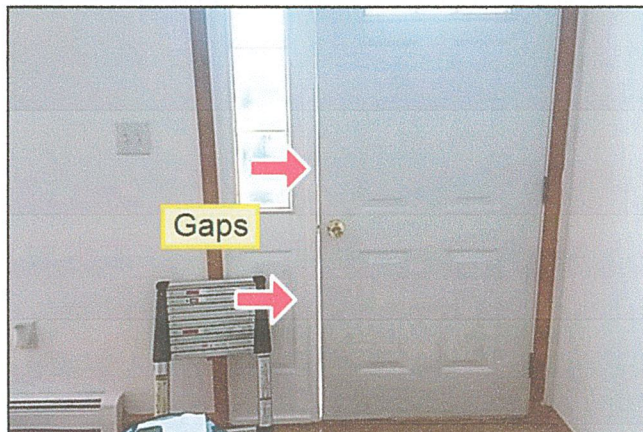
I recommend improving the weather seal at the front door to improve heating performance. This can be done by a qualified person.

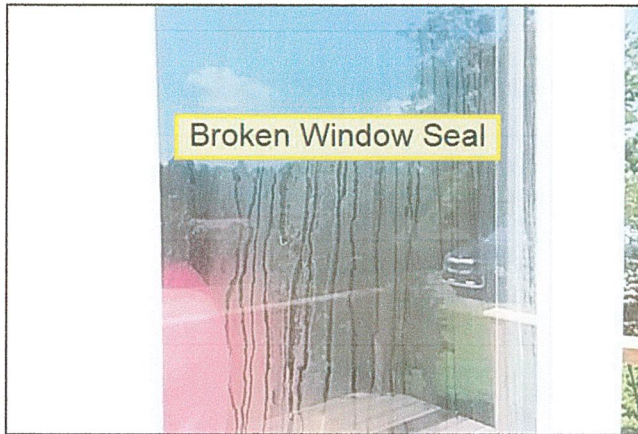
The insulating glass on the windows has lost its seal. This has resulted in condensation developing between the panes of glass. I recommend a qualified contractor replace the glass to correct this condition. The walls around this window tested as dry on the day of the inspection using a Tramex Moisture Meter Plus.

REPAIR BROKEN WINDOW SEAL ON FRONT WINDOW.

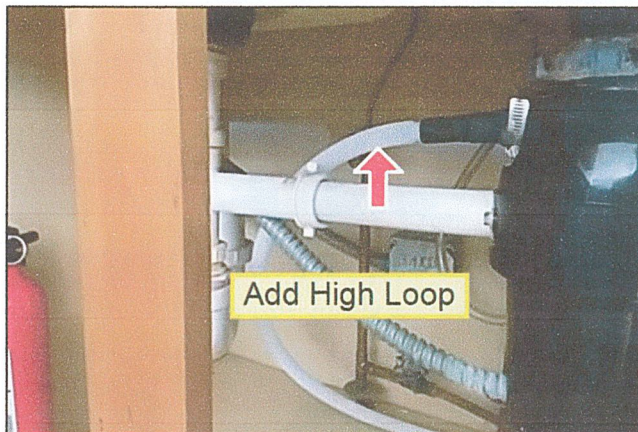
The drain line for the dishwasher does not contain a high loop under the sink. A high loop will keep water from draining into your dishwasher. I recommend a qualified person attach a high loop to the dishwasher drain line.
