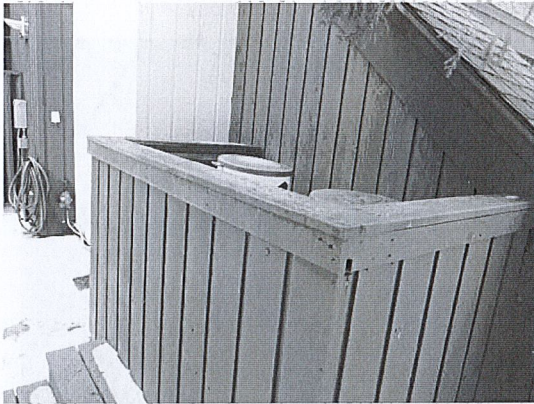
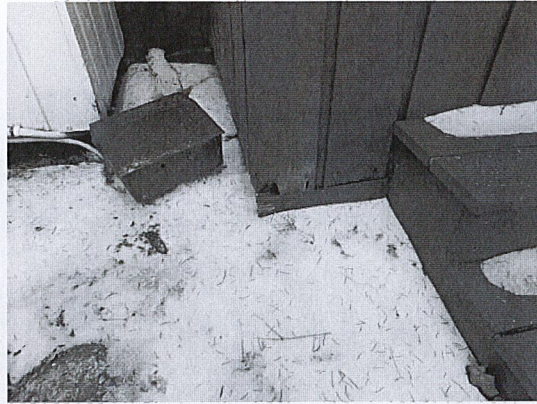
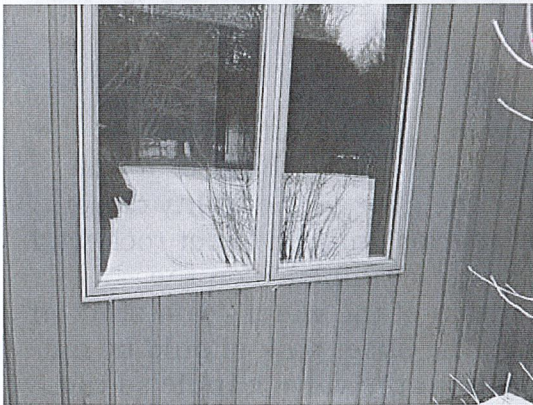
Minor water damage was noted at the base of the wood siding at the enclosure that houses the propane tanks at the rear of the home.

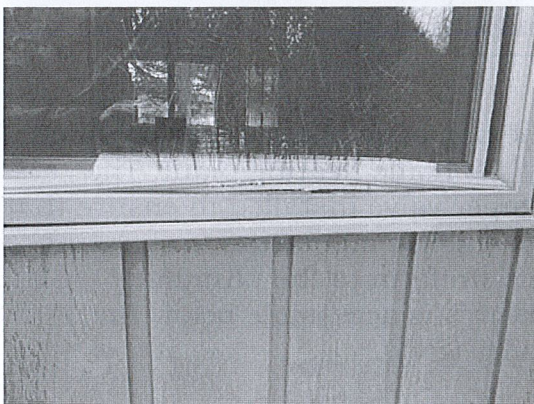
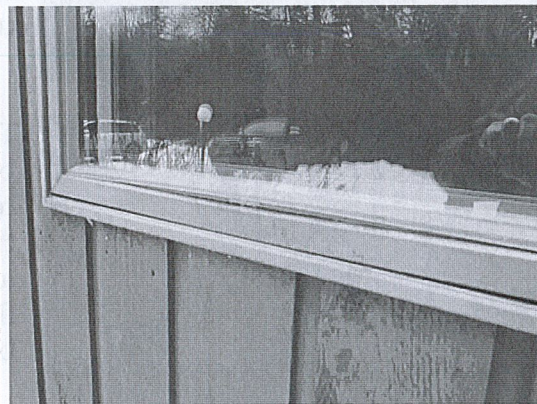
The bottom rails of the 1<sup>st</sup> floor bedroom windows at the front of the home are not properly sealed. The gasket at one of the windows is exposed.

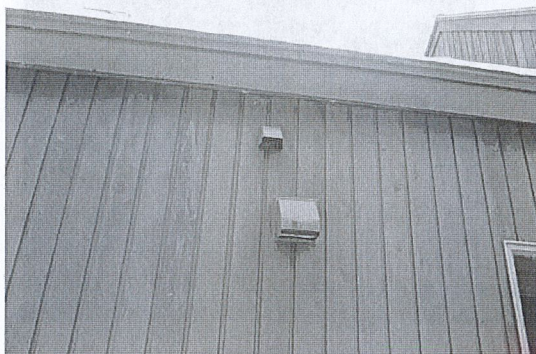
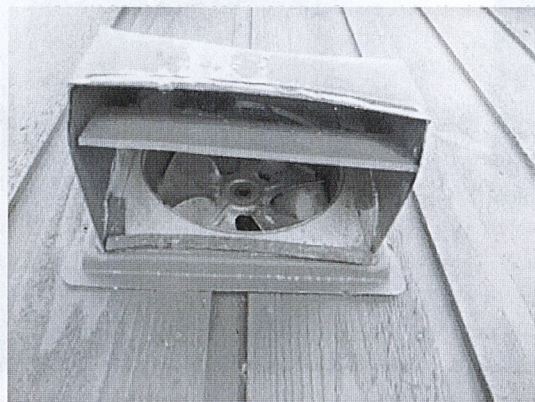
The old bathroom ceiling fan hood at the front of the home should be sealed to keep moisture, bees and vermin etc. from the interior of the hood assembly.

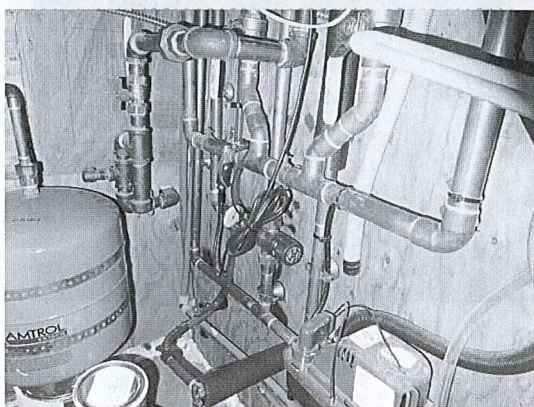
The water main shut off valve is located just above the floor to the left of the door in the utility closet. The interior finished sheet rock wall in the closet impedes on the operation of the water main shut off valve. The sheet rock should be cut away from the valve handle so the valve opens and closes unobstructed.

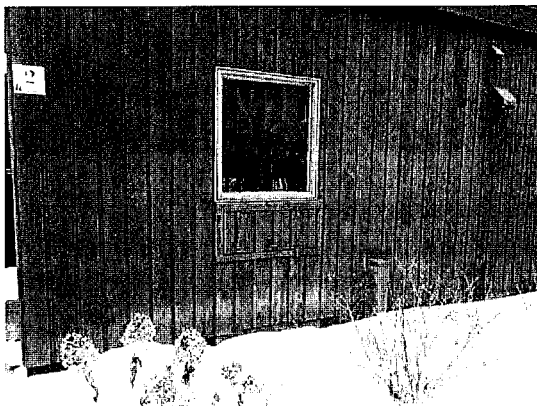
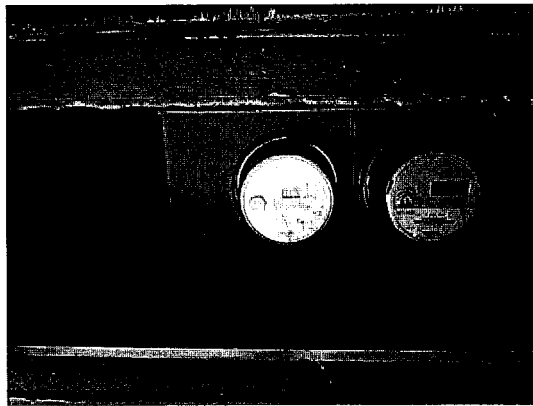
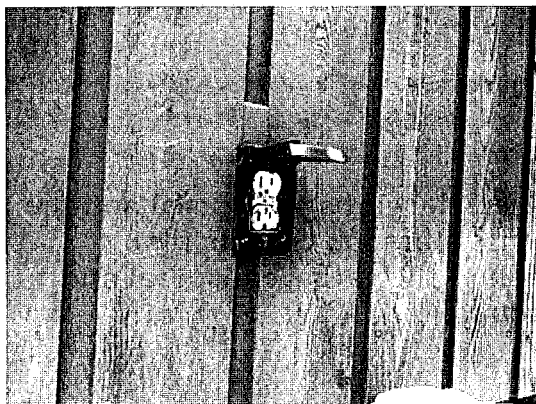
The electrical meter and the ground system for the electrical distribution system are installed in the enclosure below the front entrance window.

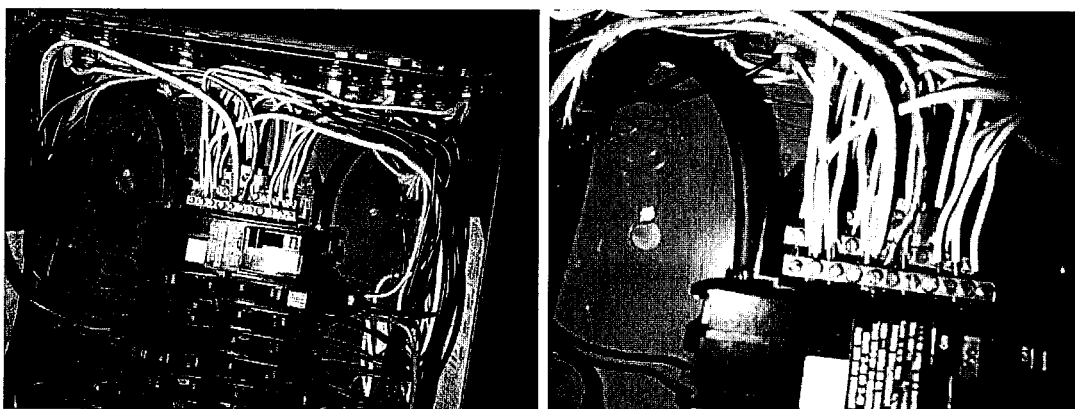
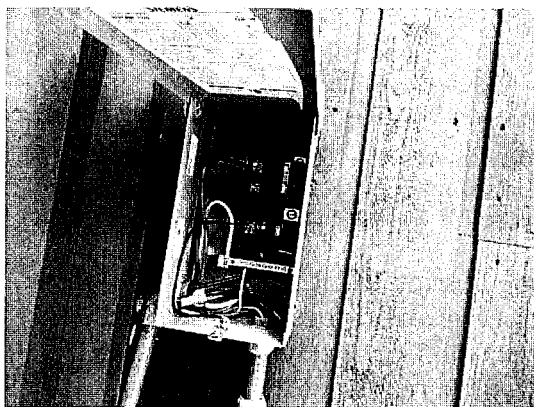
The electrical panel installed in the utility closet is not properly bonded. The neutral busbars (horizontal silver bars) at the upper panel are improperly isolated from the metal panel. A neutral busbar bond clamp or green bond screw should be installed at the neutral busbars to properly bond the panel. Also, there are two sets of neutral conductors (white wires) from four individual electrical branch circuits that improperly terminate on the same neutral busbar screws (double tapped). Each neutral conductor should terminate on an individual neutral busbar screw.

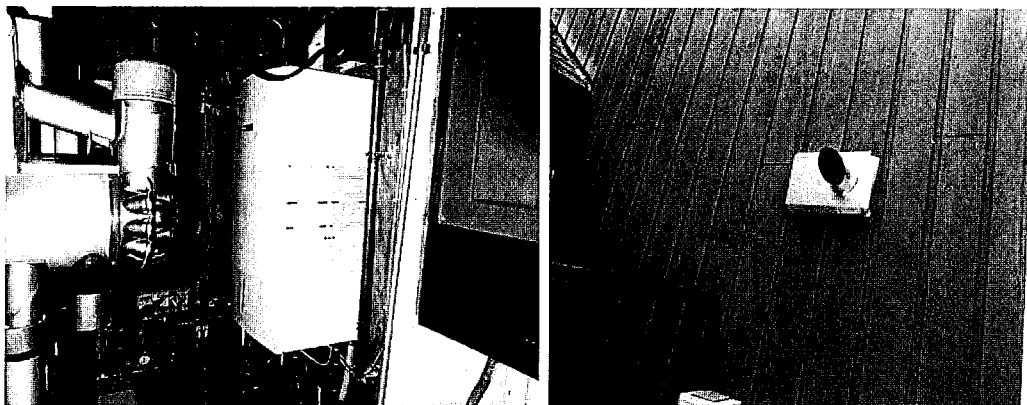
The primary heat source to the home is provided by a 1-year-old propane fired direct vented boiler that is installed in the utility closet.

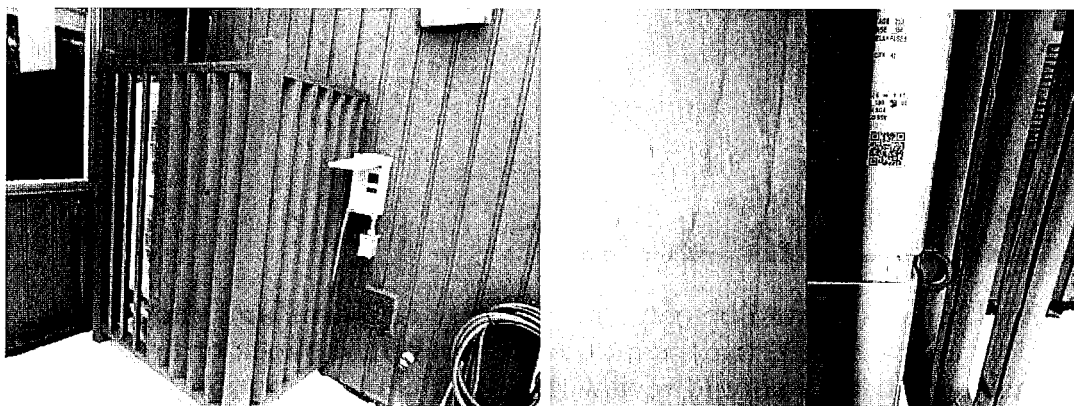
A 1-year-old split air-conditioner is installed in the enclosure at the rear of the home. Air handlers are installed on the interior walls to distribute the conditioned air in the winter and summer throughout the home.

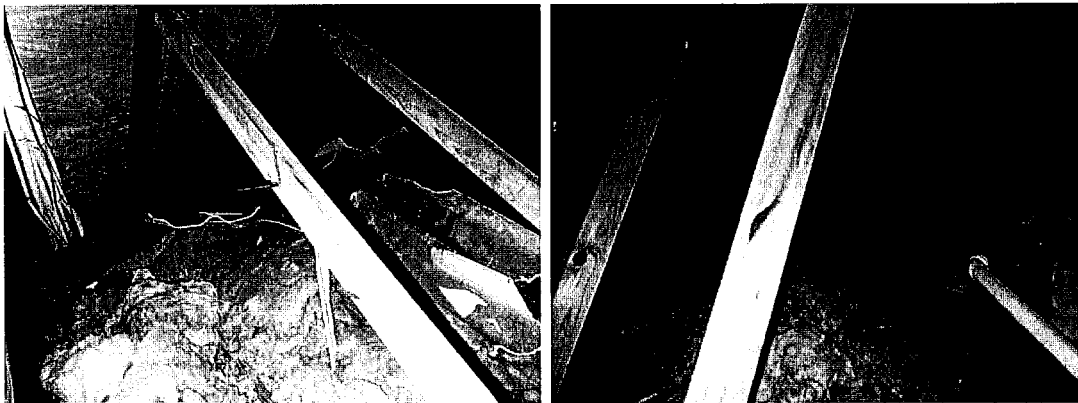
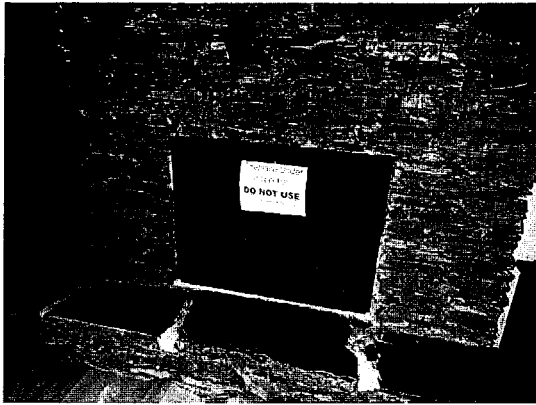
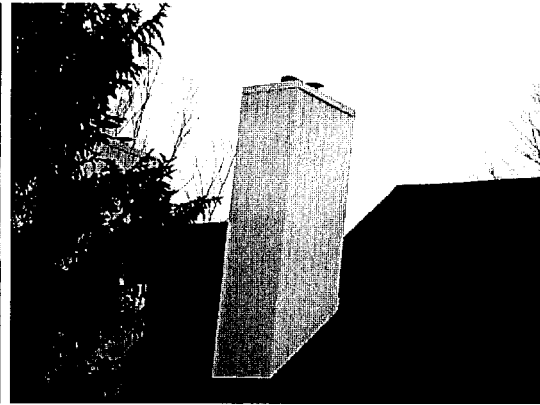
10 inches of fiberglass batt insulation is installed in between the truss joist cavities. Much of the insulation is installed uniformly across the attic floors but should be uniform across the entire attic to maximize energy efficiency.

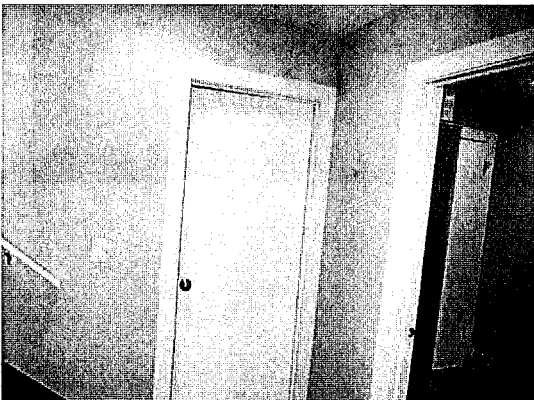
The front bedroom door sticks slightly at the top of the doorframe. The door operates properly and only needs a minor adjustment.

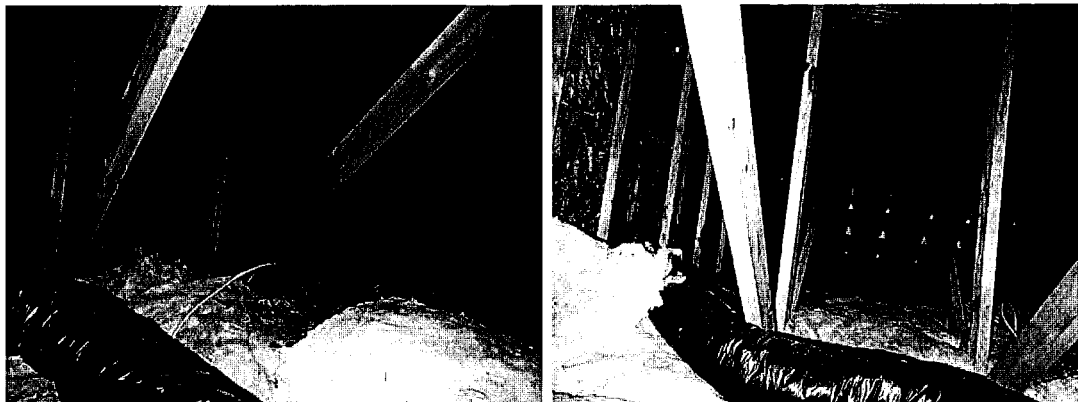
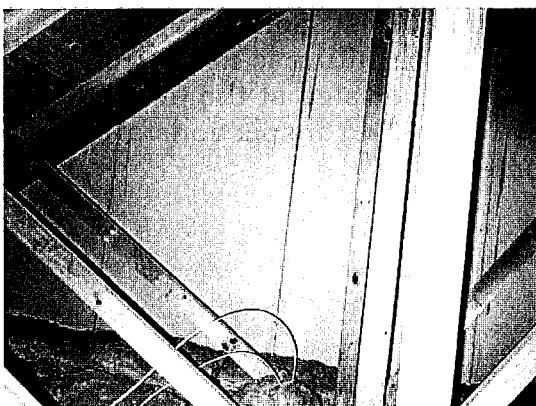
Sealing the sheet rock seams at the thermal wall in the attic with fire rated joint tape is recommended to slow an attic sourced fire from igniting the wood gable end structure.
