Electric Service

Jason Cone Thursday, January 18, 2018 Page 41 of 68

687 Stowe Hollow Rd. Unit # 2, Stowe VT 05672

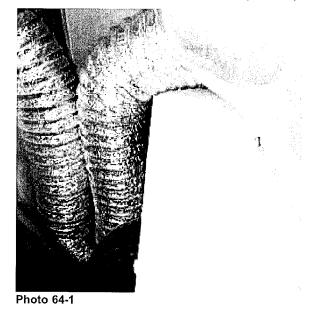
64) The clothes dryer is equipped with a PVC, cloth, vinyl or foil and /or an accordion-type, flexible exhaust duct (something other than metal). Clothes dryer manufacturers specify the use of a rigid or corrugated semi-rigid metal duct due dryer fire containment safety concerns. Recommend a qualified contractor review ductwork and repair per standard practices. For more information on dryer safety issues, see

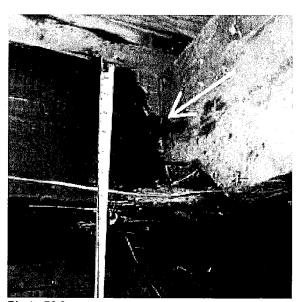
Photo 76-3

Dry rot noted on the bottom of this 7-8" beam. Note floor joist notched into it. This is how the dry rotted joists where where originally attached to the sill plate until they decayed away.
