Michael Casey
385 Maple Street, Stowe, Vermont

Inspection date
July 09, 2020

Reason for inspection
Transfer of property

Level of inspection
Level II

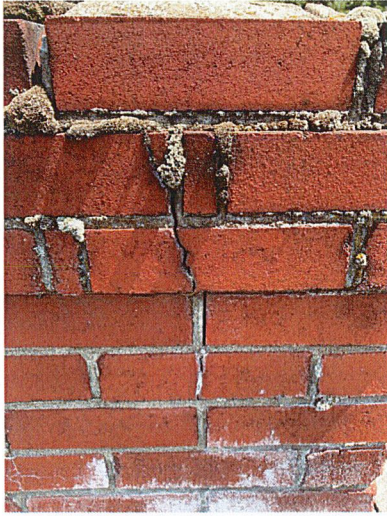
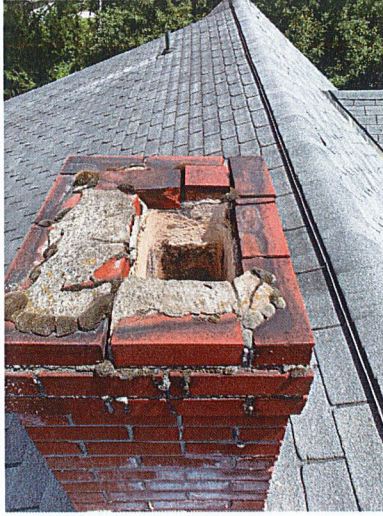
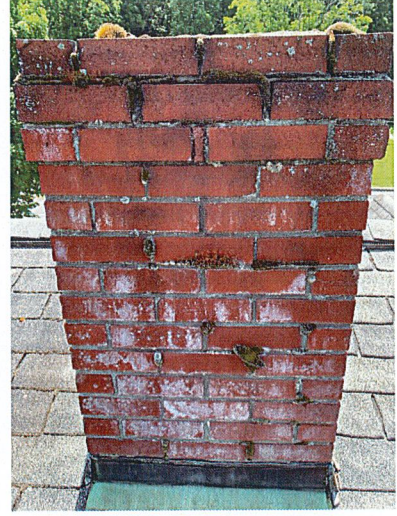
- **Mortar Condition:** Does not meet industry standards

There is significant deterioration, or missing mortar between the bricks. This can not only allow water intrusion into the chimney and cause potential leaks inside the home, but it also allows water into the chimney which can damage the chimney structure. The chimney is potentially unstable

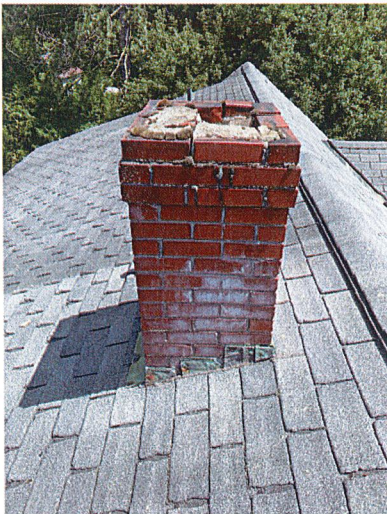
- **Crown / Wash cap:** Does not meet industry standards

The crown / wash cap of the chimney is not constructed in a way that properly protects the chimney. The crown should be constructed with concrete. It must have an expansion joint around the flue tile. It should overhang the main structure to allow a drip edge to protect the chimney. A properly made crown will help protect the chimney from water intrusion and damage.

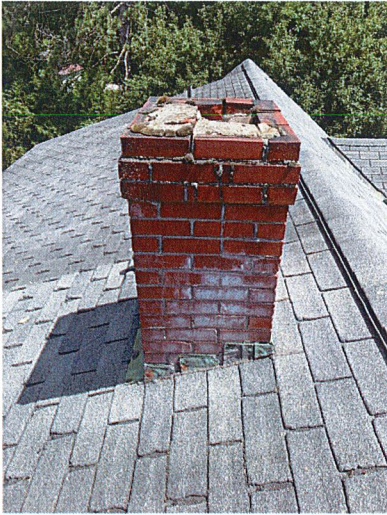
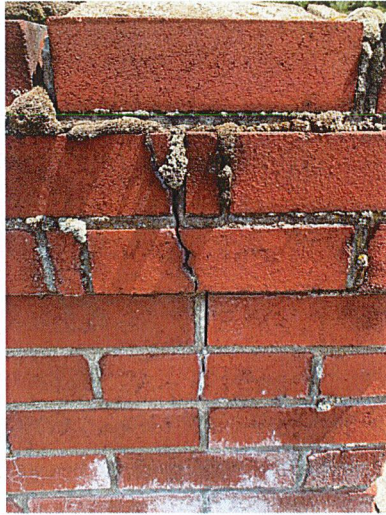
• **Brick / Stone / Chimney walls condition: Deteriorated**

The bricks are cracked and / or deteriorated and should be replaced

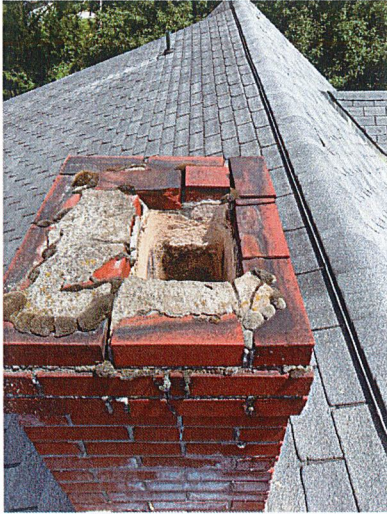
- **Height of liner above crown:** Does not meet industry standards

Due to deterioration the flue is no longer extending the required 2" above the crown.

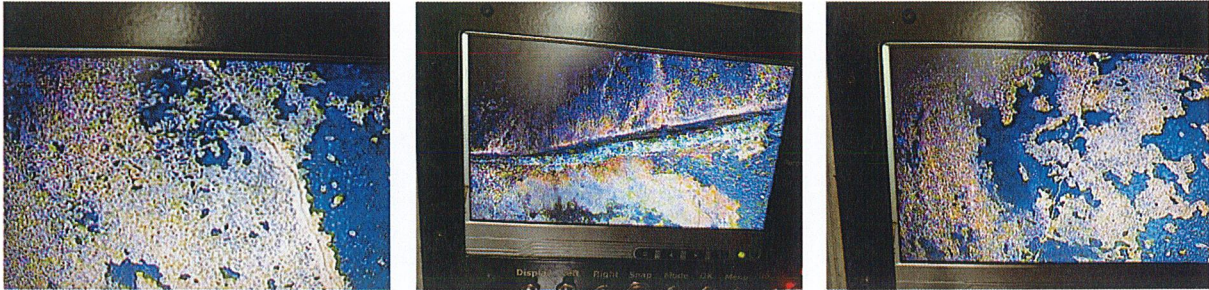
- **Flue shape (used to determine flue size ratio to fireplace opening):** Rectangular
- **Verification that the flue is not blocked or significantly restricted or obstructed:** Meets industry standards
- **Indications the flue is not drafting properly:** No
- **Chimney liner presence, condition regarding readily visible defects, holes, cracks, missing mortar joints, spalling, mortar protrusions, and proper alignment:** Does not meet industry standards

There are tiles that have vertical cracks. Vertical cracks are an indication that there has been a sudden rapid heating of the tile. This rapid heating causes thermal shock to the tile. Thermal shock causes the inside of the tile to heat more rapidly than the exterior of the tile. Heat causes the inside of the tile to expand more rapidly than the exterior of the tile. When this occurs the tile will crack vertically. This flue tile can no longer perform its intended function. The chimney must be relined. 2016 NFPA 211 14.9

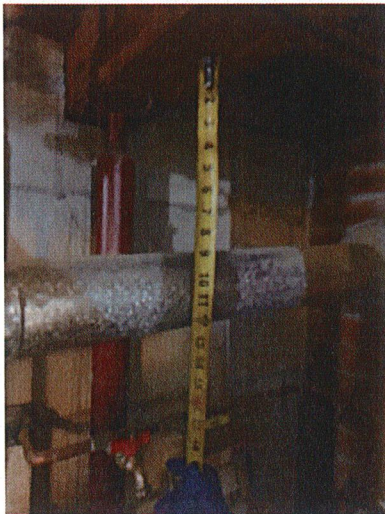
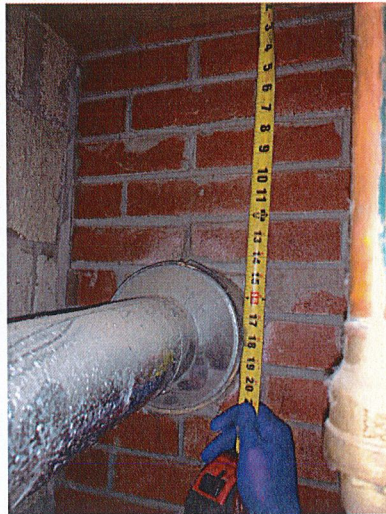
- **Connector pipe type, material, size, suitability for the appliance condition:** Meets industry standards
- **Slope and proper clearance to combustibles:** Needs attention

Vent does not meet the proper clearance to combustibles. IRC 2006 TABLE M1803.3.4. Along the 4' run of the connector pipe, the slope of a 1/4" per foot is maintained however the 18" of clearance to the floor joists and ceiling is not met.
