Radon Inspection Report

Property Inspection Report

Property address: **57 Edson Woods Rd
Stowe VT 05672**

Inspection date: **Monday, August 10, 2020**

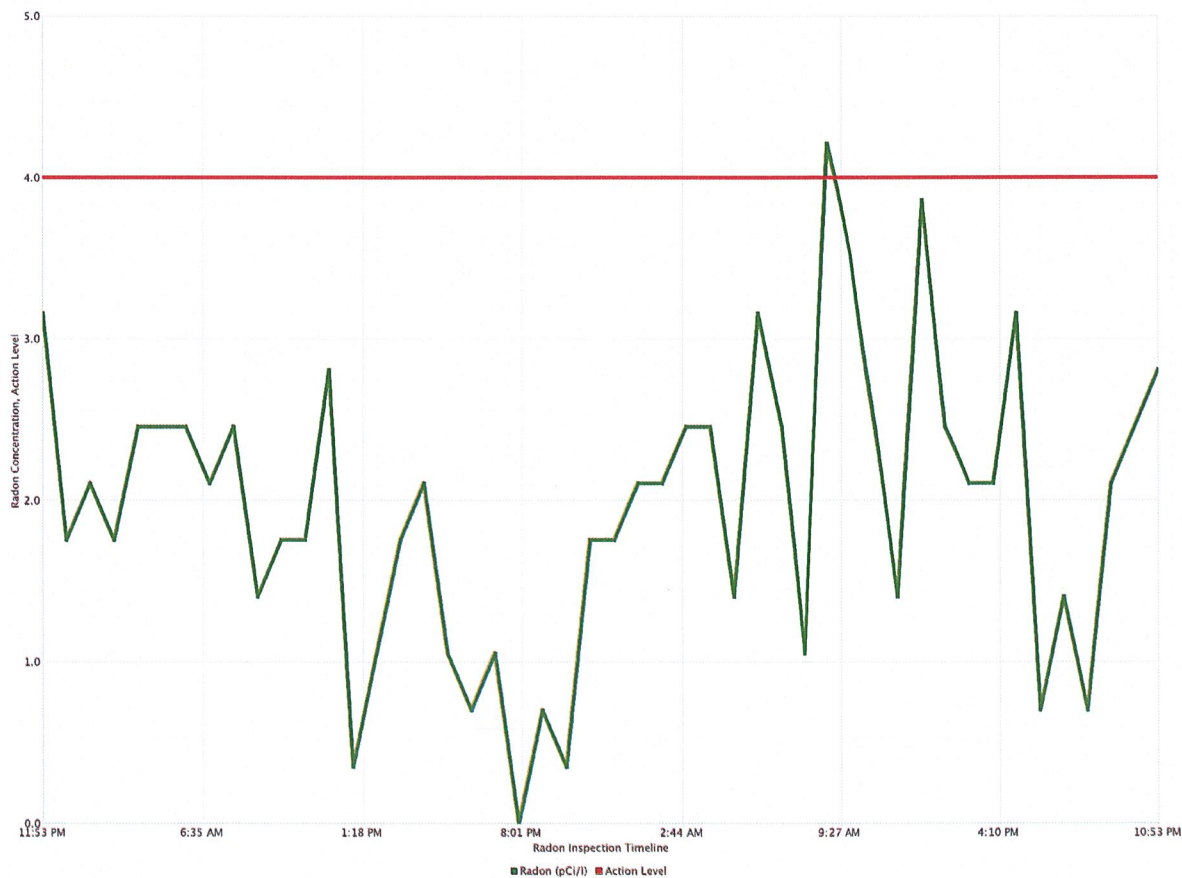
Radon Inspection Chart

Test Result: Below EPA Recommended Action Level

<u>Min:</u>	<u>Max:</u>	<u>Average:</u>	<u>Measurement Units:</u>
*First 4 hrs of data excluded Radon Concentration:	0.0	4.2	1.9	pCi/l

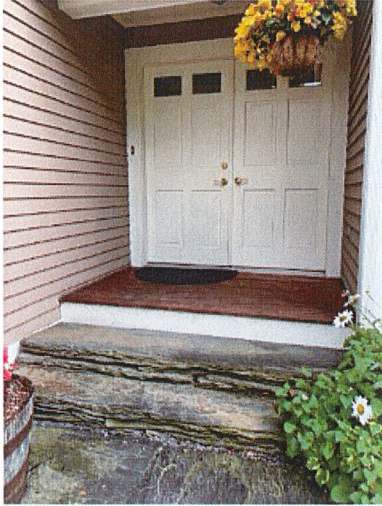
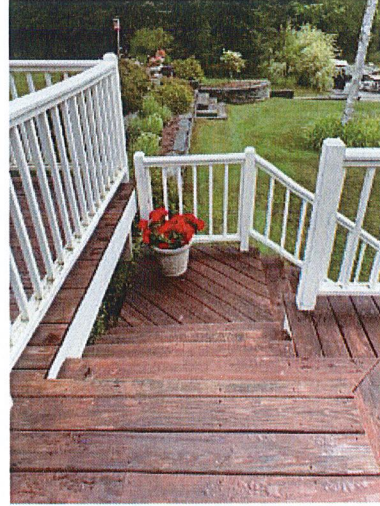
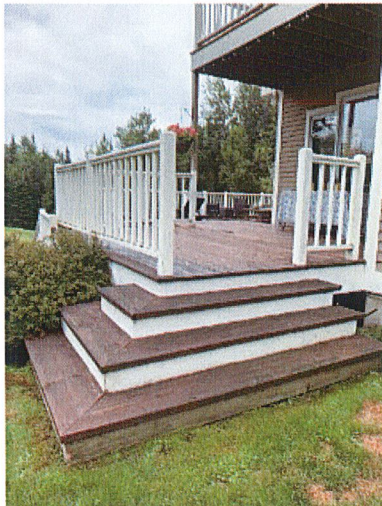
21) One or more flights of stairs with more than two risers have no handrail installed. This is a safety concern. A qualified contractor should install graspable handrails that your hand can completely encircle at stairs where missing per standard building practices. See image:

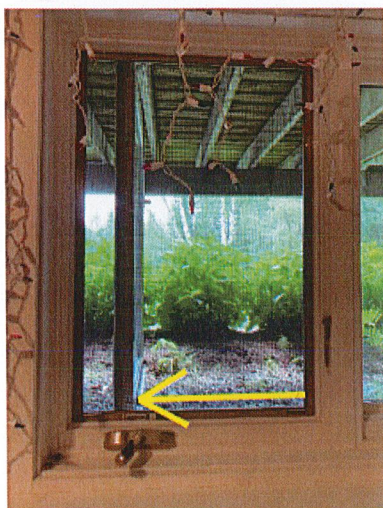
Photo 22-1

22) Basement bedroom windows have inadequate egress in the event of a fire due to the opening size being too small. Raw opening is 20 inches wide, however, when the casement window is fully open, the open air space is reduced to 16 inches. Egress windows should be easy to open, stay open by themselves, and have:

- A minimum width of an opening of 20 inches
- A minimum height of the opening of 24 inches
- A minimum net clear opening of 5.7 square feet (5 square feet for ground floor).

Windows appeared to be adequate to escape from in the event of an emergency, however, recommend having a qualified contractor make modifications as necessary, such as moving or replacing window(s) to comply with these recommendations when replacing windows in the future. For more information, visit:

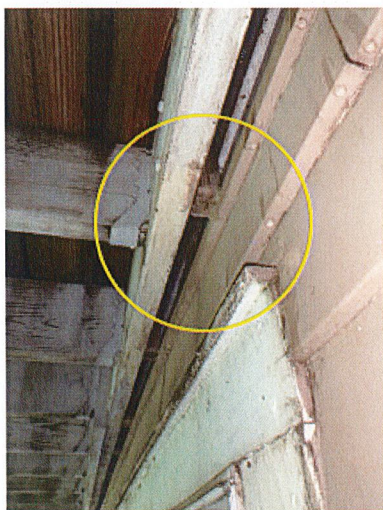
Photo 24-1 Flashing is missing from above one or more deck ledger boards. This can cause moisture to accumulate between the ledger board(s) and the structure. Pass by ledger board blocking has been installed between the deck and the home that will allow water to pass by. Multiple areas of decay were noted below the deck in this area.

A qualified contractor should install flashing above the ledger board(s) where necessary per standard building practices. For more information on installing deck ledger boards visit:

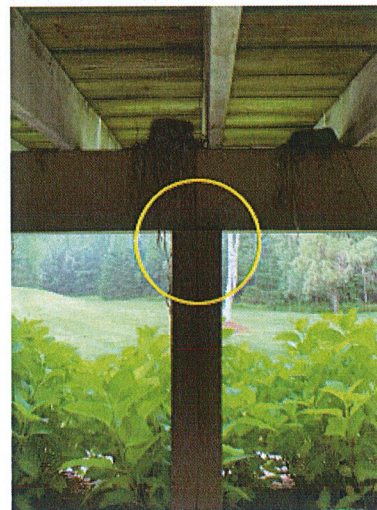
Photo 24-2 Wooden support posts are not securely fastened to beams above. A qualified contractor should evaluate and make repairs as necessary, such as installing metal ties, bracing with lumber, and/or gussets as per standard building practices.

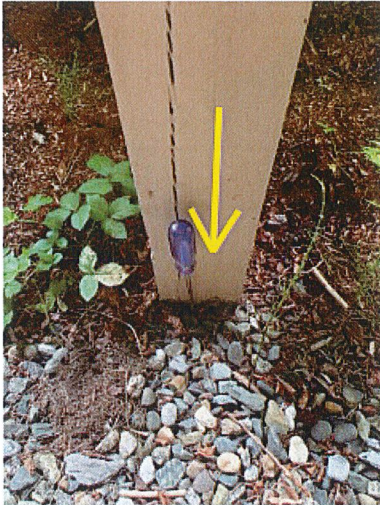
Photo 24-3 Deck support posts are below grade and have wood to earth contact, subject to eventual decay. No visible decay noted the day of inspection. Consider improving by installing proper concrete footings with wooden supports above grade (avoiding earth contact) by a qualified contractor.

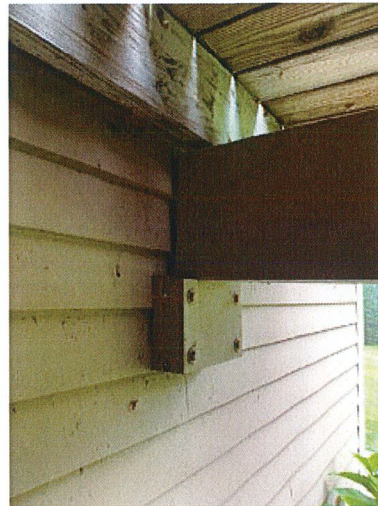
Photo 24-4 Substandard support for the deck beam. Recommend further review and repairs by upgrading support by a qualified contractor. Additional bracing should be considered as well where needed to prevent rolling of the outer deck beam.

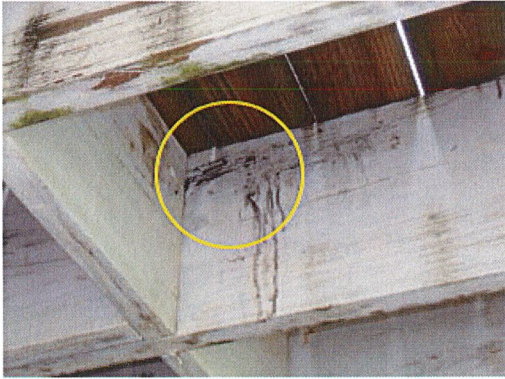
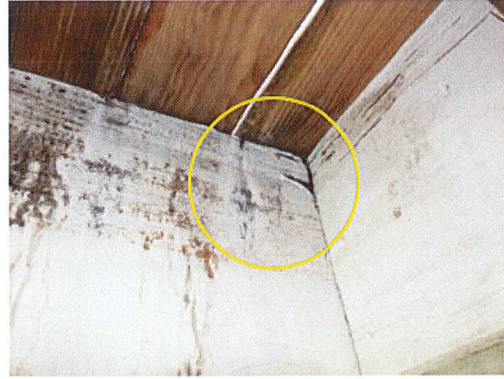
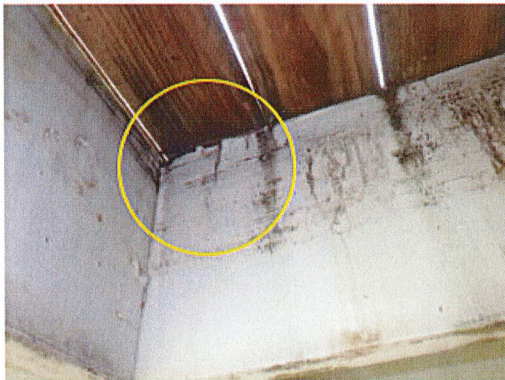
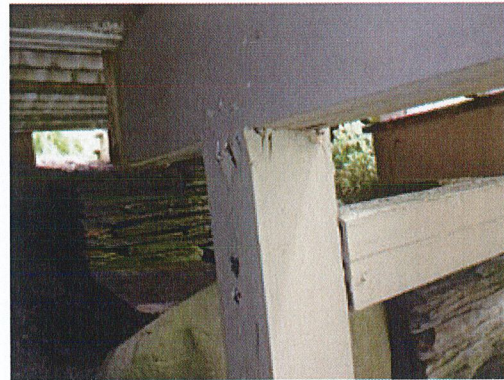
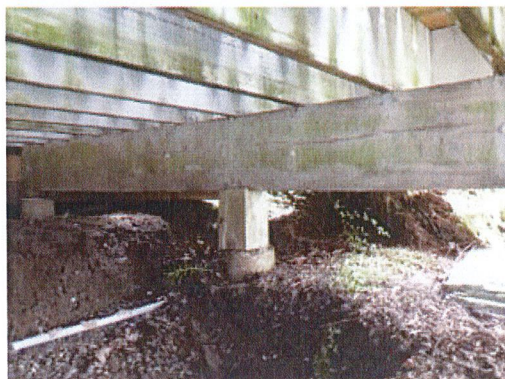
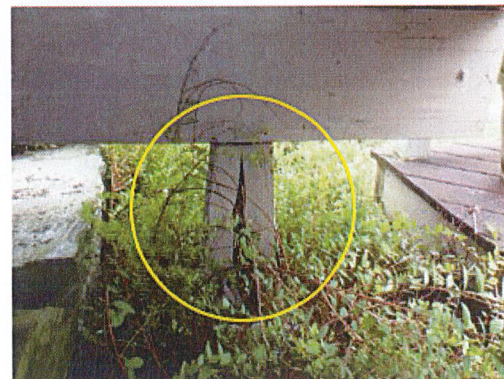
25) Multiple areas of the deck substructure are decayed. Rot was noted at one or more joists, joist block stabilizers, and vertical support posts. Recommend a qualified contractor fully review and repair deck substructure by replacing all rotten wood where needed.

Please have a qualified and licensed contractor conduct repair and wood replacement where needed

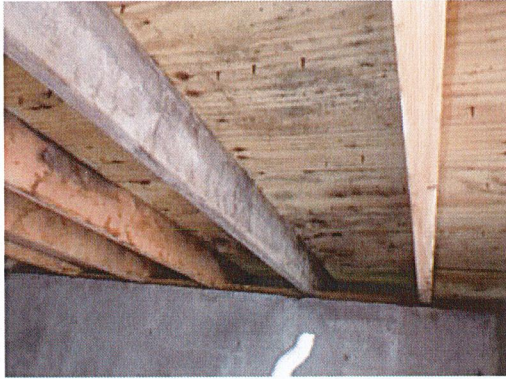
Photo 26-1 Small area of mildew noted to the roof decking in the storage shed. This may not pose a health concern since it is not located in living space, however, recommend proper cleaning of affected area as needed by a qualified contractor.

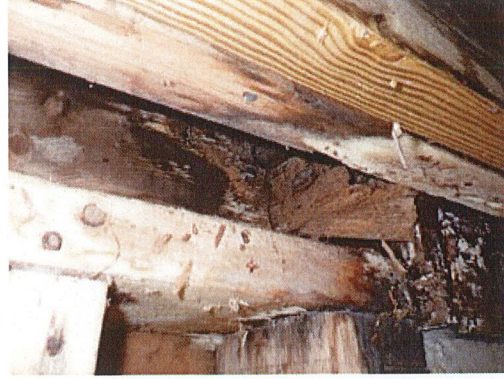
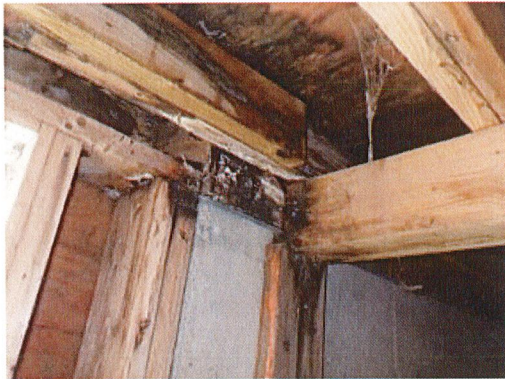
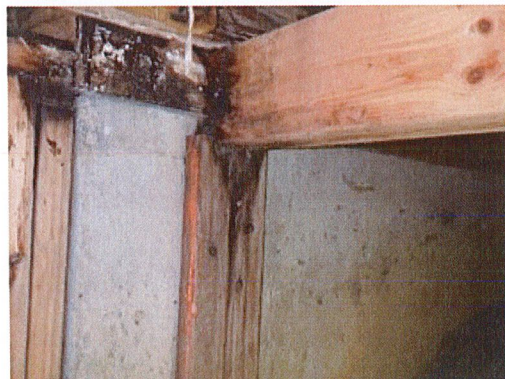
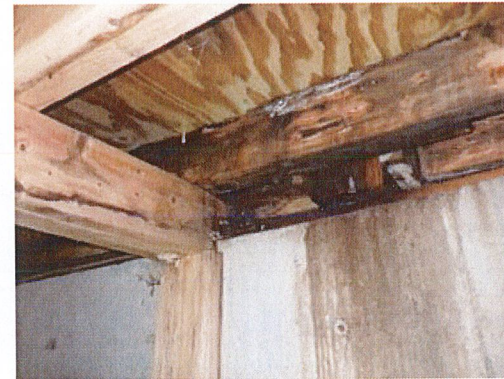
26) Areas of rot were noted to the rim joist, roof decking (plywood), beam, and vertical supports at the storage shed under the deck. Storage shed roof may have an active leak. Recommend a full review and repairs by a qualified contractor replacing any rotten wood.

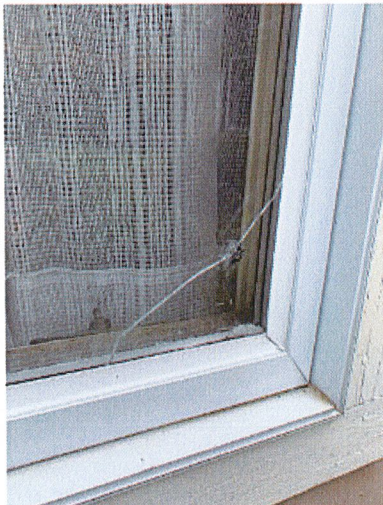
29) Glass in one garage window and basement stairway window is broken or cracked. A qualified contractor should replace glass where necessary.

Photo 29-1 Broken glass in outer pane of garage window.

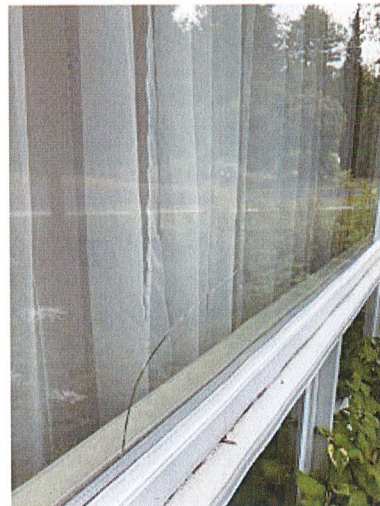
Photo 29-2 Broken glass in inside pane of basement stair way window.

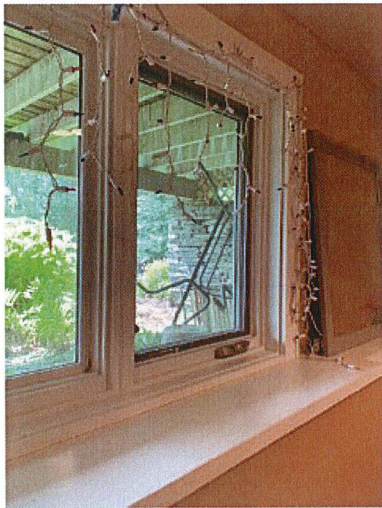
One basement bedroom window that was built to open, will not open. This may be due to humidity and/or little use. Repairs should be made as necessary, and by a qualified contractor if necessary so windows open fully, and open and close easily.

Photo 29-3 The basement bedroom window will not open. It was stuck shut the day of inspection.

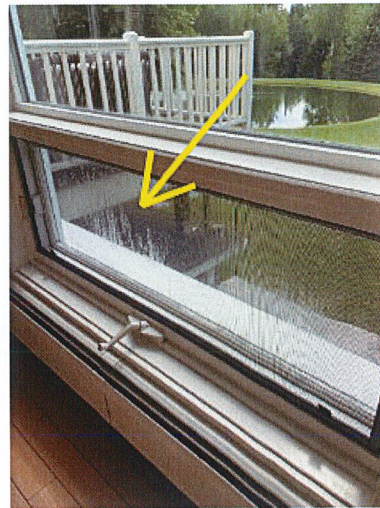
Photo 29-4 Seals between double-pane glass in one or more windows appear to have failed based on condensation or stains between the panes of glass. Recommend review and repairs or replacement as needed by a qualified contractor.

The client(s) should be aware that evidence of broken seals may be more or less visible from one day to the next depending on the temperature, humidity, sunlight, etc. Windows or glass doors other than those that the inspector identified may also have failed seals and need glass replaced too.

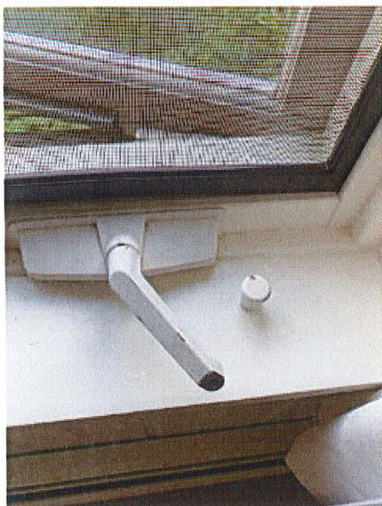
Photo 29-5 The window crank mechanism handle is in need of repair. Recommend repairs as needed by a qualified contractor.

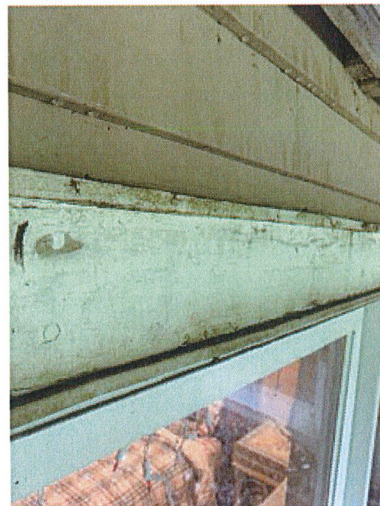
Photo 29-6 Basement bedroom window trim decay under deck.

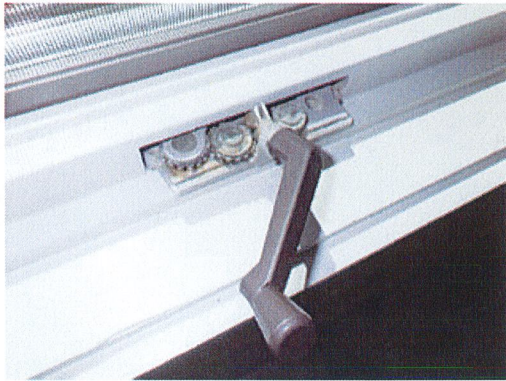
Photo 29-9 Casement window crank is missing its cover and presents a pinch hazard. Recommend installing cover where missing. This is the basement window to the left of the slider.

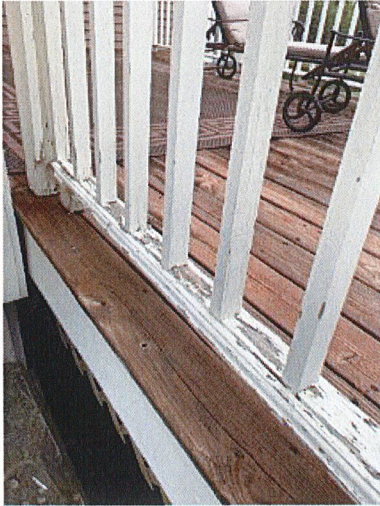
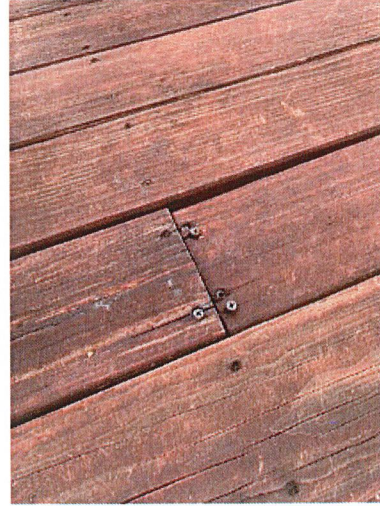
32) The finish on the deck(s) and railing(s) is worn and/or deteriorated. One deck board is loose. Recommend refastening deck boards where needed and cleaning and refinishing as necessary.

please have the deck board fasten by your deck contractor

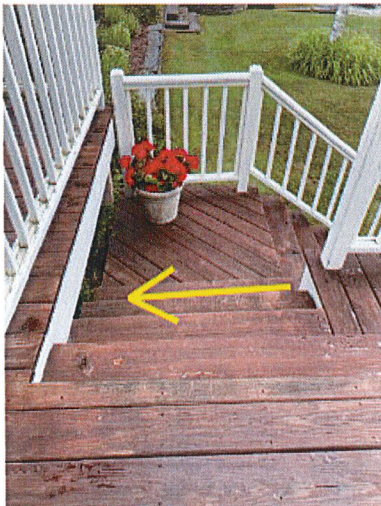
33) Stairs are tipped recommend leveling by a qualified contractor as needed.

Photo 33-1 Tipped stairs may possibly be due to the rotten deck vertical support below.

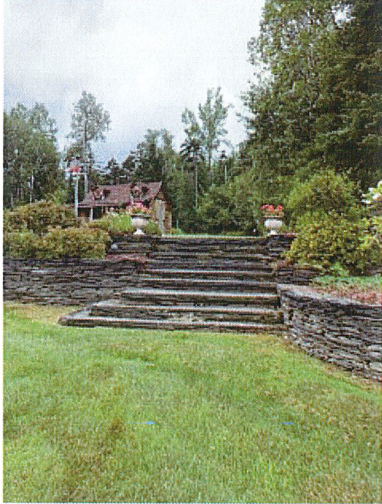
Photo 34-1

34) For additional safety recommend having a qualified contractor install graspable handrails at stone walkways where missing. These are often missing due to aesthetic reasons.

I will have wrought iron handrail installed myself

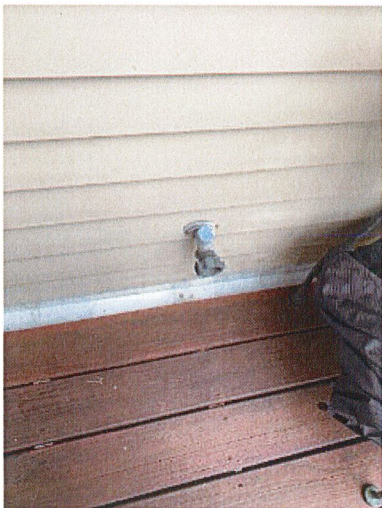
Photo 38-1

38) One or more outside faucets appeared to be inoperable. No water came out of the faucet(s) when turned on. This may be due to a (winterizing) shut-off valve being turned off. As per VT and or NH Standards of Practice, the inspector did not attempt to turn on or off any water supply shut-off valves. Recommend that the client(s) ask the seller about outside faucets with no water, have them turned on prior to the final walk through so the clients can verify operation and/or have a qualified plumber evaluate and repair faucet(s) if necessary.

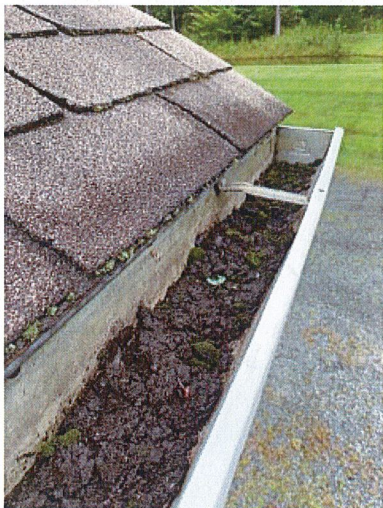
Photo 41-1

Repair 41) Gutters have debris in them. They should be cleaned now and maintained as necessary in the future.

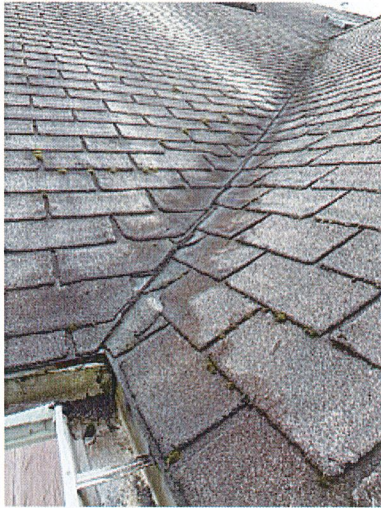
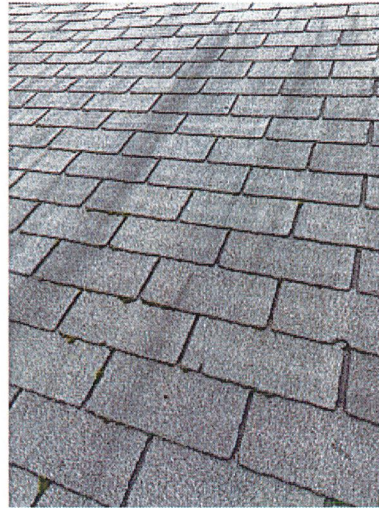
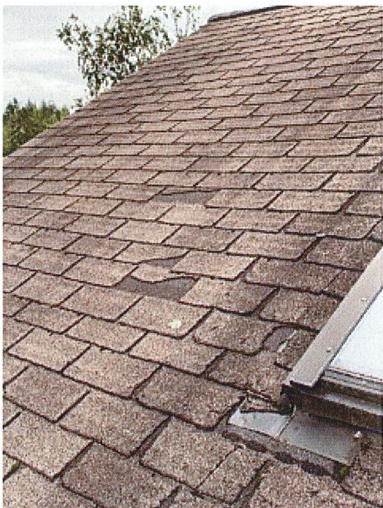
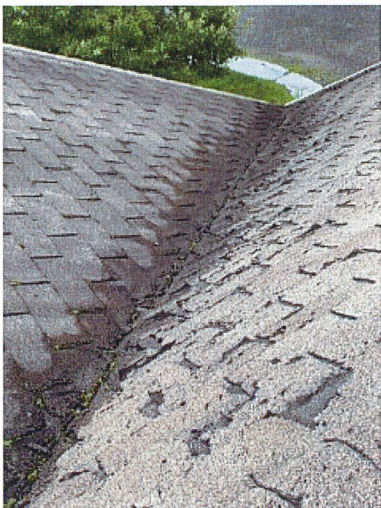
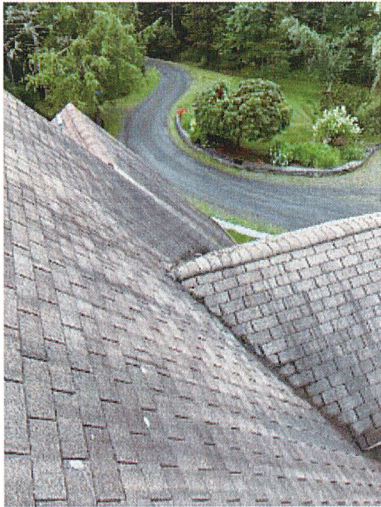
48) The South facing roof surface was recently replaced and appeared in adequate condition. The North facing roof surface material appears to be near the end of its service life and will likely need replacing in the near future, even with repairs. The client(s) should budget for a replacement roof surface, and should have a qualified roofing contractor evaluate and repair to extend the life of the current roof if replacement is not an option now.

Please have a licensed roofing contractor finish the roof repair

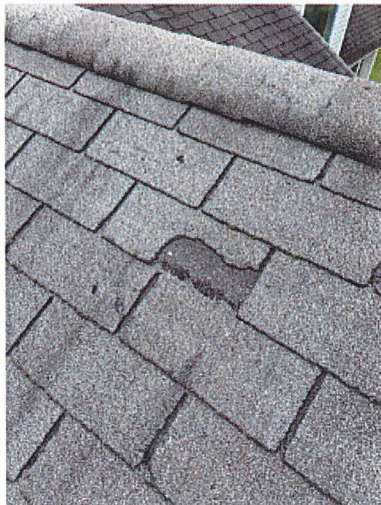
Photo 48-3 Deteriorated shingles with exposed nails. Potential for leaks.

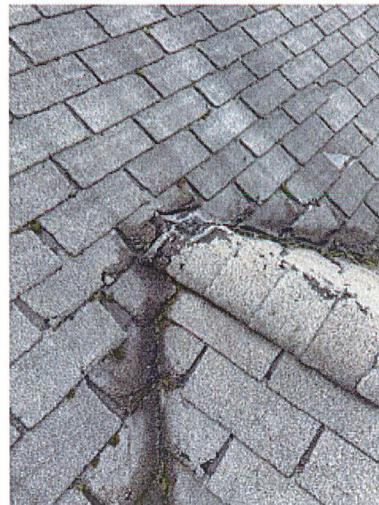
Photo 48-4 Valley wear noted.

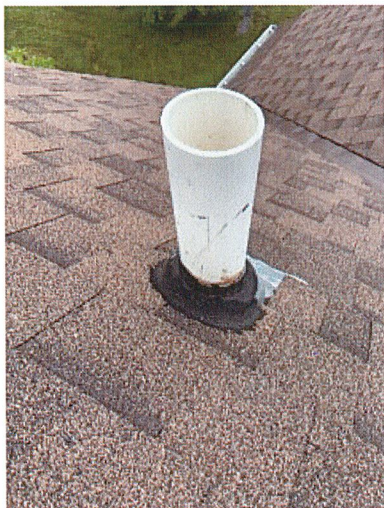
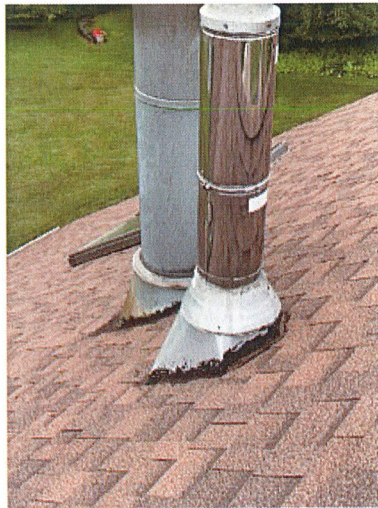
49) Roof / tar patch has been applied in one or more areas of flashing, Recommend review and repairs as needed by a qualified roofer and or mason as needed. Tar / roof patch is considered a temporary repair. Uncertain if the patch is reactive or a preventive measure. At a minimum, conduct continual evaluation of sealant and repair when needed until review/ repair can be done.

Please have a licensed roofing contractor verify this repair

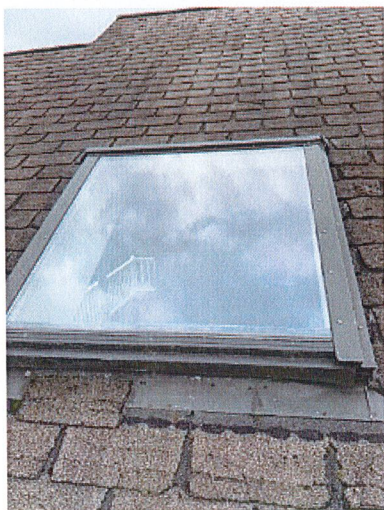
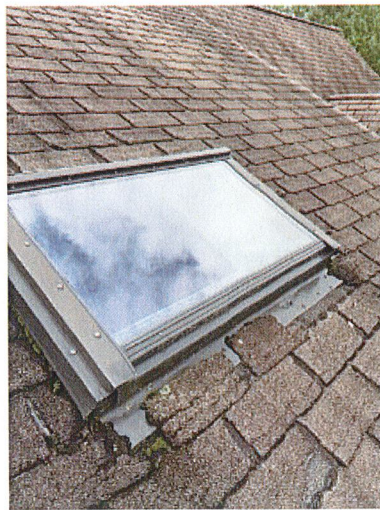
50) Nails are exposed around skylight flashing due to missing shingles. Potential for leaks. A qualified roofing contractor should evaluate and make repairs as necessary.

Please have a licensed roofing contractor finish the roof repair

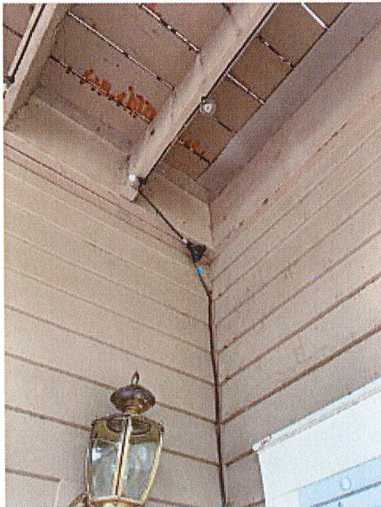
Photo 55-1

55) Extension cords were being used for permanent wiring in one or more areas. They should only be used for portable equipment on a temporary basis. Cords should be removed as necessary if used permanently, and or a qualified electrician should evaluate and make repairs as necessary. For example, installing additional circuits and/or electric receptacles.

Please have a qualify electrician make the repair

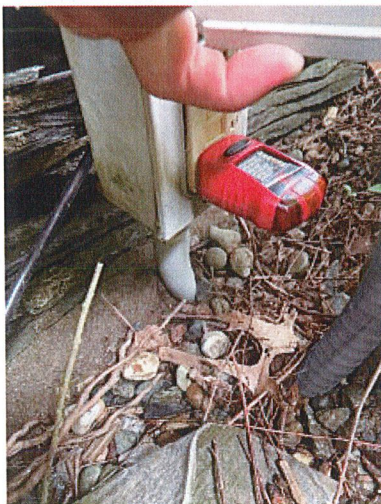
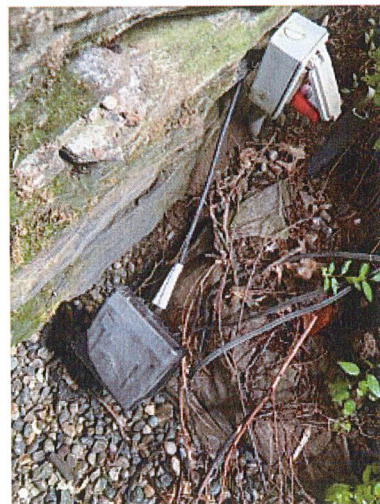
56) One or more electric receptacles appear to have no power. Recommend asking the property owner(s) about this. Switches may need to be operated to make some receptacles energized, or in this case, receptacle may be on a timer. If necessary, a qualified electrician should evaluate and make repairs as necessary.

Please have a qualify electrician make the repair

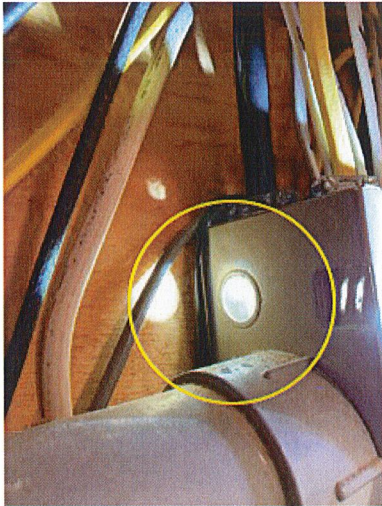
Photo 57-1

57) One or more knockouts have been removed inside the main service panel where no wires and bushings are installed, and no cover(s) have been installed to seal the hole(s). This is a safety concern due to contamination in the panel. A qualified electrician should install knockout covers where missing.

Please have a qualify electrician make the repair

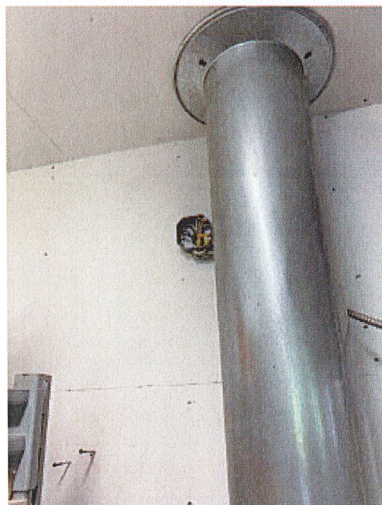
58) Cover plates are missing in one or more areas, recommend covers be installed on all open receptacles and or junction boxes as needed by a qualified electrician.

Photo 58-1 Junction box near chimney in garage.

Please have a qualify electrician make the repair

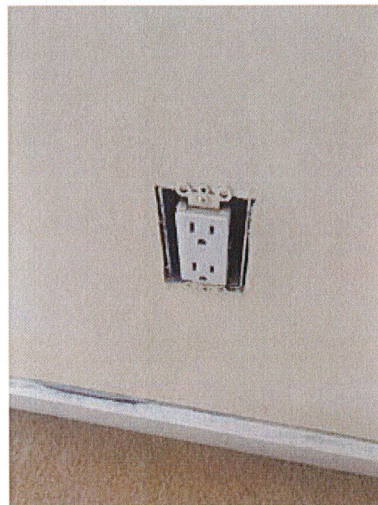
Photo 58-2 Receptacle behind master closet door.

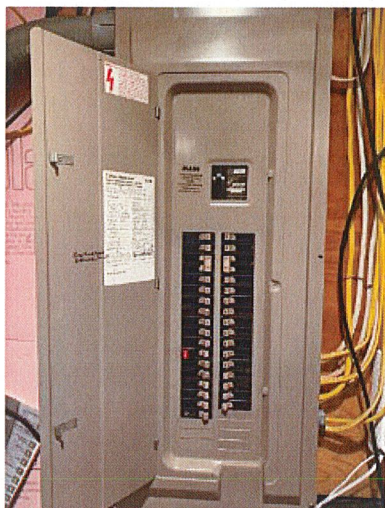
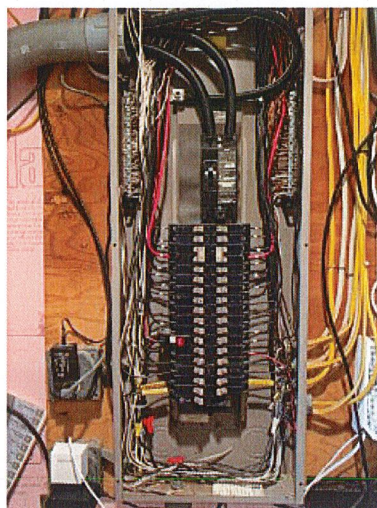
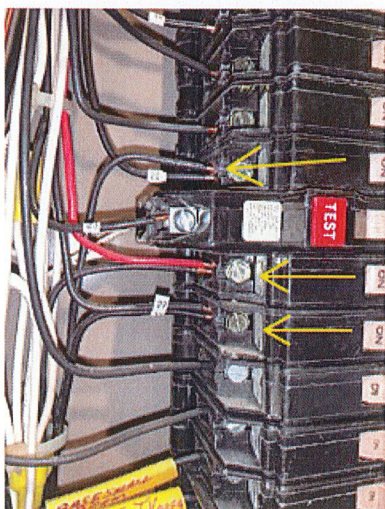
59) Panel(s) appeared in adequate overall condition, however, neutral wires are doubled or bundled together on the neutral bar. This is unsafe due to the need to turn off multiple circuit breakers to work on any of the circuits using these wires. A qualified electrician should evaluate and repair as necessary.

One or more over-current protection devices (circuit breakers) are "double tapped", where 2 or more wires are clamped in a terminal designed for only one wire. This is a safety concern since the bolt or screw may tighten securely against one wire, but leave others loose. A very common item found during home inspections. A qualified electrician should evaluate and repair as necessary.

Please have a qualify electrician make the repair and if ne pessary replace for a bigger electrical panel to accommodate a single wire per breaker and a properly loaded neutral bar.

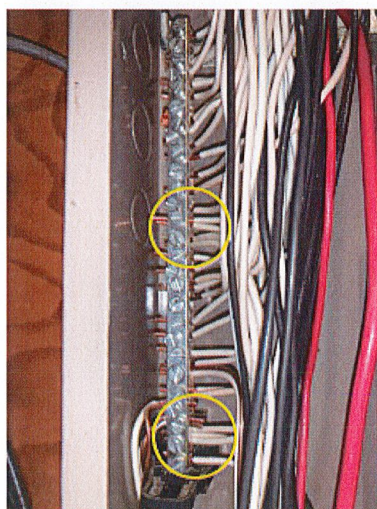
Photo 59-4 Bundled neutrals.

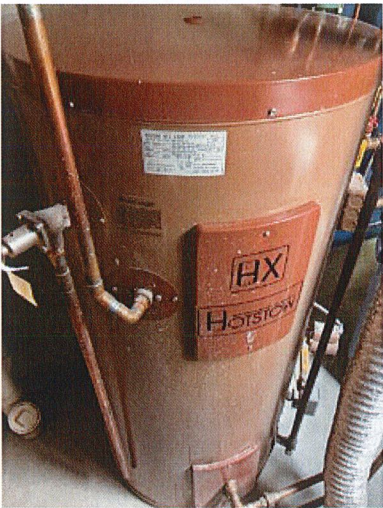
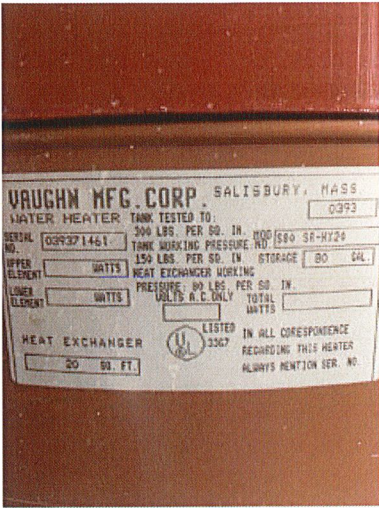
63) The estimated useful life for most water heaters is 8 to 15 years. This water heater appears to be 27 years old and may need replacing at any time. Recommend budgeting for a replacement in the near future.

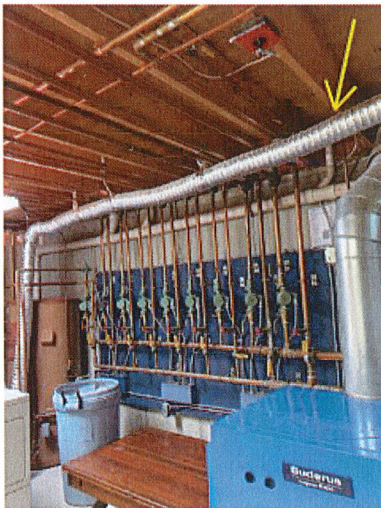
Photo 78-1

78) The clothes dryer is equipped with a PVC, cloth, vinyl, or foil and /or an accordion-type, flexible exhaust duct (something other than metal). Clothes dryer manufacturers and the CPSC specify the use of a UL Listed rigid or corrugated semi-rigid metal duct due to dryer fire containment safety concerns. Some manufactures allow aluminum foil connection from the dryer to the venting system (although, in our opinion not the best choice). Recommend a qualified contractor review manufactures instructions and ductwork repair as/if per standard practices using UL Listed components. For more information on dryer safety issues, see

Dryer ducts should be cleaned annually, or more often if necessary in the future. See link for maintenance: https://www.facebook.com/coveredbridgeinspections/posts/1430958000415662?_xts

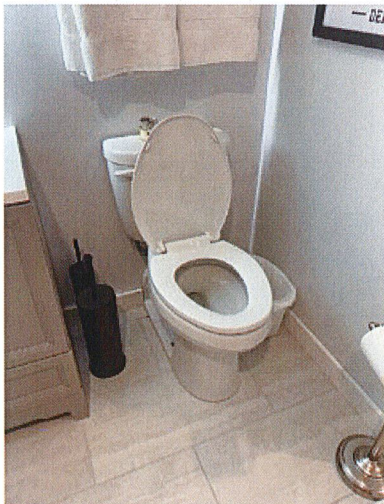
102) One or more toilets are loose, it just may need tightening. Loose toilet / wax rings can cause water damage to the sub floor that is not visible. Recommend a qualified contractor evaluate and repair as needed.

Photo 102-1 Basement bathroom toilet.

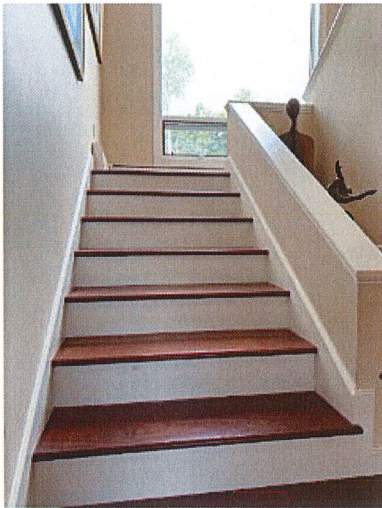
Photo 113-1

113) Handrail(s) at some stairs are ungraspable and are a safety concern. Handrails should be sized and shaped so your hand can encircle them. A qualified contractor should make repairs or modifications as necessary. For example, replacing existing handrails or installing additional handrails. See image: <https://coveredbridgeprofessionalhomeinspections.com/blog/wp-content/uploads/2020/04/S095-Deck-Stair-Handrail-Grip-Size-640x480.jpg>

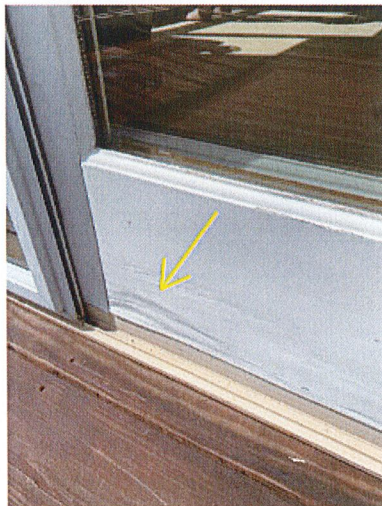
Photo 114-1

114) Master bedroom exterior sliding door is damaged and/or deteriorated and should be repaired or replaced by a qualified contractor.

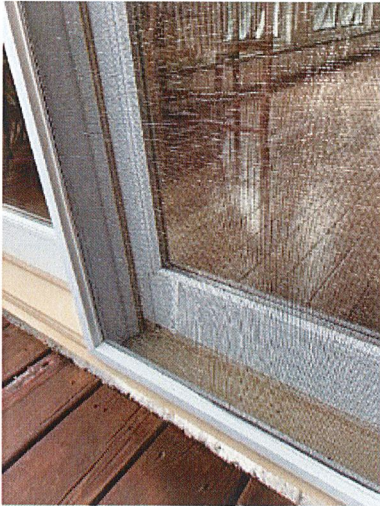
Photo 115-1

Repair **115)** Screens in one or more sliding doors are torn or have holes in them. Screens should be replaced where necessary.

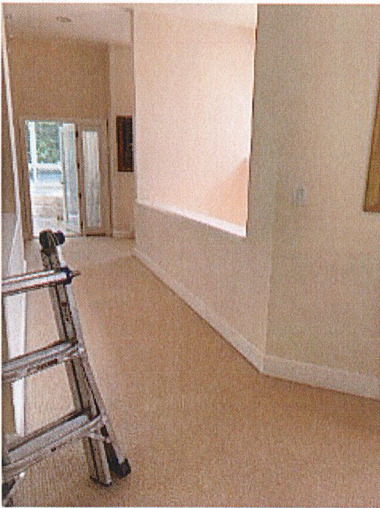
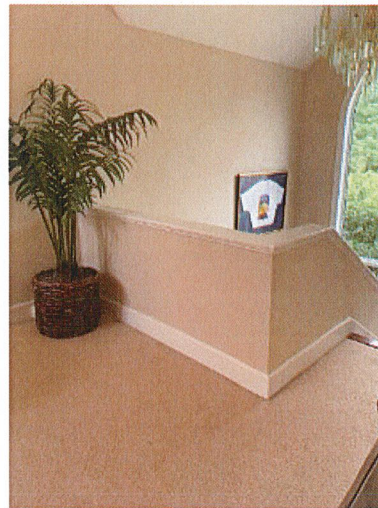
Credit closing costs **119)** One or more guardrails are too low. This is a safety concern due to the risk of falling. Standard building practices require that guardrails above drop-offs be 36 inches high. A qualified contractor should evaluate and modify or replace guardrails where necessary, and especially above drop-offs higher than 30 inches. See image for more information;

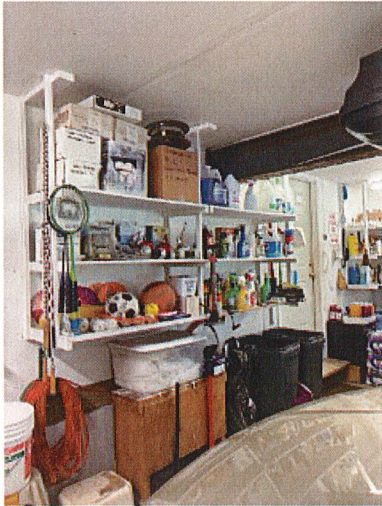
127) Recommended upgrade for added safety,
One or more wall and/or ceiling surfaces between the attached garage and interior living spaces have inadequate surface materials, recommend fire wall protection. These surfaces are intended to prevent vehicle fumes from entering living spaces, and to slow the spread of fire from the garage to living spaces. A qualified contractor should evaluate and make repairs as necessary so the attached garage wall and ceiling surfaces that adjoin living spaces are tightly sealed and fire rated as per standard building practices. Typically these surfaces have a one-hour fire rating.

Photo 127-1 Plywood is present on the wall surface between the garage and living space.
