**Joel Pinsky**  
**189 Foster Farm Road, Stowe, Vermont**

Inspection date  
**September 21, 2020**

Reason for inspection  
**Transfer of property**

Prepared by  
**Mike Remington - CSIA #9922**  
**Brickliners Corp**

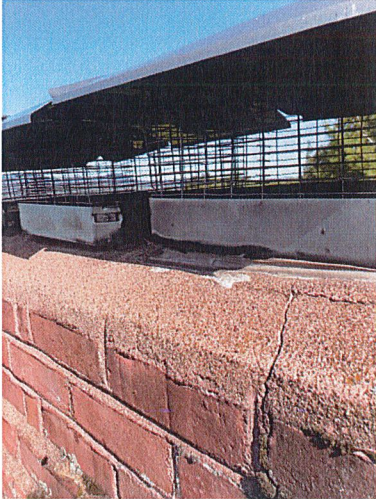
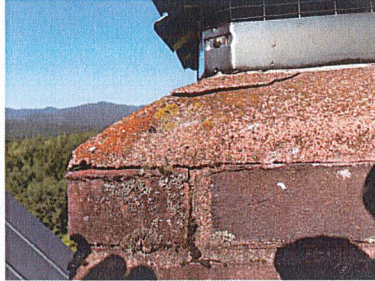
- **Crown / Wash cap: Deteriorated**

The masonry work that protects the top of the chimney structure is deteriorated and no longer protects the chimney structure from water intrusion that will allow damage to the chimney structure and possibly the home

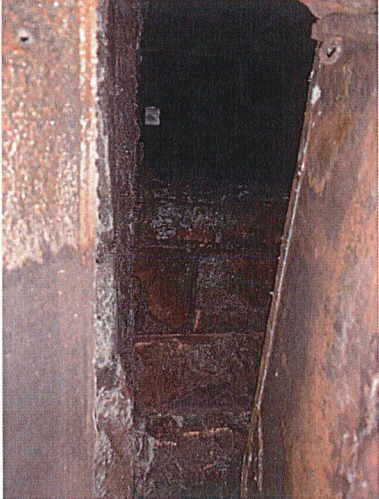
- **Smoke chamber general accessibility, construction, parging and condition:** Does not meet industry standards

The smoke chamber is a crucial part of the fireplace system and is often the most poorly constructed area of the structure. Most structural fires associated with fireplaces originate in this area. It is imperative that this area be completely sealed and parged smooth. 2016 NFPA 211 11.2.1.13 IRC 2006 2111.5

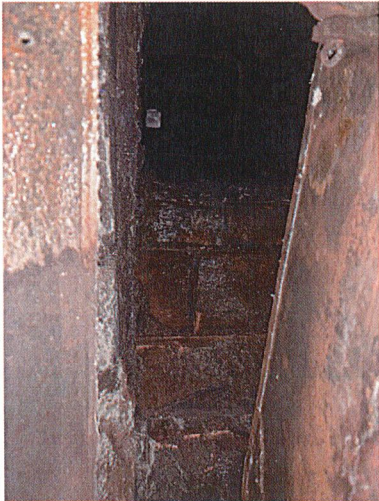
• **Smoke chamber general accessibility, construction, parging and condition:** Does not meet industry standards

The smoke chamber is a crucial part of the fireplace system and is often the most poorly constructed area of the structure. Most structural fires associated with fireplaces originate in this area. It is imperative that this area be completely sealed and parged smooth. 2016 NFPA 211 11.2.1.13 IRC 2006 2111.5

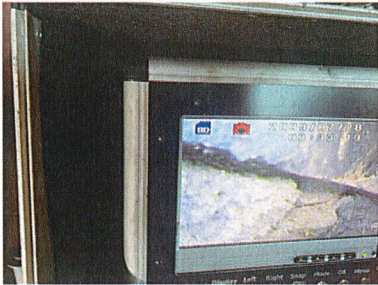
- **Flue tile sealed at smoke chamber: Does not meet industry standards**

The flue tile is not sealed at the top of the smoke chamber. This can allow the byproducts of combustion to go behind the flue tiles and may migrate to areas of the chimney and home not meant to contain them. The potential hazard exists that combustible residue could build up where it cannot be maintained and allow the possibility of a structure fire. This defect could also allow carbon monoxide to enter the home. 2016 NFPA 211 11.2.1.13
