## Part A. # 1

**Part A. # 2****Electric Service**

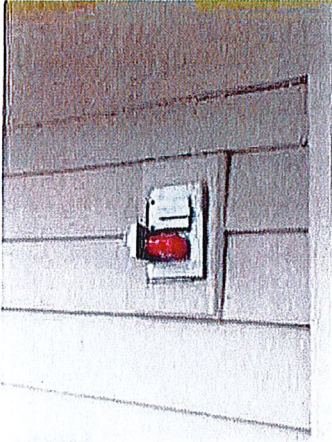
Photo 26-1

Recommended upgrade. Recommend all exterior receptacles be GFCI (Ground Fault Circuit Interrupter) protected, installation by a qualified electrician per standard building practices. They may not have been recommended at the time this home was built, however, it is a recommendation of the Inspector for added safety.

Observation: This is a common inspectional issue and requires the plugs be replaced with GFCI plugs. Occasionally, if there is more than one plug on the same circuit, a GFCI breaker can replace the current breaker in the panel.

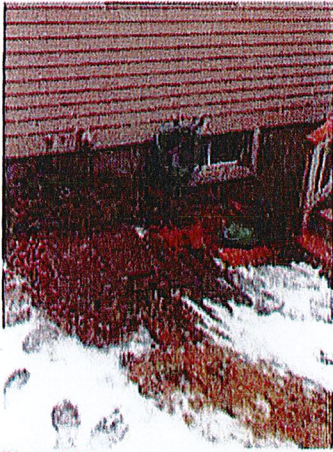
Photo 27-1

One or more flights of stairs with more than two risers have no handrail installed. This is a safety concern. A qualified contractor should install graspable handrails that your hand can completely encircle at stairs where missing per standard building practices.

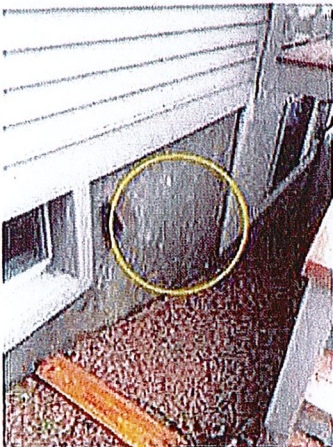
The foundation was covered by insulation and/or plywood materials. A full evaluation from the exterior was not possible due to this material. One or more areas of the parge coat covering the insulation should be repaired by a qualified contractor to prevent damage to insulation.

Photo 28-1  
South side of home. Recommend repairs to parge coat covering the insulation.

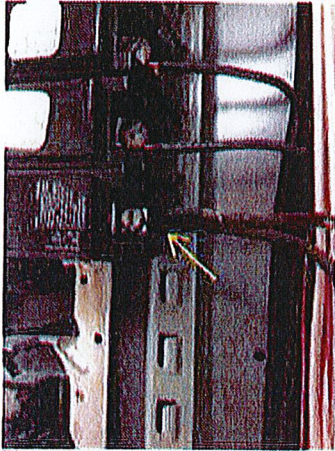
Photo 47-1

47) One or more over-current protection devices (circuit breakers) are "double tapped", where 2 or more wires are clamped in a terminal designed for only one wire. This is a safety concern since the bolt or screw may tighten securely against one wire, but leave others loose. A very common items found during home inspections. A qualified electrician should evaluate and repair as necessary.

It appears that in 47-1 the double tapped breaker actually has a space for another breaker right below it, which is how it will be corrected. 47-2 may be in the panel pictured on the right in 47-3. That panel looks completely filled.

I'm certain this can be fix with one breaker that allows for each wire to be inserted separately.

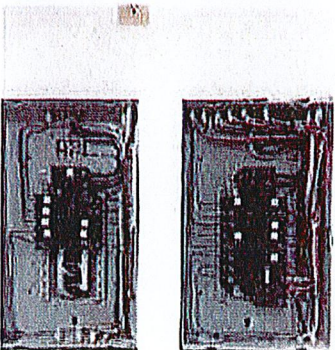
Photo 47-3

Panel on right is for top two floors of house. Panel on left is for basement. Two 100 amp services.

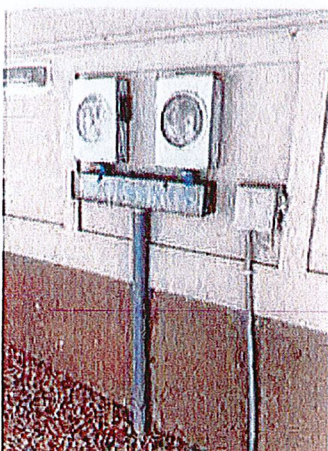
Photo 47-4

Meter is located off-site, the power line in the woods on the east side of the home.

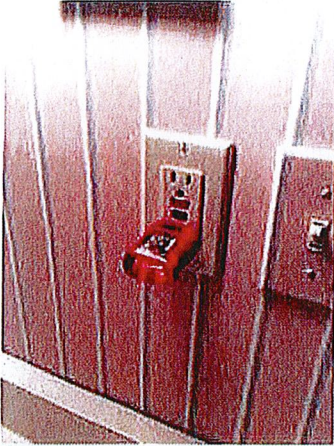
Photo 89-1

GFCI(s) were present and functioning in one or more bathrooms. Reverse polarity in South bathroom was noted in the Electrical section of this report. It should be repaired and upgraded to have GFCI protection.

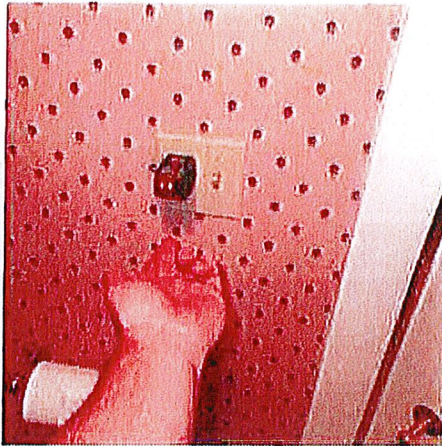
Photo 89-2  
Reverse-polarity.

Same light switch as on previous page.

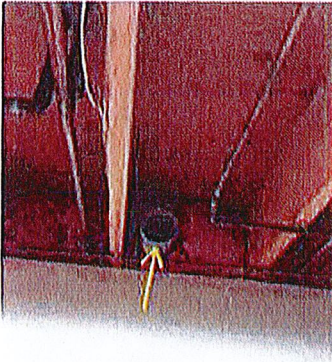
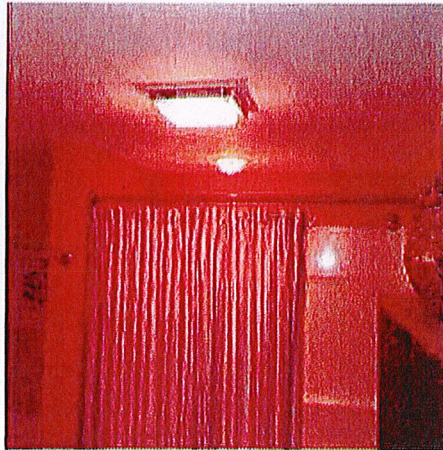
90-1 & 2

Bathroom(s) have exhaust fans installed, however, the basement bathroom fan terminates inside the basement. While no ill effects were noted as a result, moisture accumulation can occur. **Recommend** a qualified contractor install ductwork that terminates outside per standard building practices.

Photo 90-1  
Basement bathroom fan termination.

Let me note this is a recommendation. My observation - with this bathroom on an outside wall, the fan vent should have been to the outside.

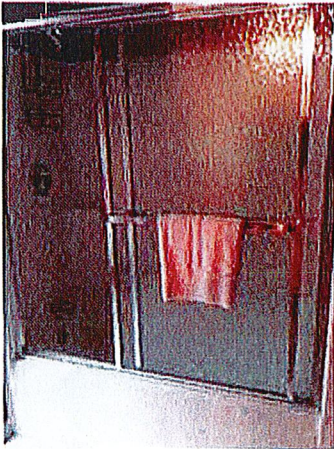
Photo 91-1

Maintain shower door seal as needed to prevent water spilling onto the floor surface.

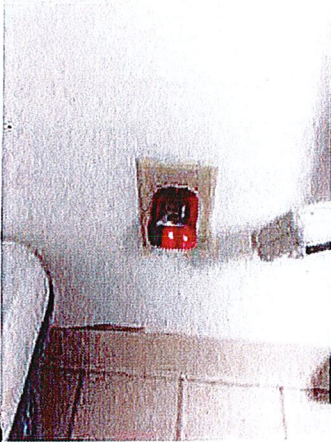
Photo 48-1  
Proper grounding and polarity.

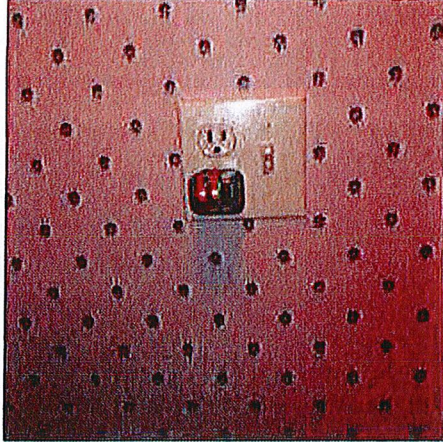
Grounding and polarity were good throughout the home in three pronged receptacles that were tested, however, one receptacle in the second floor south bathroom has reversed-polarity wiring, where the hot and neutral wires are reversed. Potential for shock is present. A qualified electrician should evaluate and make repairs upgrading it to GFCI where necessary per standard building practices.

Photo 48-2  
Second floor south bathroom has reversed-polarity wiring. It should be repaired and upgraded to have GFCI protection.

Quite certain an easy fix. A matter of reversing the wiring.

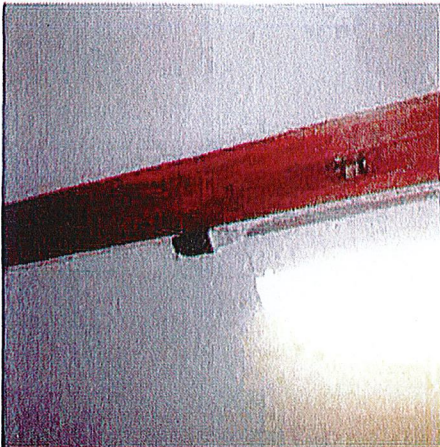
Extension cords are being used as permanent wiring in one or more areas. They should only be used for portable equipment on a temporary basis. Extension cords should be removed as necessary if used permanently, and or a qualified electrician should evaluate and make repairs as necessary. For example, install additional circuits and/or electric receptacles.

Photo 49-1  
Closet area.

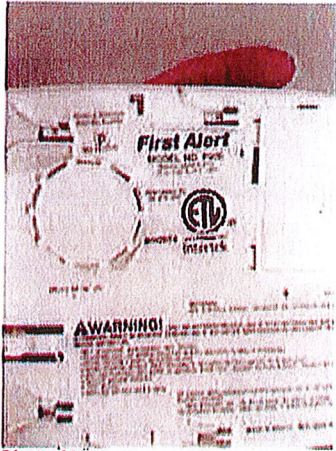
**Photo 93-1**  
Battery operated photoelectric smoke detector located in the basement. It is not a 10-year lithium battery. Replace battery annually.

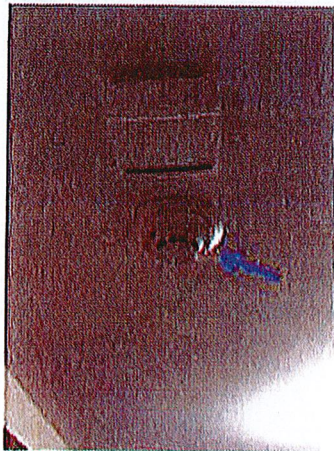
Current smoke detectors appeared to photoelectric type sensors in the basement. We could not visually ID what type of smoke detectors were present on the first and second floors. They are tied into the security system, we do not sound them or remove them due to possible false alarming the security system. These units are tied into the security system and typically are photoelectric type. Recommend confirming with owners and or security company to ensure photoelectric type sensors are present. They should also be replaced after 10 years.

**Photo 93-2**  
We could not visually ID what type of smoke detector.

When an electrician is at the house, you could him check the photoelectric sensors. Home Security should be called to verify the ones connected to the alarm system are working. I will send you a copy of the document Faith will have to sign at the closing assuring that all of them work.

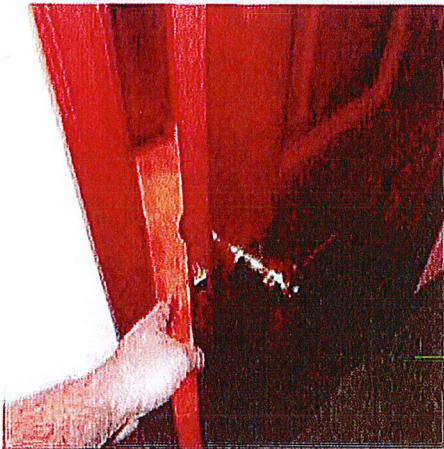
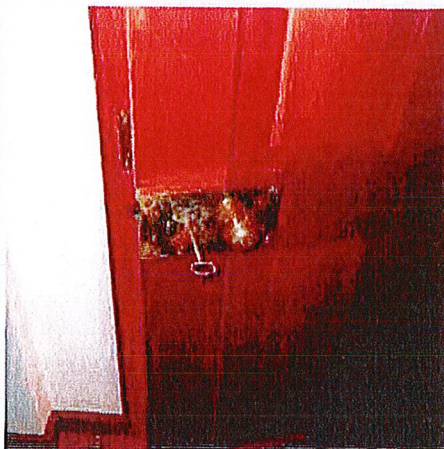
One or more doors will not latch when closed. Repairs should be made as necessary, and by a qualified contractor if necessary. For example, aligning strike plates with latch bolts.

Noted per listing agent the key should be left in the front door entrance, owner had to call a locksmith for repair in the past. Recommend consulting with the owners about this and repairs or replacing the lock as if needed by a qualified contractor.

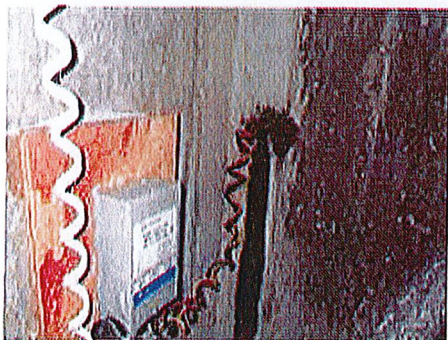
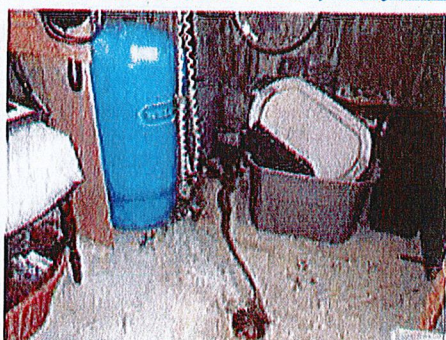
Basement appeared dry the day of inspection. The only visible signs of water was an active leak at the conduit for the well pump. Recommend digging down outside when ground thaws to seal from outside and seal from inside as well. Recommend review and repairs as needed by a qualified contractor.

70-1 & 2. Probably a contractor (cement?) or even Manosh could advise you on the fix for this issue. I'm sorry I did not recommend that you have a contractor address and fix this leak when it first occurred. If a contractor could recommend it can be fixed from inside, great.

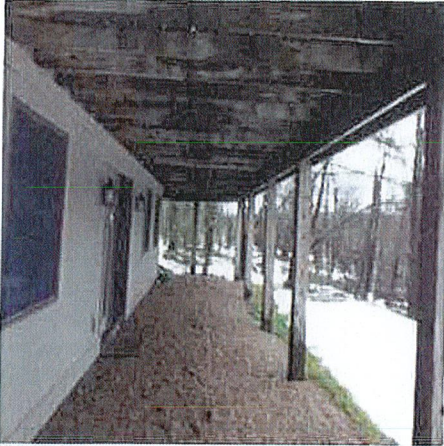
**Photo 21-7**

Posts are spaced 10' + here.

21-7 & 8 A deck contractor should be consulted and a quote gotten.

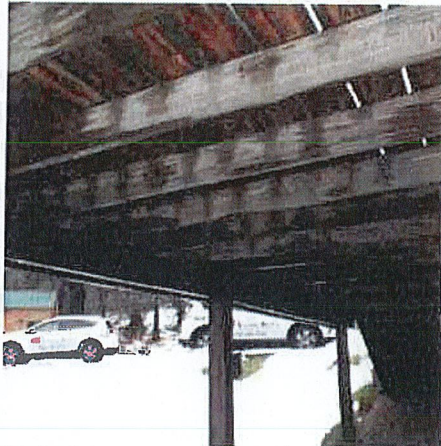
**Photo 21-8**

Longer than 10' span on the south side, some deflection noted in the beam support.

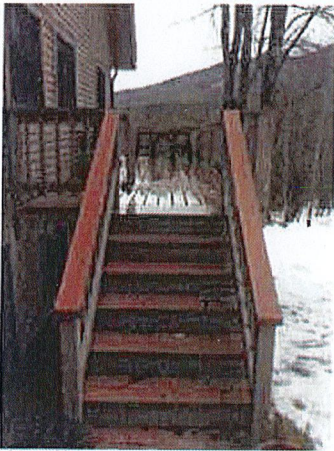
**Photo 21-9**

Handrail(s) at some stairs are ungraspable and are a safety concern. Handrails should be sized and shaped so your hand can encircle them. A qualified contractor should make repairs or modifications as necessary. For example, replacing existing handrails or installing additional handrails.

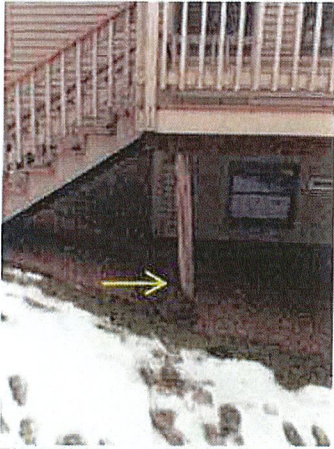
**Photo 21-1**  
This vertical support is out of plumb and has been shimmed at its base. Recommend repairs as needed.

21-1 May need to be addressed further.

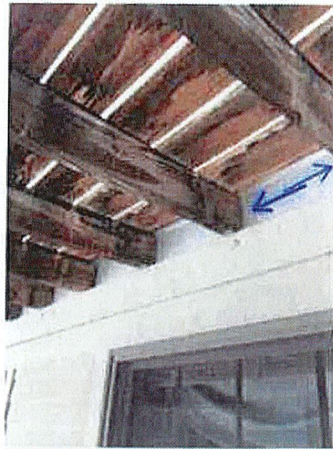
**Photo 21-2**  
Recommend installing blocking between joists to prevent twisting. Ledger board has been bolted, flashing detail was noted. Only 2x6" joists used.

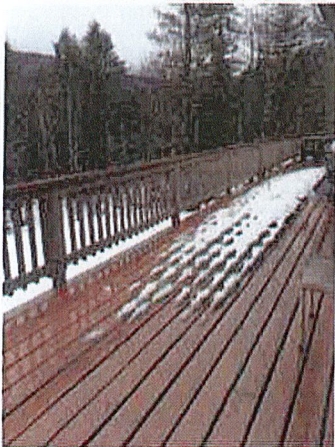
**Photo 21-3**  
Railing was a little wobbly in some areas.

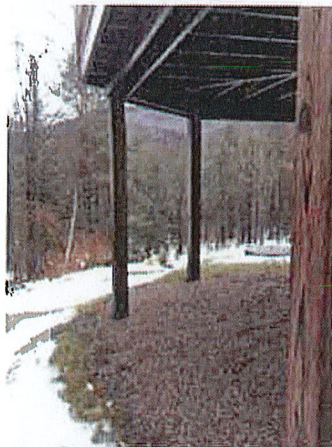
**Photo 21-4**  
Concrete piers were noted at the base of all vertical supports. Monitor annually for movement.

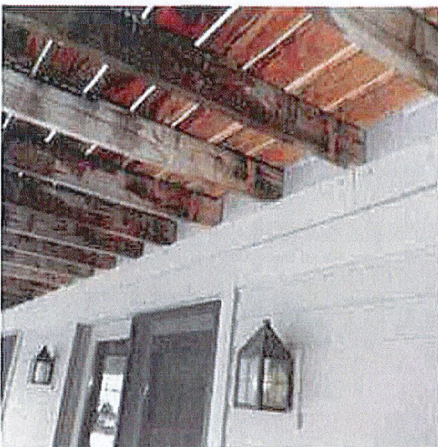
joists. Consider blocking be installed between joists. Recommend further review and repair by a qualified contractor to prevent twisting or rolling of 2x6" joists.

**Photo 21-5**  
Deck joists are sitting on top of the ledger board with no bracing / joist hangers to prevent rotation of the

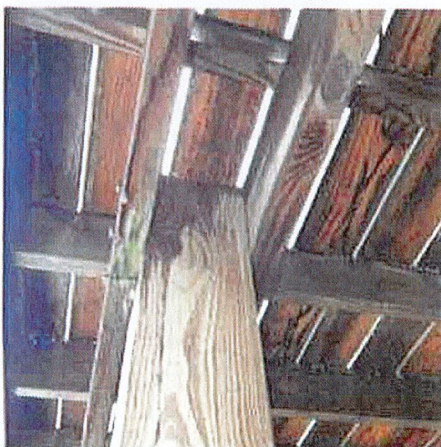
weight is held by these lag bolts. Upgrade as needed.

**Photo 21-6**  
Connection is by lag bolts, not through bolting, monitor bolt at a minimum consider through bolting, deck

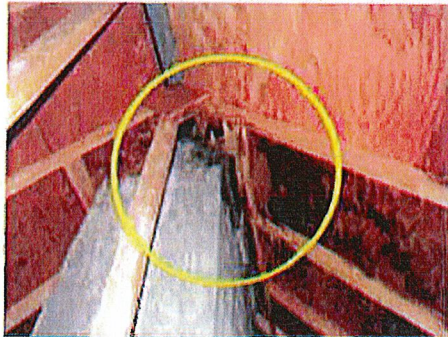
Photo 43-1

Water stains on one area of the roof structure near the chimney and an active leak were noted around chimney or other roof penetrations in the attic. These areas were wet at the time of the inspection. Recommend qualified roofing contractor evaluate and repair as *if* needed.

Active leak was dripping the day of inspection. Possible flashing and or masonry absorbing water. Review repair as needed.

43-1 Caulking or re-flashing, but rebuild?

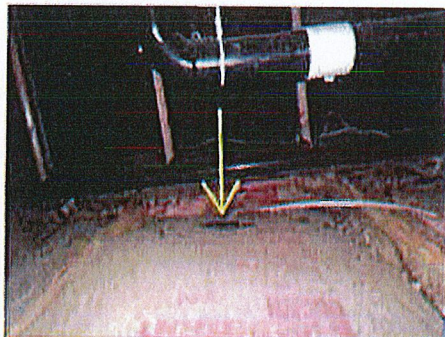
Photo 43-2

Heavy rains were noted the day of inspection. Water was found dripping from the plumbing vent stack in the attic. Possible rain water getting by the vent stack boot and/or condensation. Recommend review / repairs by a qualified contractor as needed.

43-2 A contractor apply sealant to vent stack?

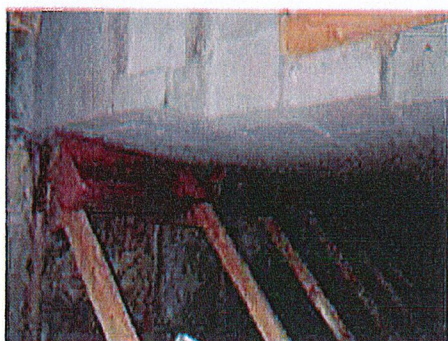
Photo 43-3

Trays below the wet area of the chimney to catch water.

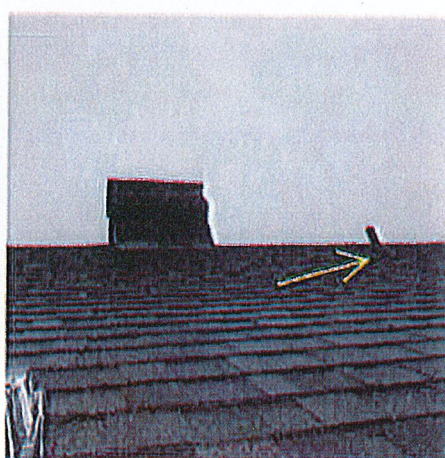
Photo 43-4

Vent boot flashing.

43-4 Caulk or replace the boot.

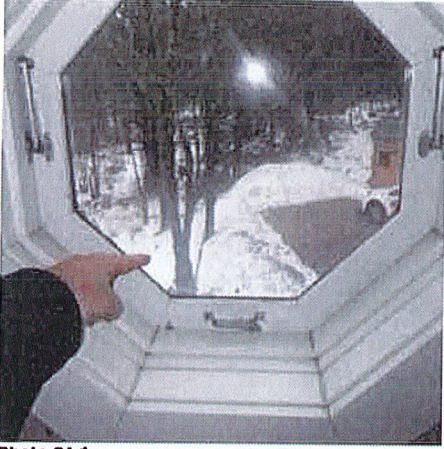
**Photo 24-1**

One window in the second floor bathroom on the south side of home appears to have a failed gas seal. Recommend review and repairs or replacement as needed by a qualified contractor.

Line across the window is a scratch from the tree that fell against the siding on the south side.

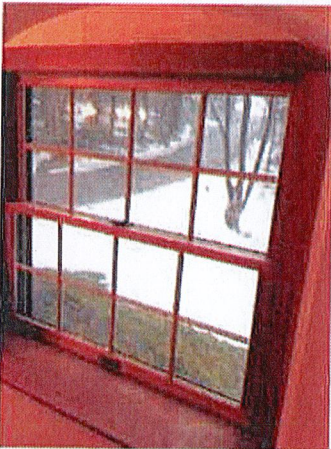
**Photo 24-3**

Overall adequate condition, some windows appeared newer than others. Anderson windows noted.

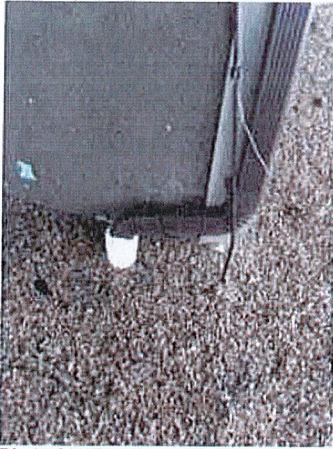
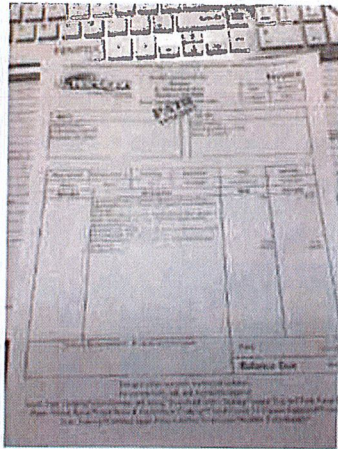
Hartigan waste water service left an invoice stating that subsurface, day-lighted perimeter and or gutter drain pipes were scoped and roots were found in one line and another line was found to be crushed. Replacement of subsurface drainage lines has been recommended by Hartigan's.

Clean out (snake out or Roto Router) as / If needed in the future as preventive maintenance.

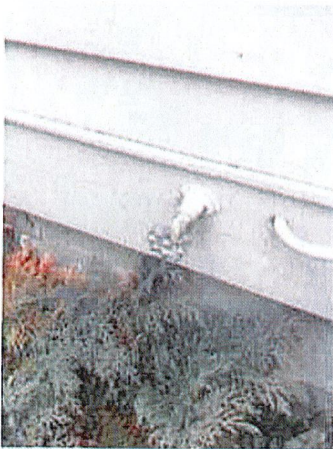
Photo 23-1

Not a material defect but the inspector's recommendation.

Consider upgrading to frost free / anti - siphoning type outside faucets where needed. Please see here for more information: [http://www.ehow.com/about\\_4743025\\_frostfree-outside-faucets.html](http://www.ehow.com/about_4743025_frostfree-outside-faucets.html)
