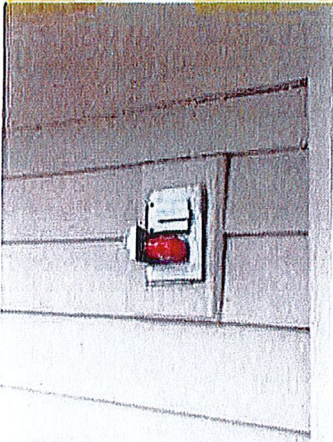
Photo 26-1

Recommended upgrade, Recommend all exterior receptacles be GFCI (Ground Fault Circuit Interrupter) protected, Installation by a qualified electrician per standard building practices. They may not have been recommended at the time this home was built, however, it is a recommendation of the Inspector for added safety.

Observation: This is a common inspectional issue and requires the plugs be replaced with GFCI plugs. Occasionally, if there is more than one plug on the same circuit, a GFCI breaker can replace the current breaker in the panel.

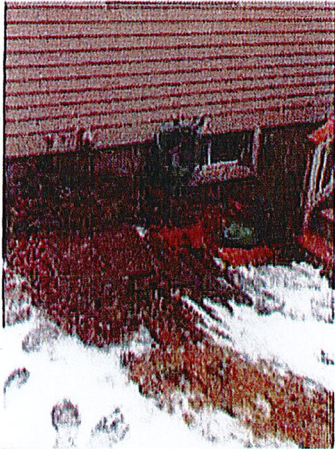
Photo 27-1

One or more flights of stairs with more than two risers have no handrail installed. This is a safety concern. A qualified contractor should install graspable handrails that your hand can completely encircle at stairs where missing per standard building practices.

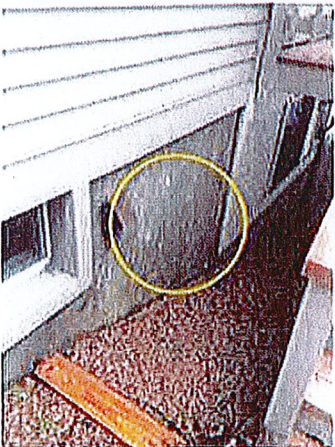
The foundation was covered by insulation and or plywood materials. A full evaluation from the exterior was not possible due to this material. One or more areas of the parge coat covering the insulation should be repaired by a qualified contractor to prevent damage to insulation.

Photo 28-1
South side of home. Recommend repairs to parge coat covering the insulation.

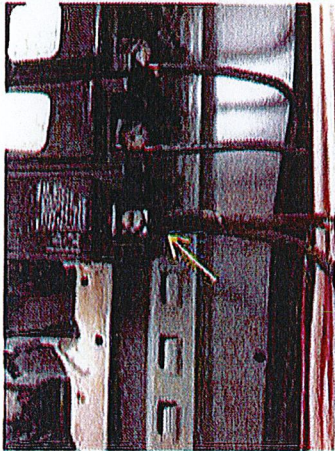
Photo 47-1

47) One or more over-current protection devices (circuit breakers) are "double tapped", where 2 or more wires are clamped in a terminal designed for only one wire. This is a safety concern since the bolt or screw may tighten securely against one wire, but leave others loose. A very common items found during home inspections. A qualified electrician should evaluate and repair as necessary.

As noted in yellow, this is not uncommon in inspections. Can't explain why. I think it is done when there is no more space in the panel. It appears that in 47-1 the double tapped breaker actually has a space for another breaker right below it, which is how it will be corrected. 47-2 may be in the panel pictured on the right in 47-3. That panel looks completely filled. I'm certain this can be fix with one breaker that allows for each wire to be inserted separately.

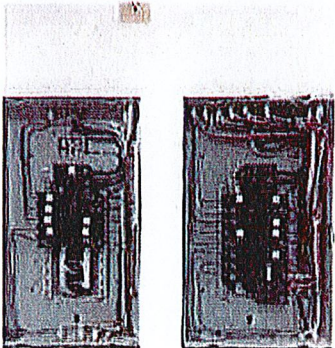
Photo 47-3
Panel on right is for top two floors of house. Panel on left is for basement. Two 100 amp services.

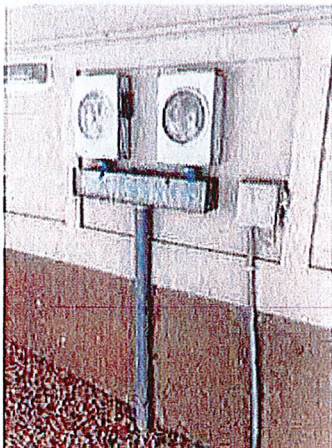
Photo 47-4
Meter is located off-site, the power line in the woods on the east side of the home.

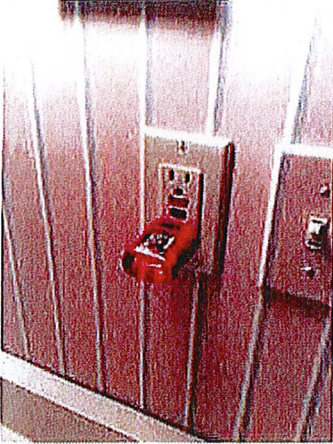
Photo 89-1

GFCI(s) were present and functioning in one or more bathrooms. Reverse polarity in South bathroom was noted in the Electrical section of this report. It should be repaired and upgraded to have GFCI protection.

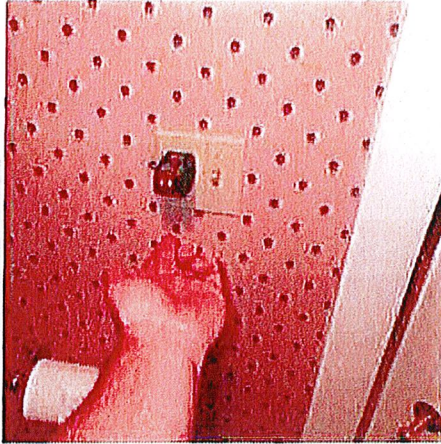
Photo 89-2
Reverse-polarity.

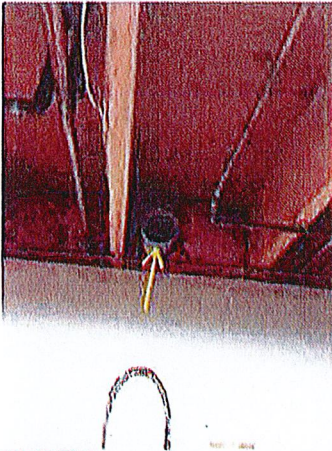
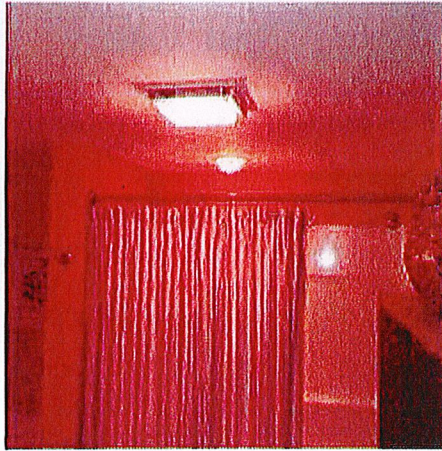
90-1 & 2

Bathroom(s) have exhaust fans installed, however, the basement bathroom fan terminates inside the basement. While no ill effects were noted as a result, moisture accumulation can occur. **Recommend** a qualified contractor install ductwork that terminates outside per standard building practices.

Photo 90-1
Basement bathroom fan termination.

Let me note this is a recommendation. My observation - with this bathroom on an outside wall, the fan vent should have been to the outside.

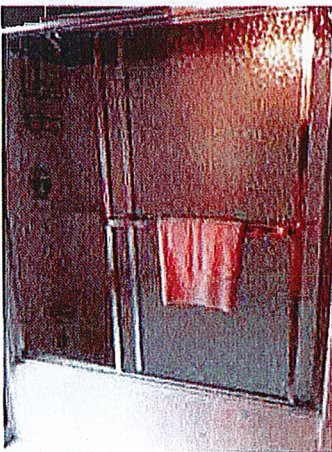
Photo 91-1

Maintain shower door seal as needed to prevent water spilling onto the floor surface.

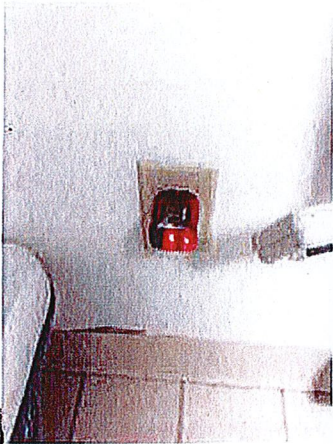
Photo 48-1
Proper grounding and polarity.

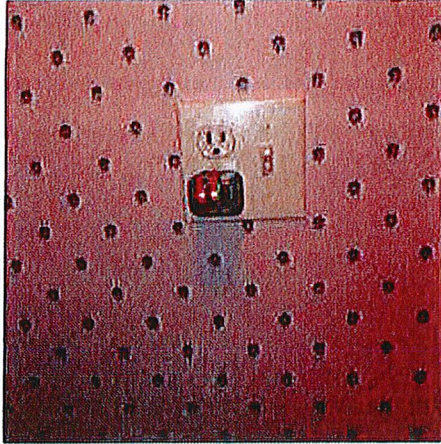
Grounding and polarity were good throughout the home in three pronged receptacles that were tested, however, one receptacle in the second floor south bathroom has reversed-polarity wiring, where the hot and neutral wires are reversed. Potential for shock is present. A qualified electrician should evaluate and make repairs upgrading it to GFCI where necessary per standard building practices.

Photo 48-2
Second floor south bathroom has reversed-polarity wiring. It should be repaired and upgraded to have GFCI protection.

Quite certain an easy fix. A matter of reversing the wiring.

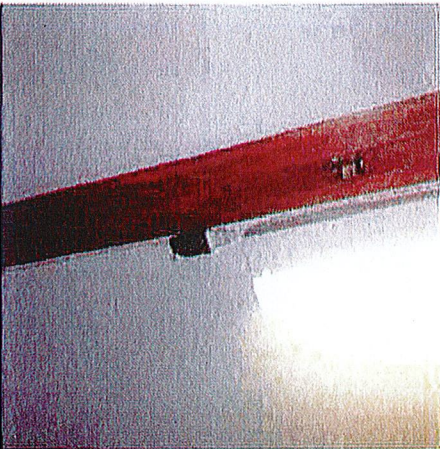
Extension cords are being used as permanent wiring in one or more areas. They should only be used for portable equipment on a temporary basis. Extension cords should be removed as necessary if used permanently, and or a qualified electrician should evaluate and make repairs as necessary. For example, install additional circuits and/or electric receptacles.

Photo 49-1
Closet area.

This too appears in many reports.

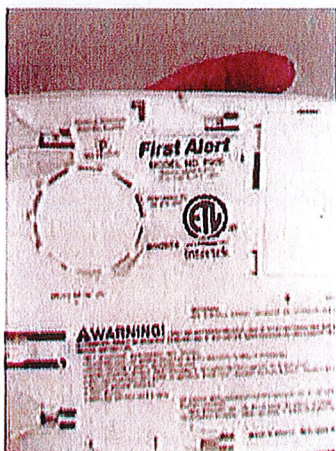
Current smoke detectors appeared to photoelectric type sensors in the basement. We could not visually ID what type of smoke detectors were present on the first and second floors. They are tied into the security system, we do not sound them or remove them due to possible false alarming the security system. These units are tied into the security system and typically are photoelectric type. Recommend confirming with owners and or security company to ensure photoelectric type sensors are present. They should also be replaced after 10 years.

Photo 93-1
Battery operated photoelectric smoke detector located in the basement. It is not a 10-year lithium battery. Replace battery annually.

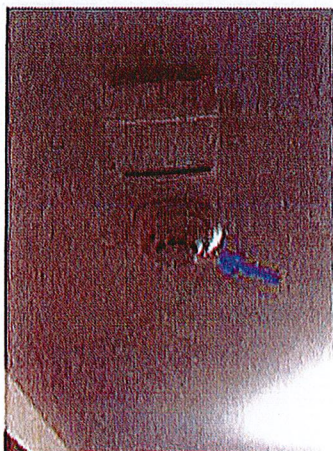
Photo 93-2
We could not visually ID what type of smoke detector.

When an electrician is at the house, you could him check the photoelectric sensors. Home Security should be called to verify the ones connected to the alarm system are working. I will send you a copy of the document Faith will have to sign at the closing assuring that all of them work.

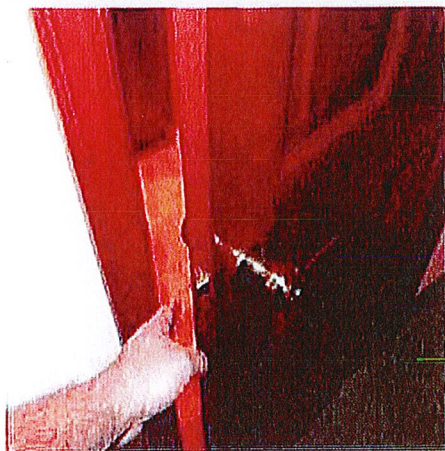
Photo 94-1

One or more doors will not latch when closed. Repairs should be made as necessary, and by a qualified contractor if necessary. For example, aligning strike plates with latch bolts.

Noted per listing agent the key should be left in the front door entrance, owner had to call a locksmith for repair in the past. Recommend consulting with the owners about this and repairs or replacing the lock as if needed by a qualified contractor.
