ITEMS TO FIX AT 50 CHENEY LANE

Vermont Home Inspection Services

Customer
Christy Patt

Address
50 Cheney Ln
Morristown VT 05661

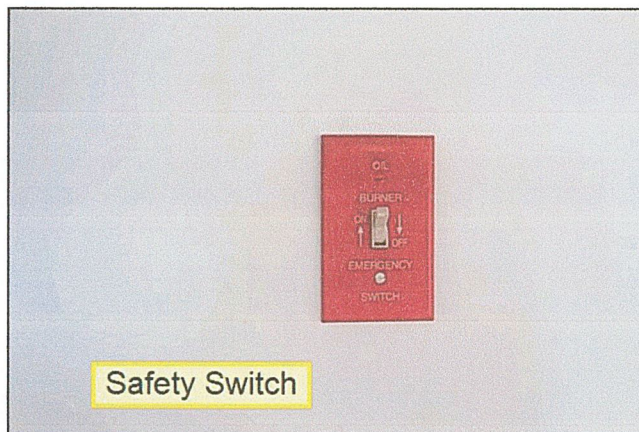
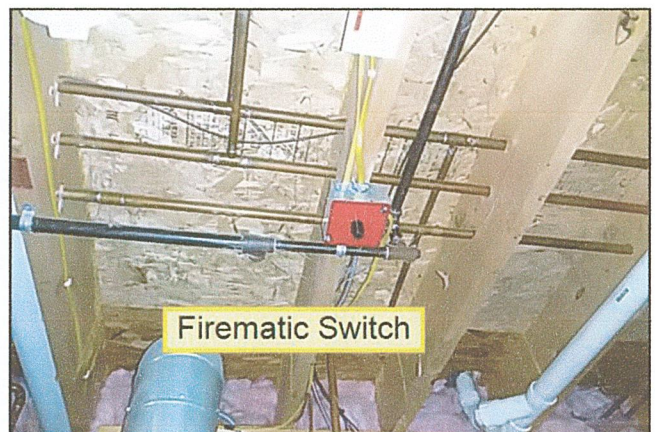
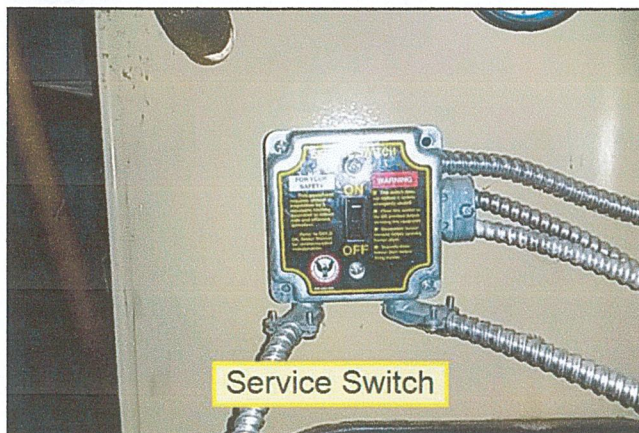
A Firematic thermally-fused switch is located above the heating appliance. In the event of a fire, this switch is designed to stop the flow of electricity to the heating appliance. This is provided for your information.

A service man's switch is present at the side of the heating unit. This is provided for your information .

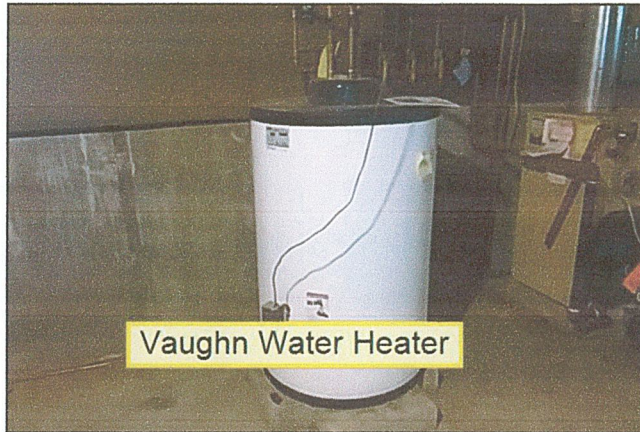
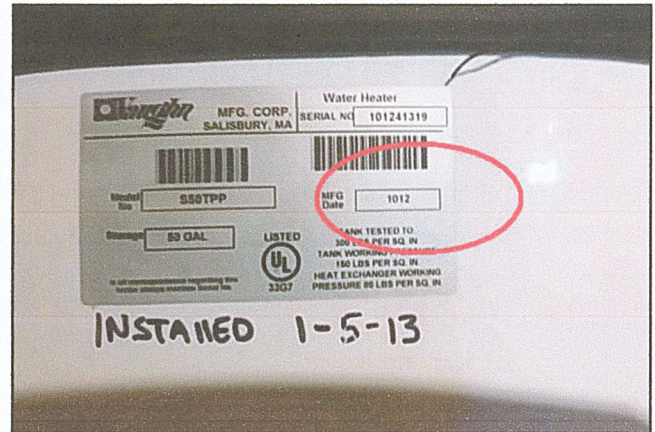
(1) The home is supplied with a Vaughn hot water heater. This unit was manufactured in October 2012, and was operational on the day of the inspection. This is provided for your information.

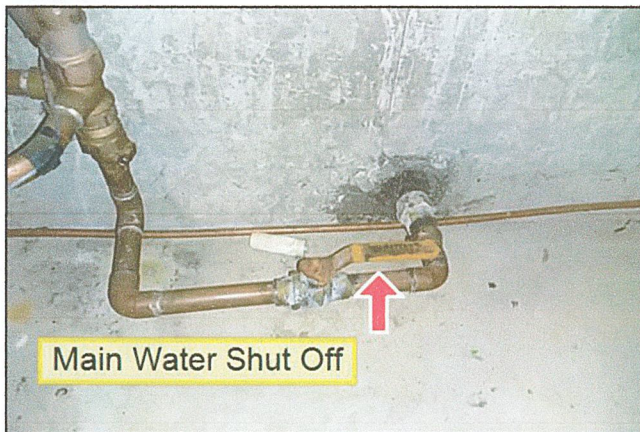
6.3 Main Water Shut-off Device (Describe location)

In Need of Repair

(1) The main water shut off is located at the water meter in the basement. This is provided for your information.

REPAIR CORRODED MAIN WATER SHUT OFF.

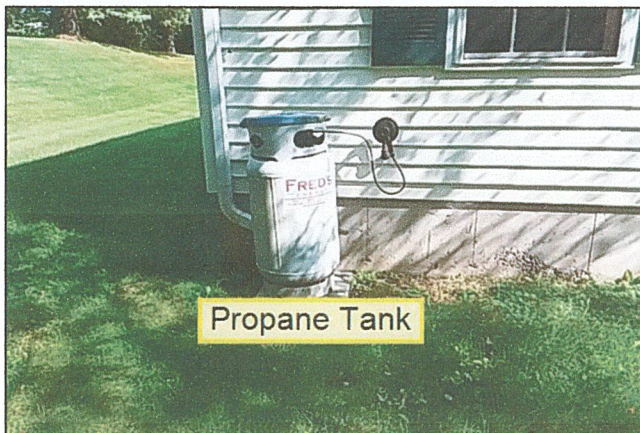
6.4 Fuel Storage and Distribution Systems (Interior fuel storage, piping, venting, supports, leaks)

(1) Propane tank(s) are present at the exterior of the home. This is provided for your information.

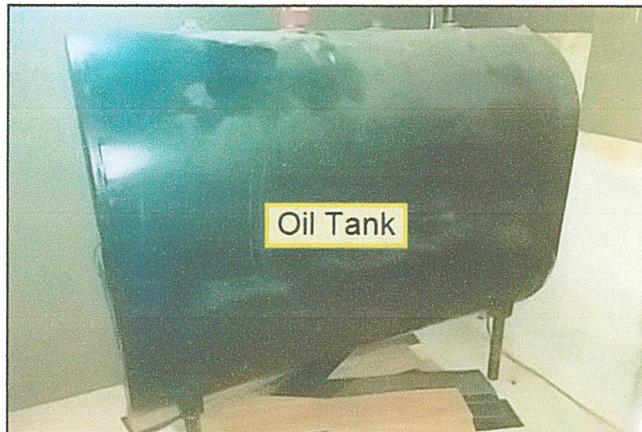
The exterior of the oil tank was inspected for leaks and rust. Oil tanks rust from the inside and the outside. The only way to know the thickness of the tank is for a heating contractor to measure the thickness of the tank with an ultrasonic device. I recommend this inspection be performed by a qualified heating professional.

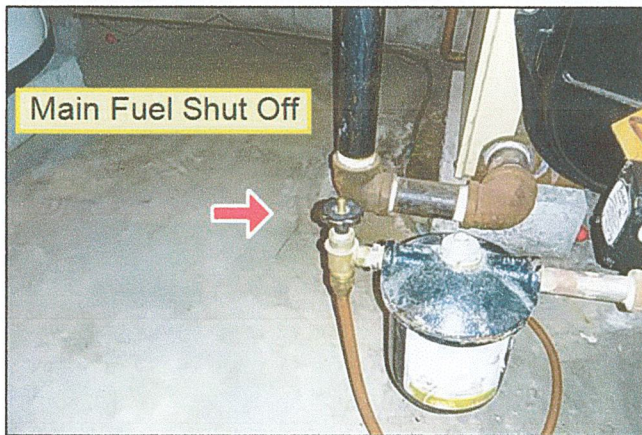
6.5 Main Fuel Shut-off (Describe Location)

The main fuel shut off is located at the oil burner in the basement. This is provided for your information.

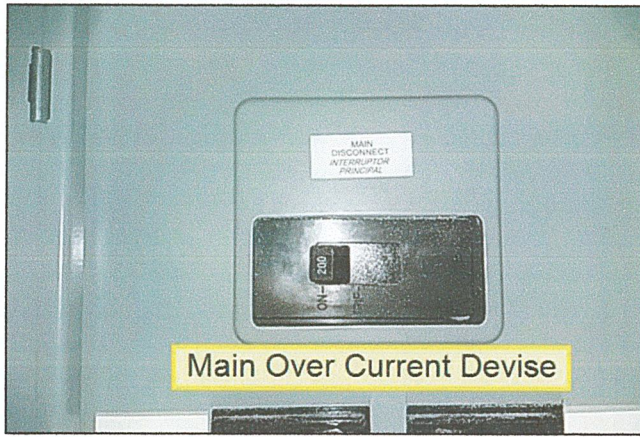
(1) The main over current devise is located in the main electric panel located in the basement. This is provided for your information.

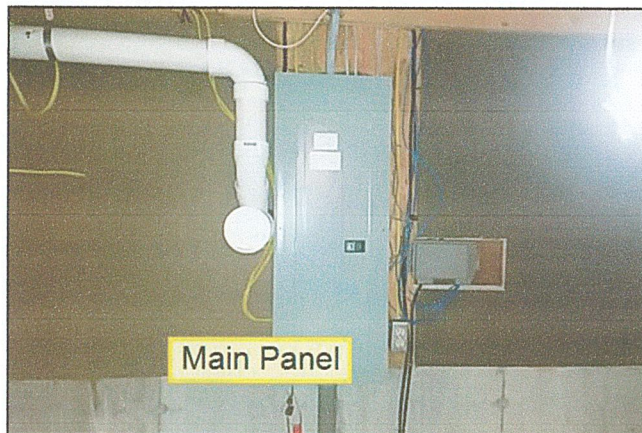
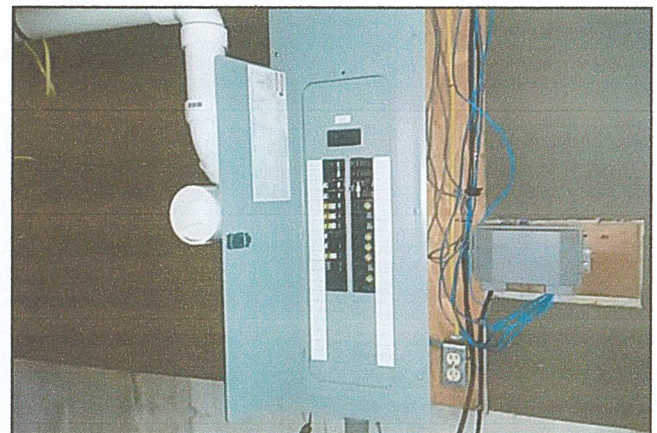
The main electric panel is located in the basement. This is provided for your information.

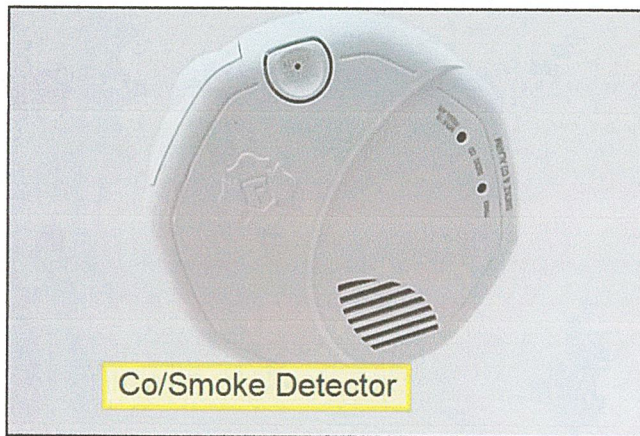
Carbon monoxide detectors are present in the home. At least one carbon monoxide detector is required in homes with a fuel burning appliance and in homes with an attached garage.

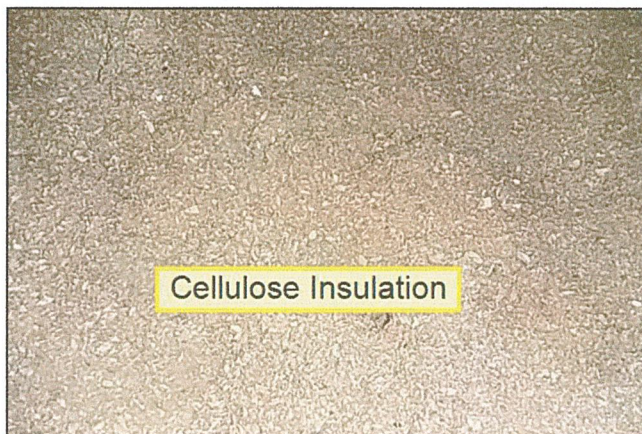
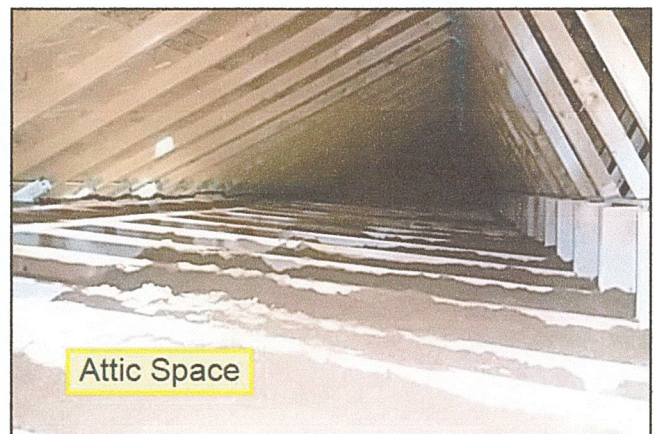
The attic is filled with cellulose insulation of various depths. This insulation was dry on the day of the inspection.

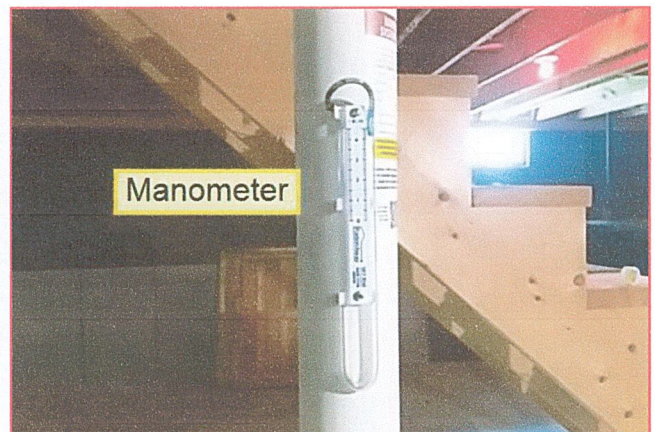
Photo 2

A radon system utilizing sub slab depressurization is present in the home (Photo 1). A manometer is present in the basement (Photo 2). Uneven fluid level in the manometer indicates a working radon fan. I recommend retesting radon levels every two years.

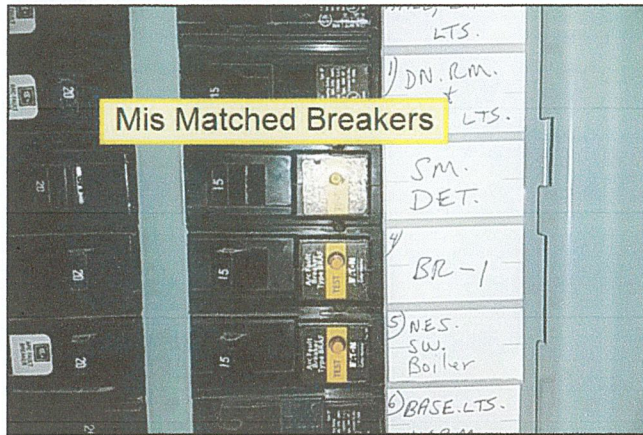
- (4) Several circuit breakers in the main panel are of a different brand than the panel manufacturer. The manufacturer requires that in order for the panel to be safe, only their brand is allowed to be used inside the

panel. Even though these circuit breakers are all "UL approved," they are not approved to be used in panels of different manufacturers unless so indicated on the panel label.

CHECK ON MISMATCHED BREAKERS.
