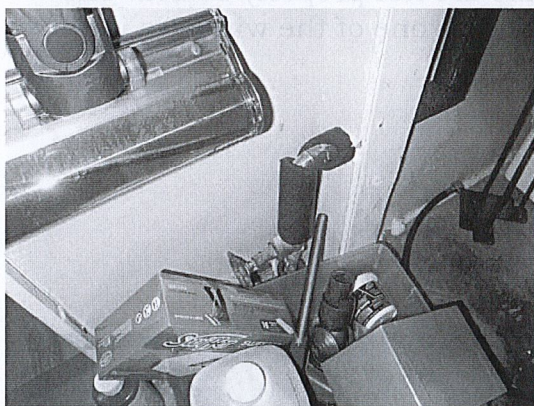
The water main shut off valve is located just above the floor to the left of the door in the utility closet. The interior finished sheet rock wall in the closet impedes on the operation of the water main shut off valve. The sheet rock should be cut away from the valve handle so the valve opens and closes unobstructed.
