Michael Casey
385 Maple Street, Stowe, Vermont

Inspection date
July 09, 2020

Reason for inspection
Transfer of property

Level of inspection
Level II

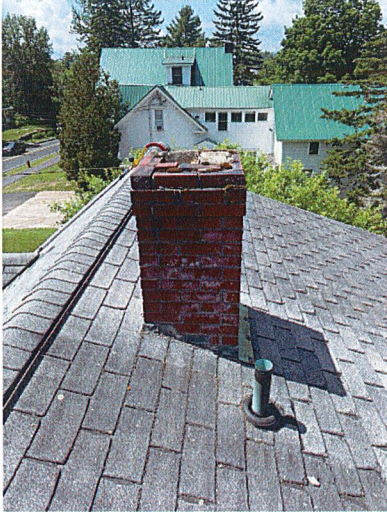
- **Roof Type:** Asphalt
- **Expansion joint between flue and wash:** Not applicable
- **Trees/vegetation or other objects that could present a hazard:** No
- **Seismic reinforcement and anchorage:** Not applicable
- **Cricket: presence / condition:** Not applicable
- **Basement / Crawl space:** Not applicable
- **Material:** Brick
- **Chimney height 3-2-10 rule:** Yes

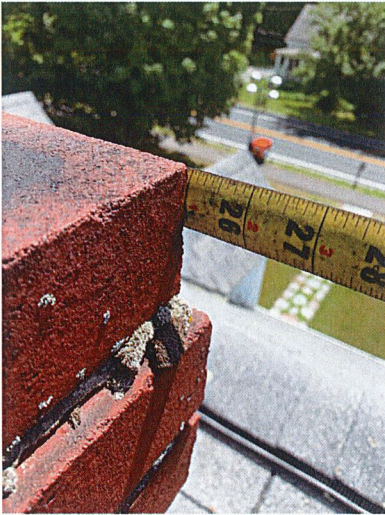
- **Crown Width: 25**

The crown / wash cap of the chimney is not constructed in a way that properly protects the chimney. The crown should be constructed with concrete. It must have an expansion joint around the flue tile. It should overhang the main structure to allow a drip edge to protect the chimney. A properly made crown will help protect the chimney from water intrusion and damage.

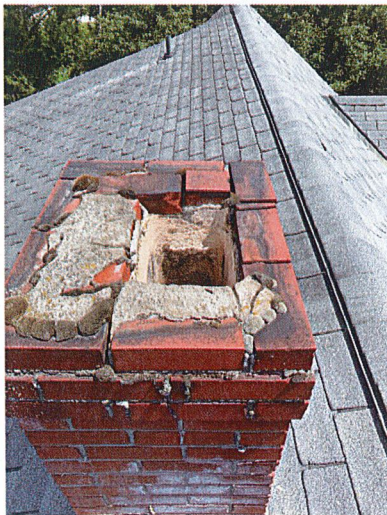
8x12 Clay Flue

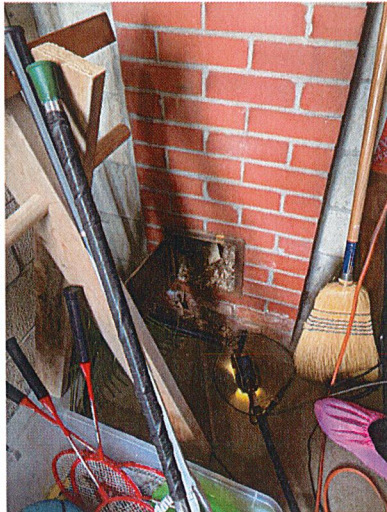
- **Flue clean out presence and condition:** Meets industry standards

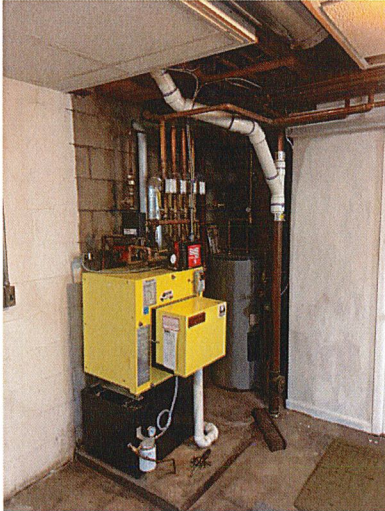
System 2000 Boiler

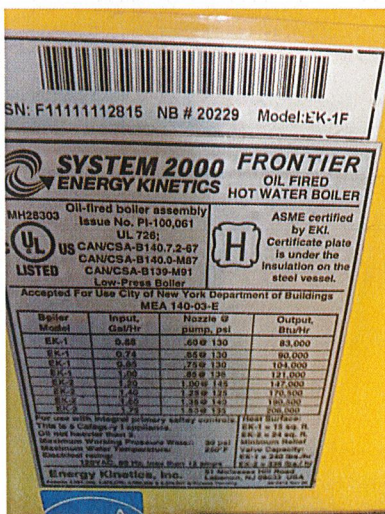
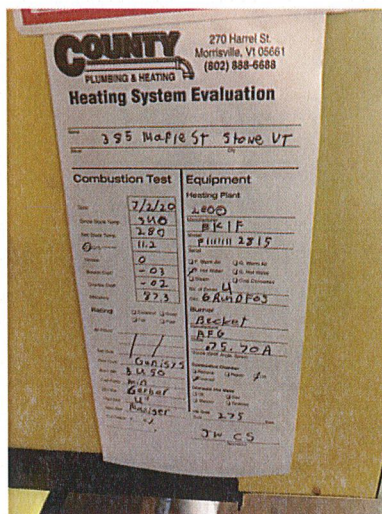
- General condition of appliance: Meets industry standards
- Fuel: Oil
- Appliance: Boiler
- Burner capacity G.P.H.: .75

- Nozzle size: 70a
