Radon Inspection Report

Property Inspection Report

Property address: **57 Edson Woods Rd
Stowe VT 05672**

Inspection date: **Monday, August 10, 2020**

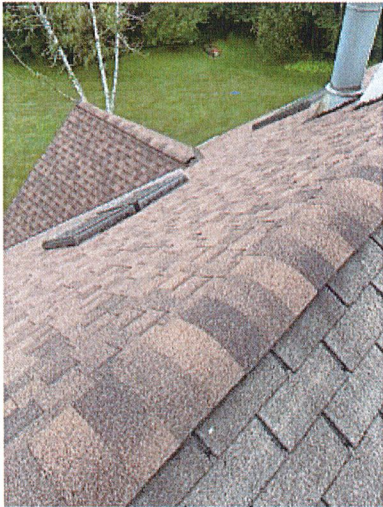
Photo 48-7 Replacement roof surface on the South facing side.

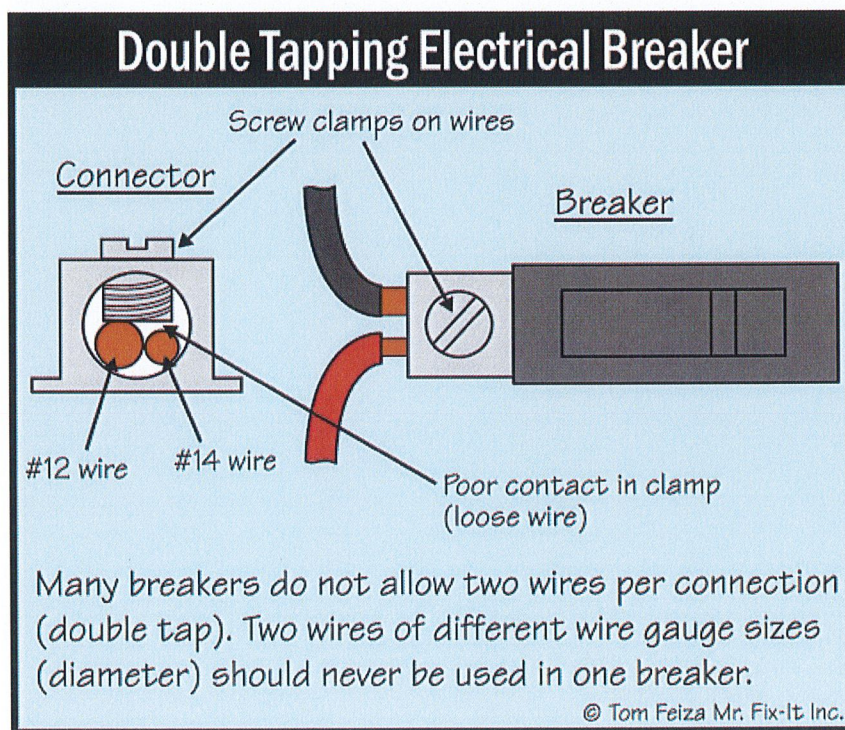
EO47C

59) Panel(s) appeared in adequate overall condition, however, neutral wires are doubled or bundled together on the neutral bar. This is unsafe due to the need to turn off multiple circuit breakers to work on any of the circuits using these wires. A qualified electrician should evaluate and repair as necessary.

One or more over-current protection devices (circuit breakers) are "double tapped", where 2 or more wires are clamped in a terminal designed for only one wire. This is a safety concern since the bolt or screw may tighten securely against one wire, but leave others loose. A very common item found during home inspections. A qualified electrician should evaluate and repair as necessary.
